the **play inspection** company

Annual Inspection

Winchester City Council

The Jubilee RG (Bramdean and Hinton Ampner PC)

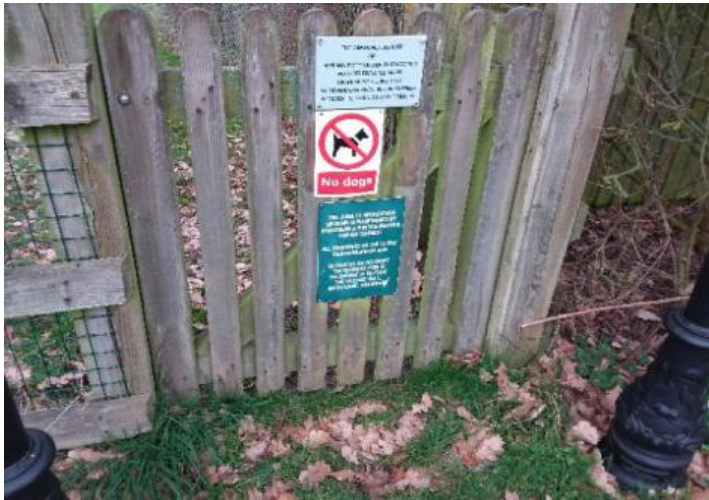
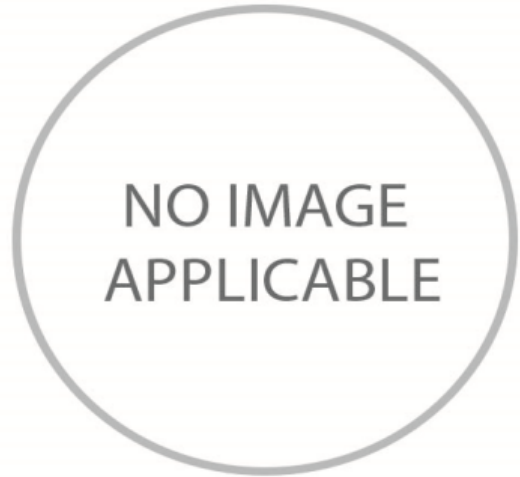
Finding: It is recommended that information signs with emergency contact details are installed at each entrance/exit set out in BS EN 1176 point to the playground

Action: Provide in accordance with the recommendations set out in BS EN 1176

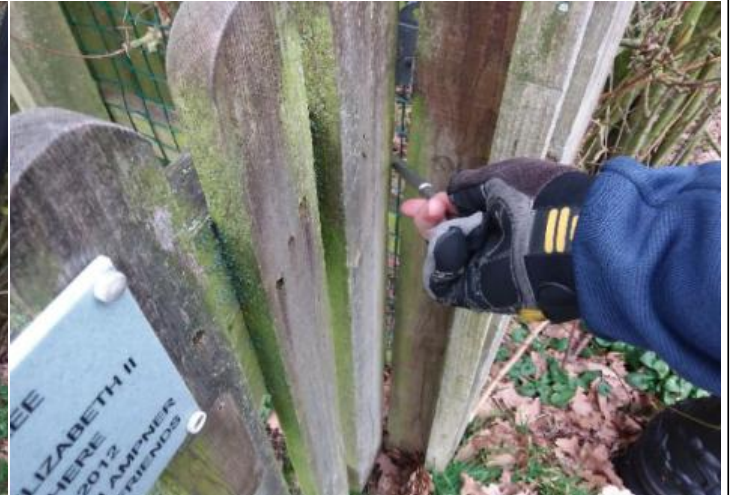
Finding: The opening between the gate and the post is less than 12mm and could trap users fingers
Action: Adjust gate to ensure a 12mm opening all around

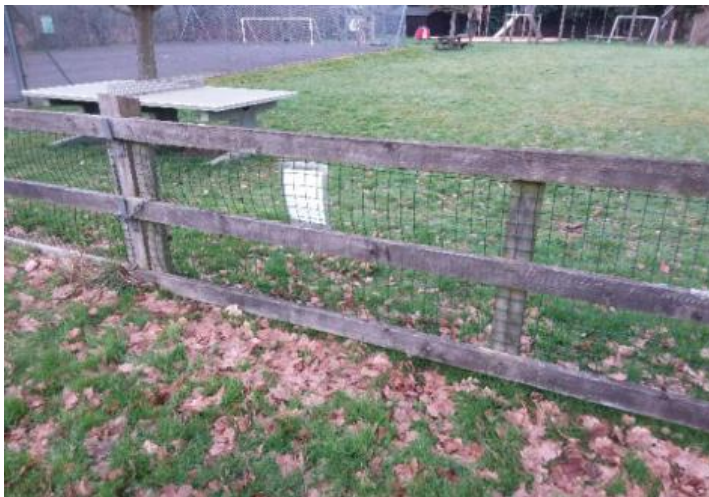
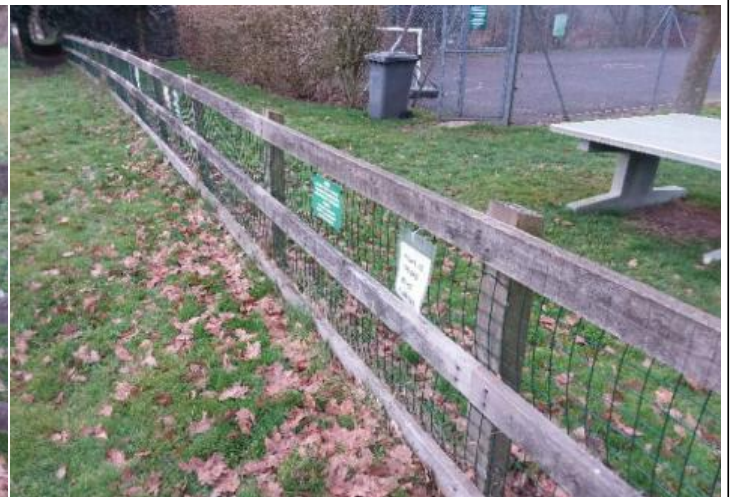
Finding: There are a number of loose posts around the fence
Action: Monitor for any further deterioration and reset as required

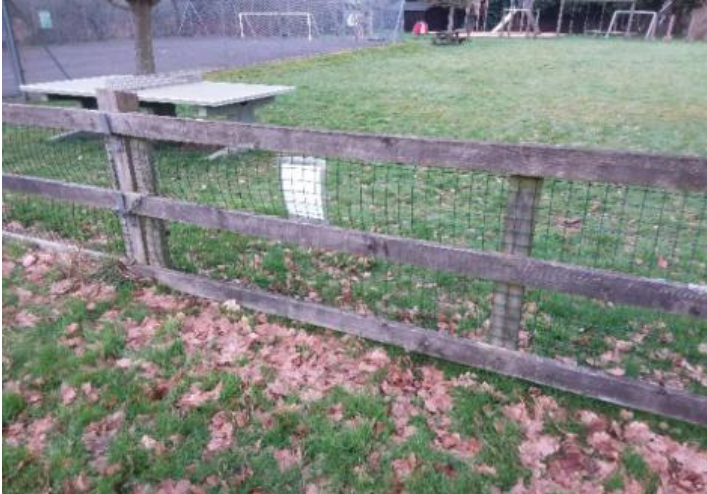
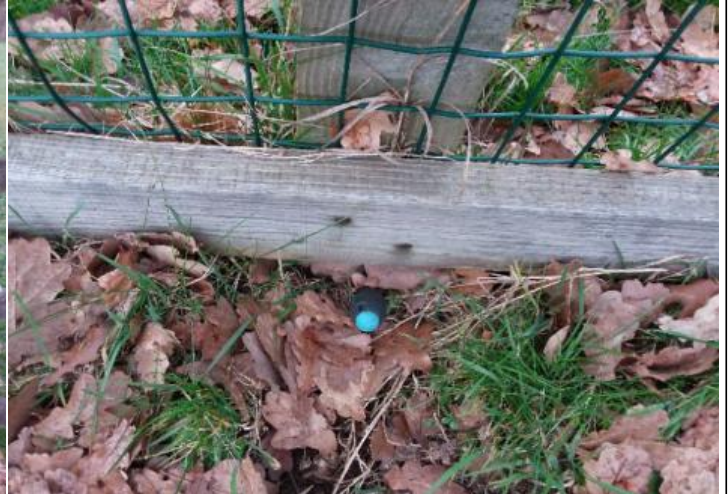
Finding: There are areas or parts of the timber on the structure that have rotted

Action: Replace all affected timbers

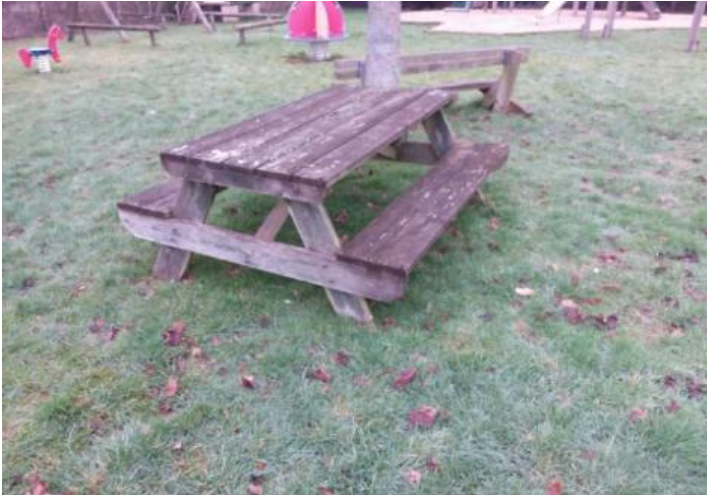
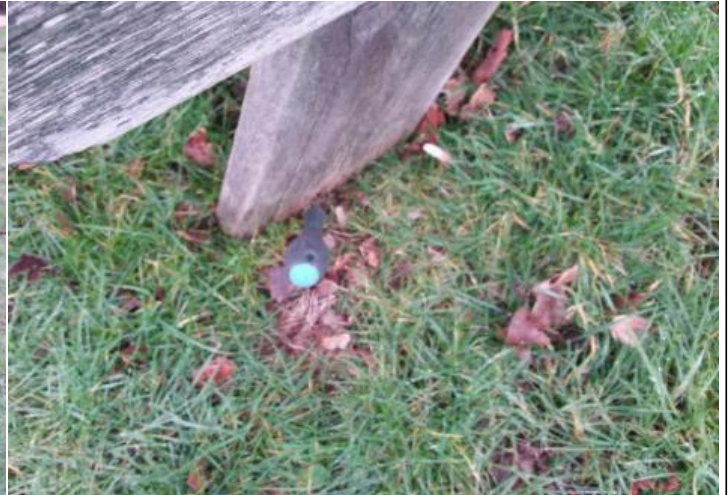
Finding: There is some evidence of rot in the timber

Action: Monitor for any further deterioration and replace as required

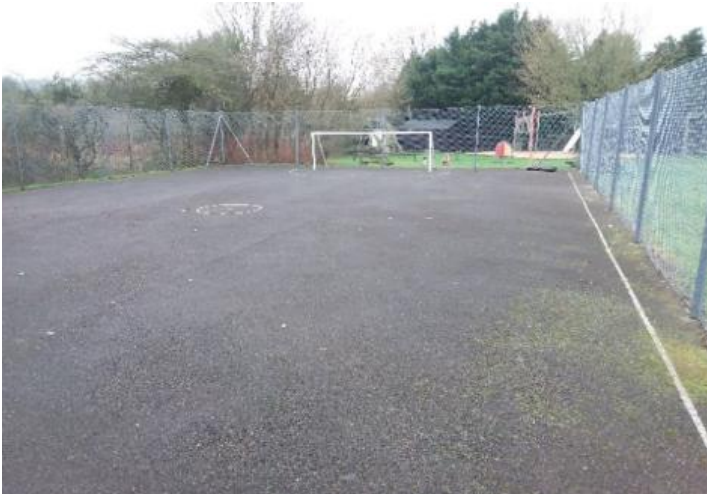
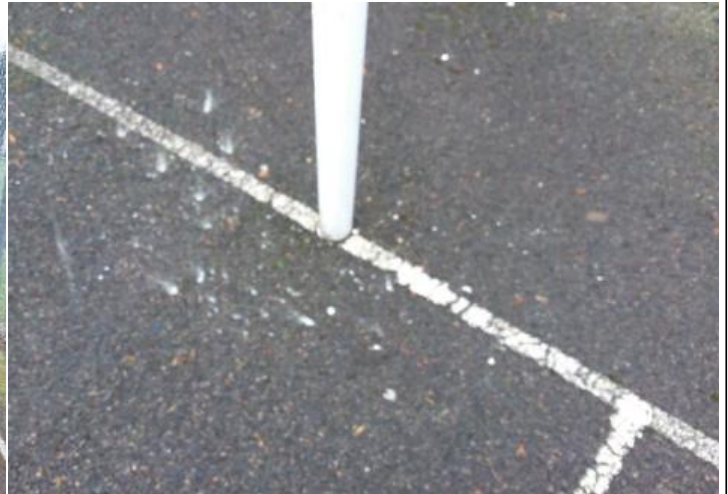
Finding: The goal posts are slightly loose in the ground

Action: Monitor for any further deterioration and repair as required

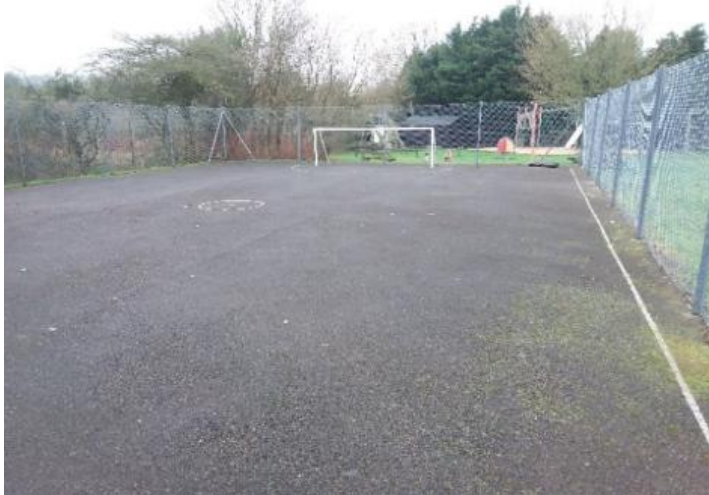
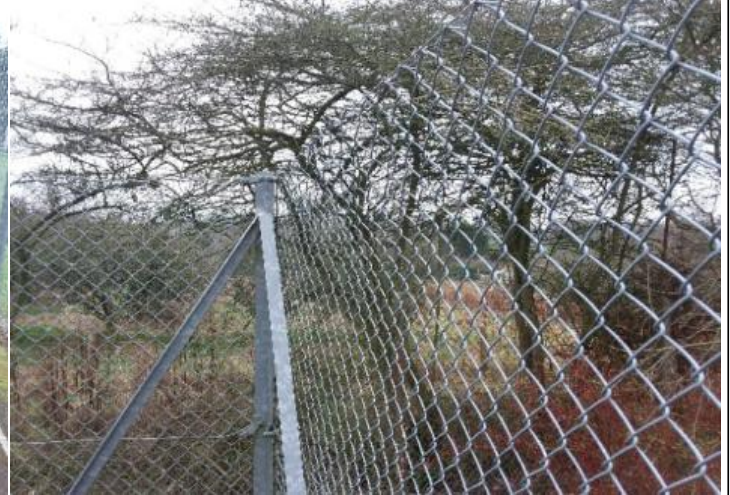
Finding: There is some damage to the fence sections

Action: Monitor for any further deterioration and repair as required

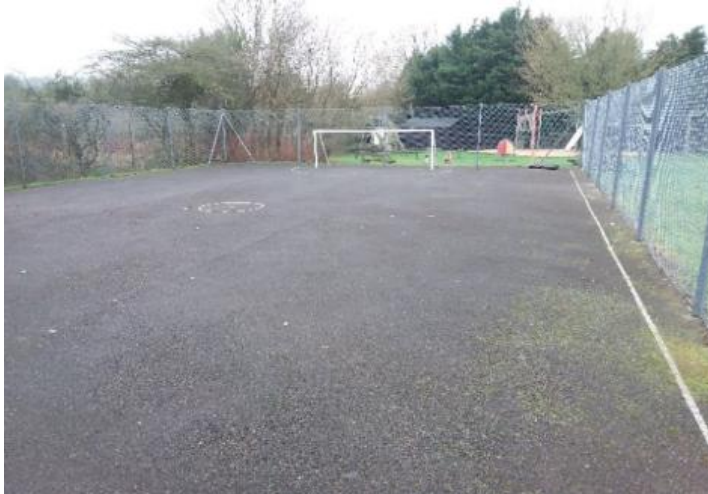
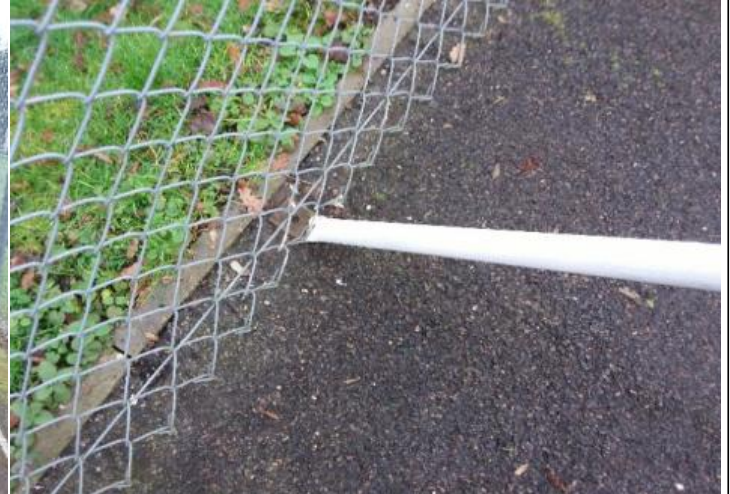
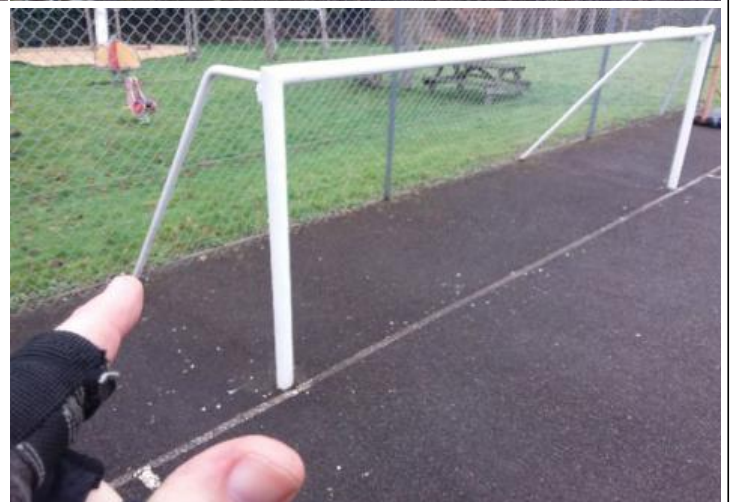
Finding: There is or are fixings missing on the goals

Action: Replace all missing fixings

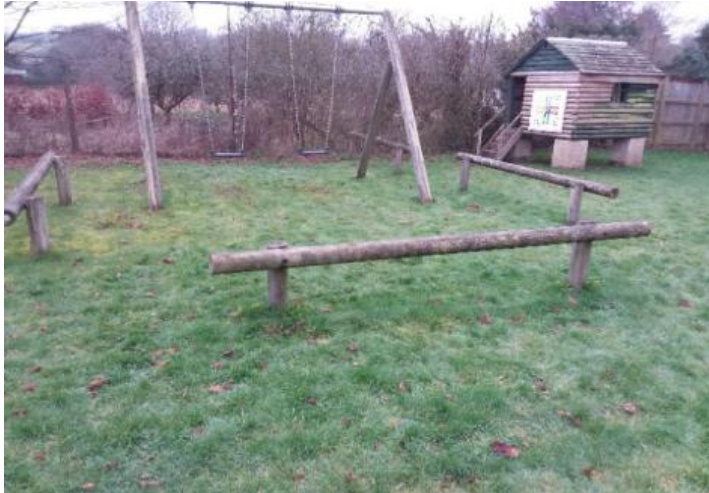
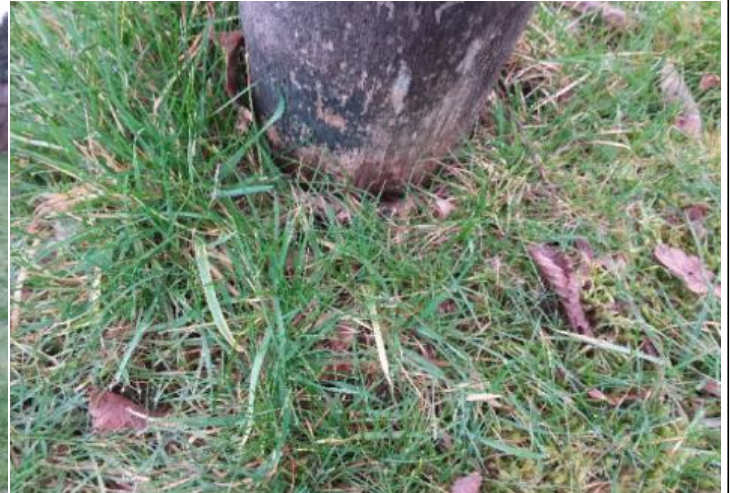
Finding: There is some strimmer / machinery damage apparent on the posts, this can penetrate the preservative applied to the timber and accelerate the rotting process

Action: Monitor for any deterioration (rot) and replace as required

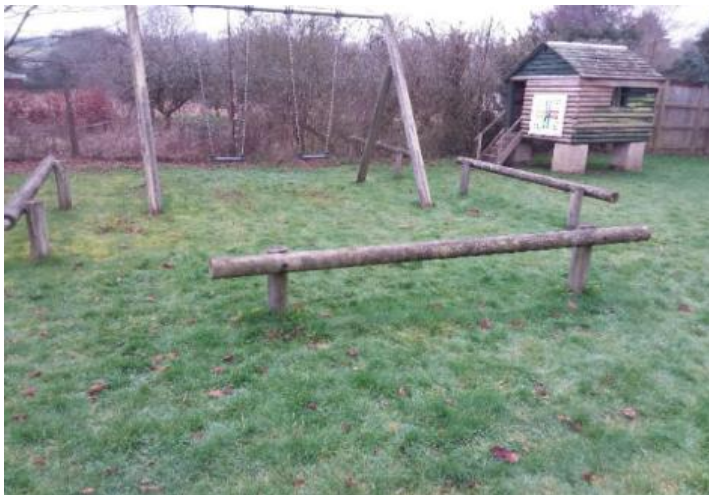
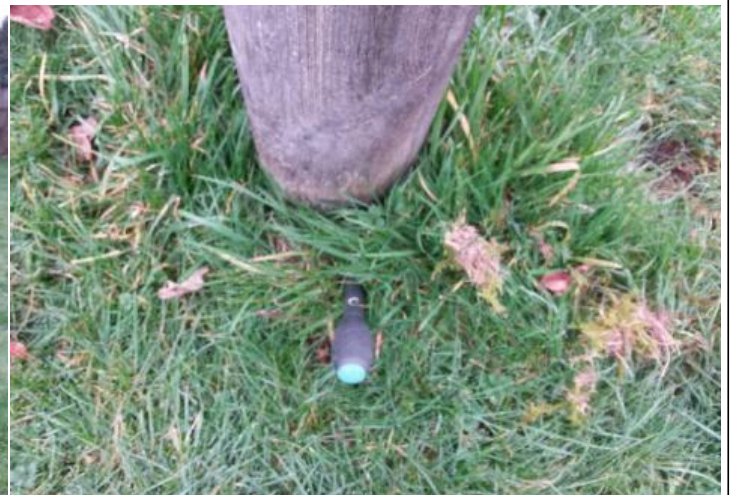
Finding: There is some evidence of rot in the timber

Action: Monitor for any further deterioration and replace as required

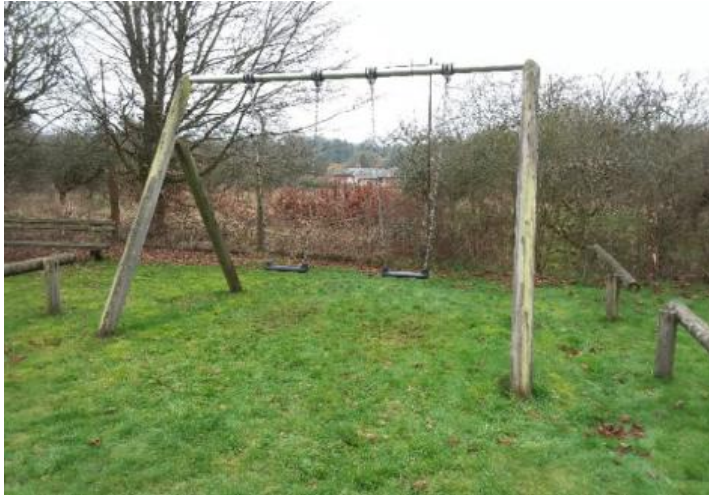
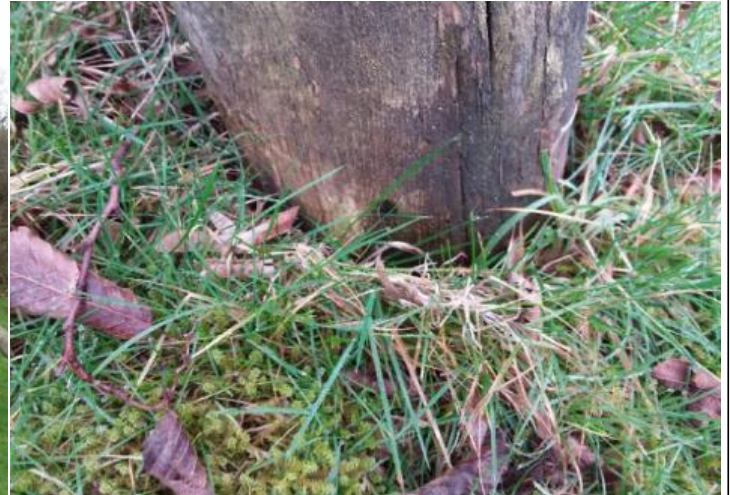
Finding: There is some strimmer / machinery damage apparent on the posts, this can penetrate the preservative applied to the timber and accelerate the rotting process

Action: Monitor for any deterioration (rot) and replace as required

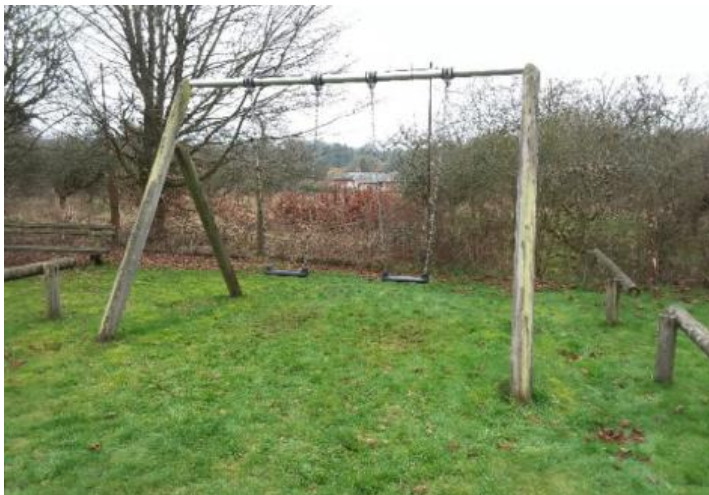
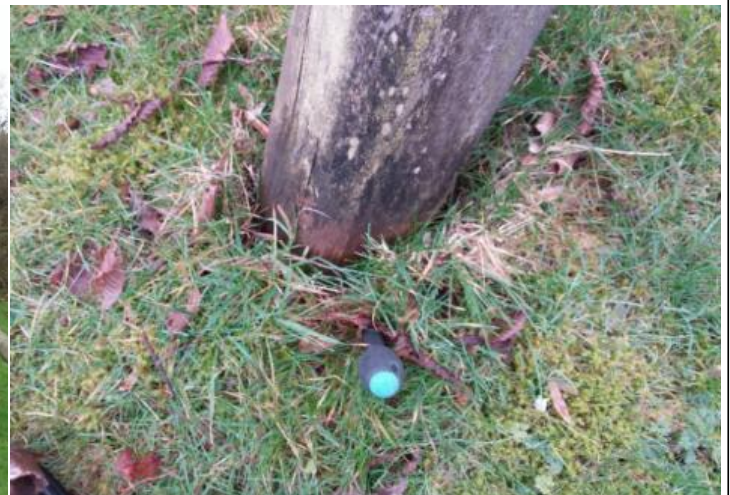
Finding: There is some evidence of rot in the posts

Action: Monitor for any further deterioration and replace as required

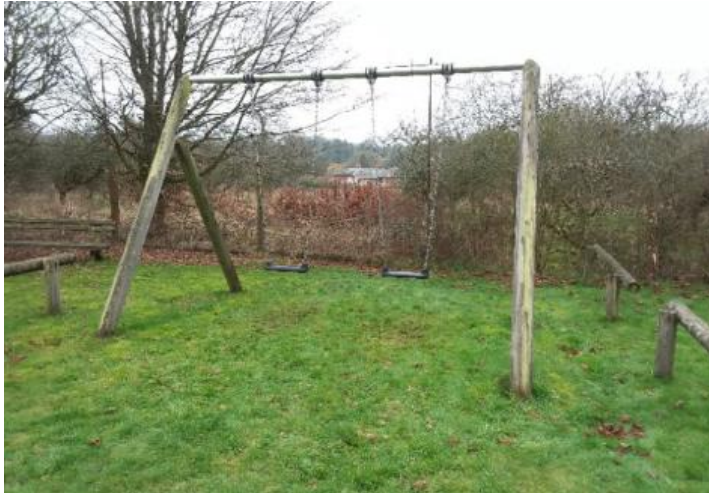
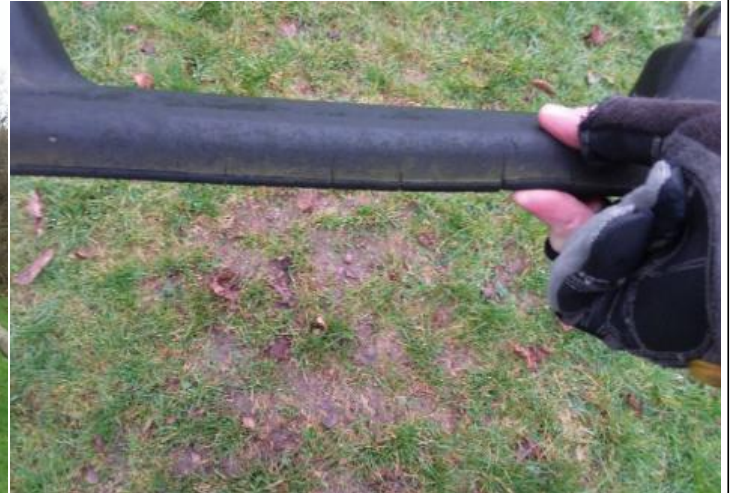
Finding: There is some notable evidence of chain wear

Action: Monitor for any further deterioration and replace when 40% worn

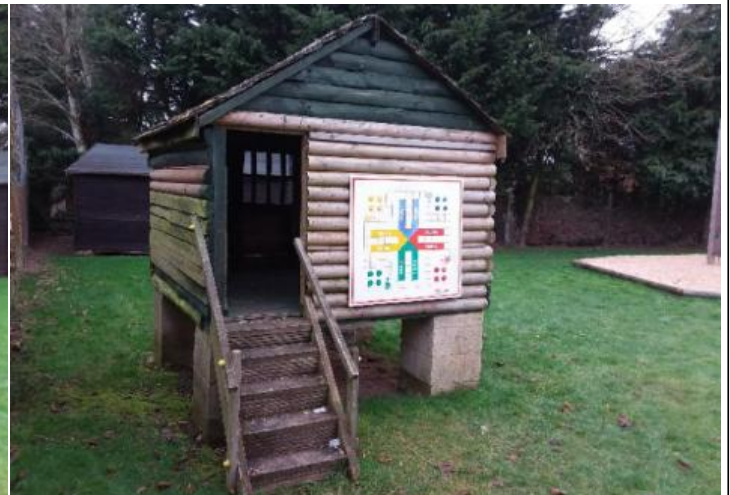
Finding: This equipment has not been designed or installed to meet with the requirements of BS EN 1176 for public playground equipment; we have however used our knowledge of these standards to assist in forming the basis of our risk assessment for the equipment and our report.

Action: Monitor use and review the use of the equipment and risk assessment regularly

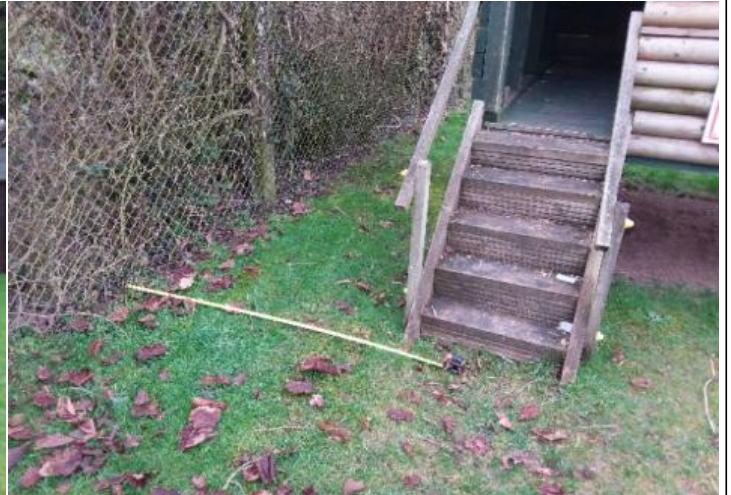
Finding: The fencing forms a hard object within the falling space / impact area of the equipment

Action: Monitor use

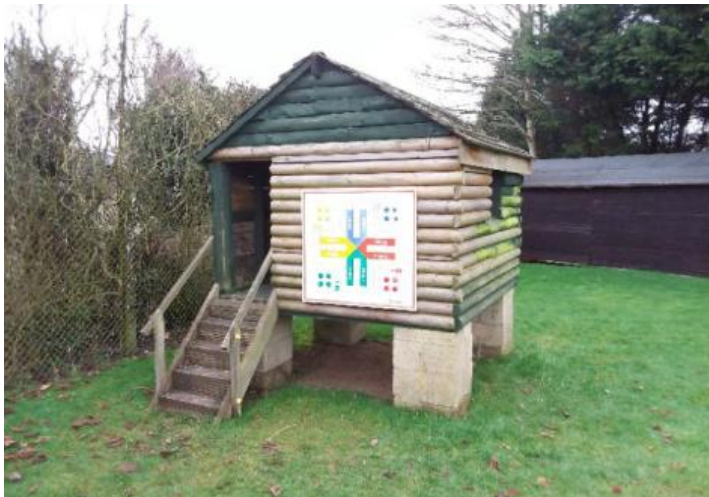
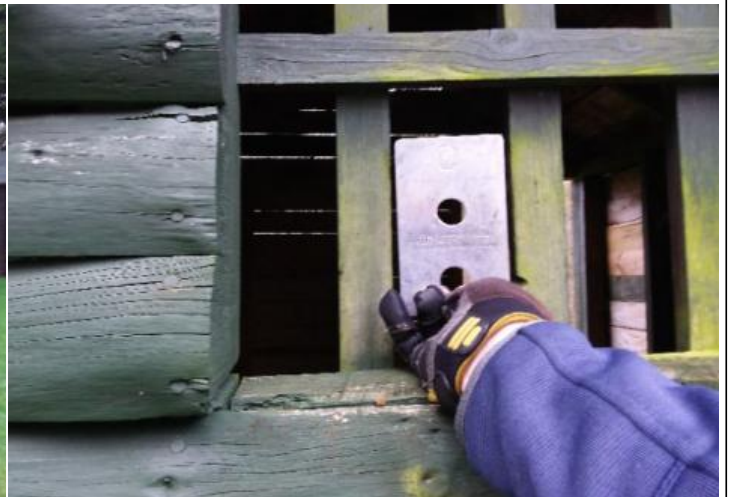
Finding: The item fails to meet the requirements of BS EN 1176 Part 1 4.2.7.2 for head and neck entrapment in the framework

Action: Monitor use

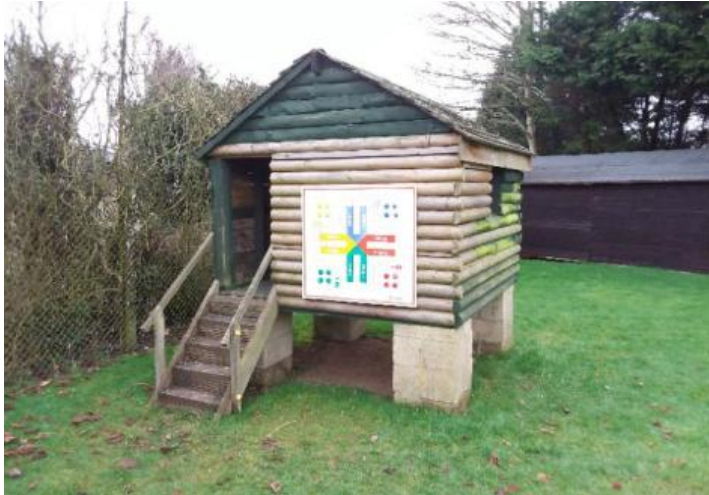
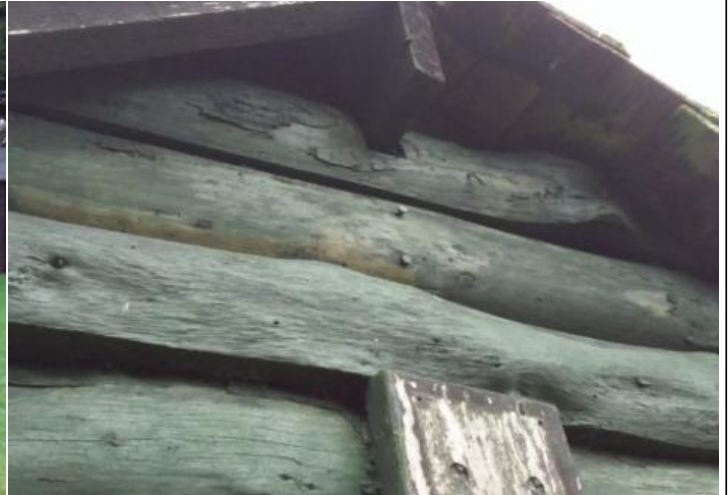
Finding: A number of fixing(s) have worked loose

Action: Secure all loose fixings

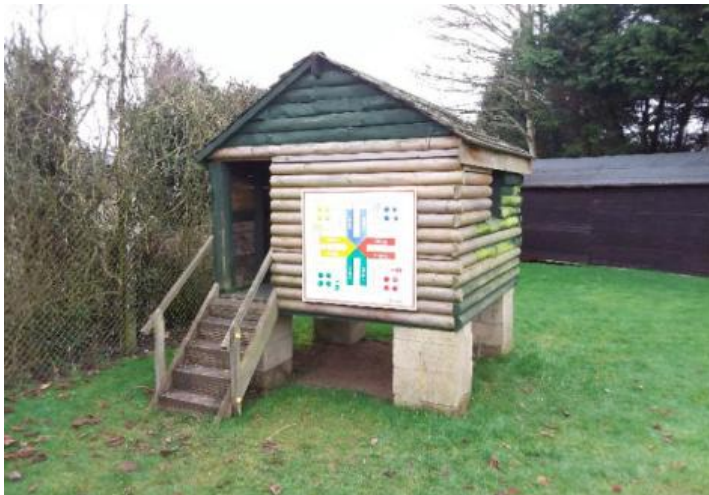
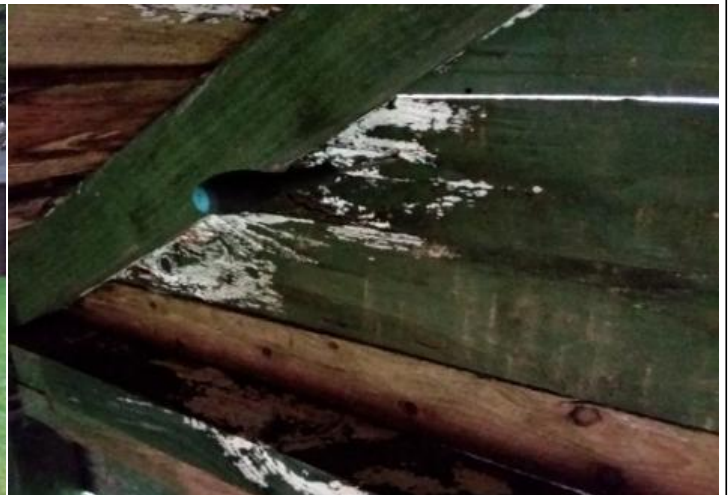
Finding: There is some evidence of rot in the timber

Action: Monitor for any further deterioration and replace as required

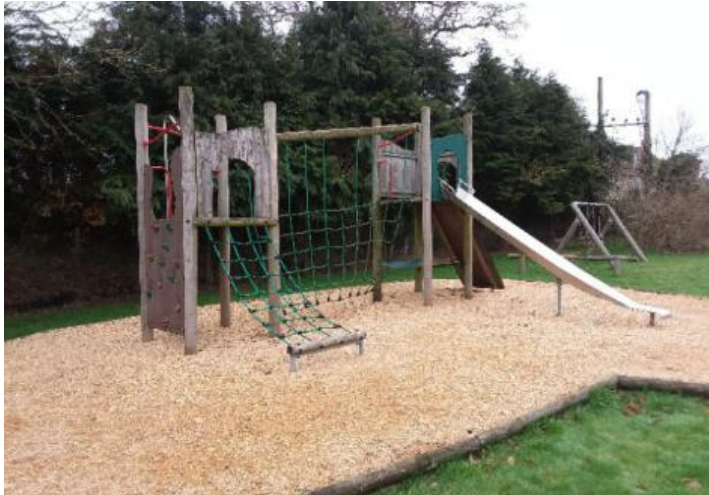
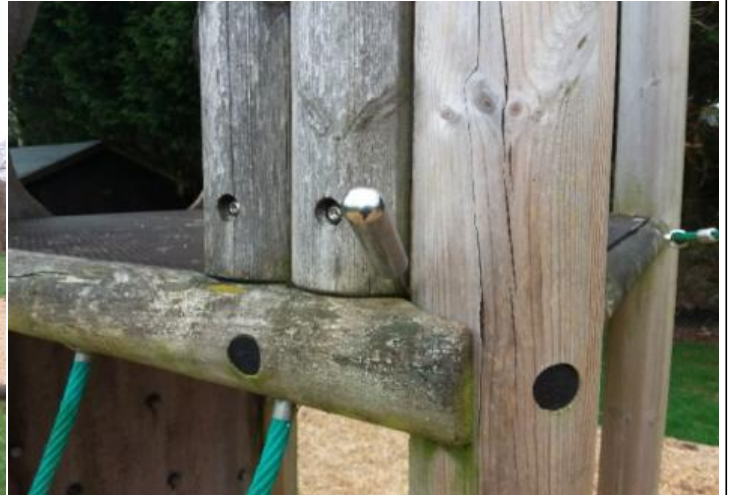
Finding: There is/are finger entrapment/s between barrier and post and the item fails to meet the requirements of BS EN 1176 Part 1 4.2.7.6 Entrapment of fingers

Action: Monitor use

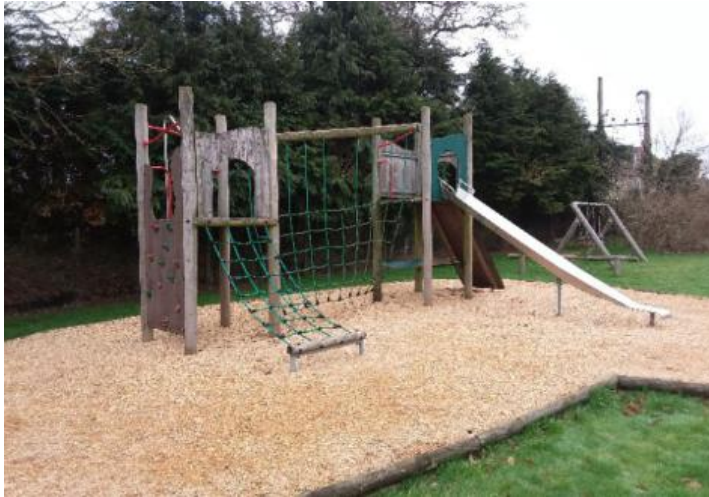
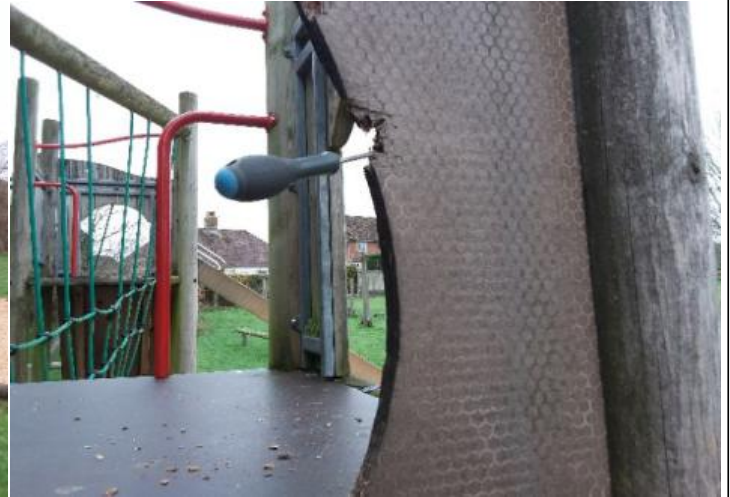
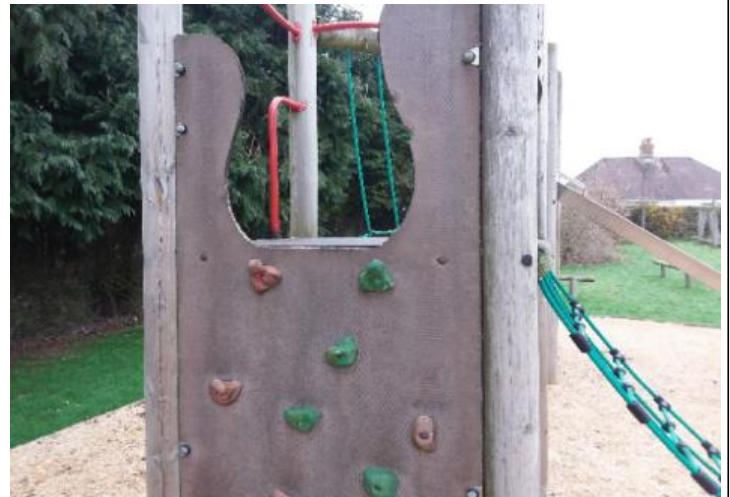
Finding: There are areas or parts of the climbing panel that have rotted

Action: Replace all affected timbers

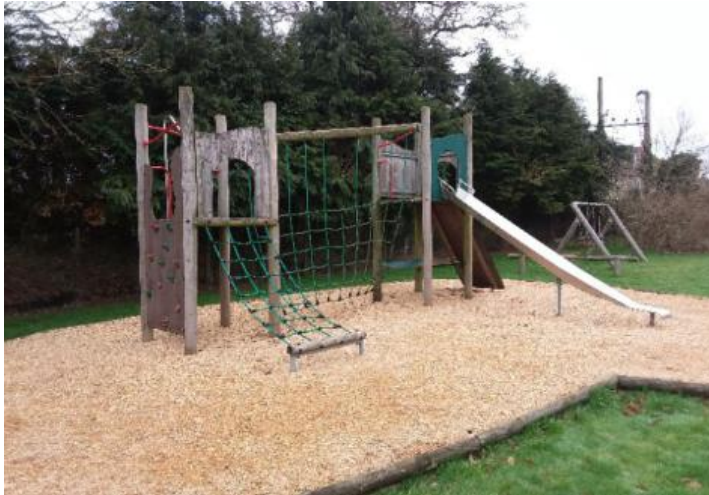
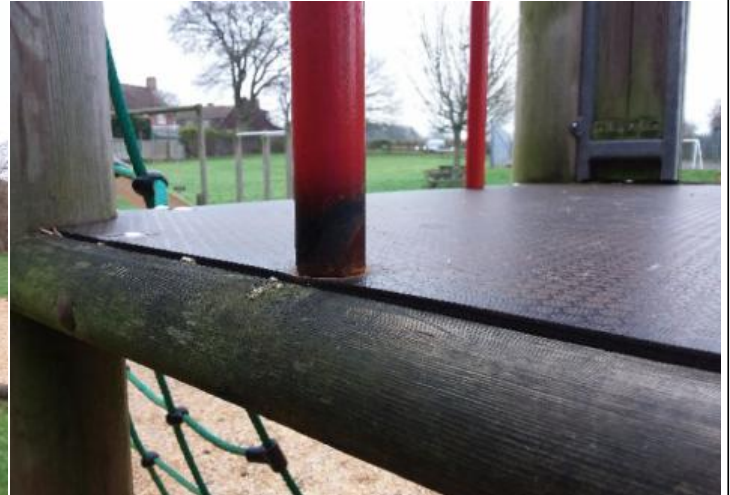
Finding: There is some evidence of fire damage to the item **Action:** Monitor for any further deterioration and repair as required

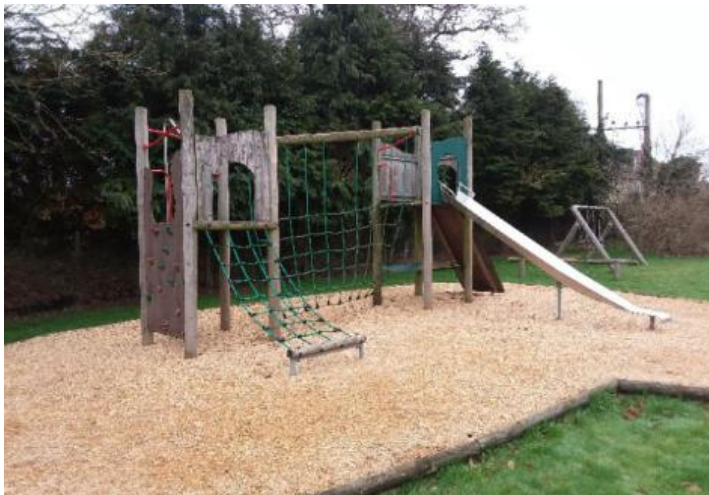
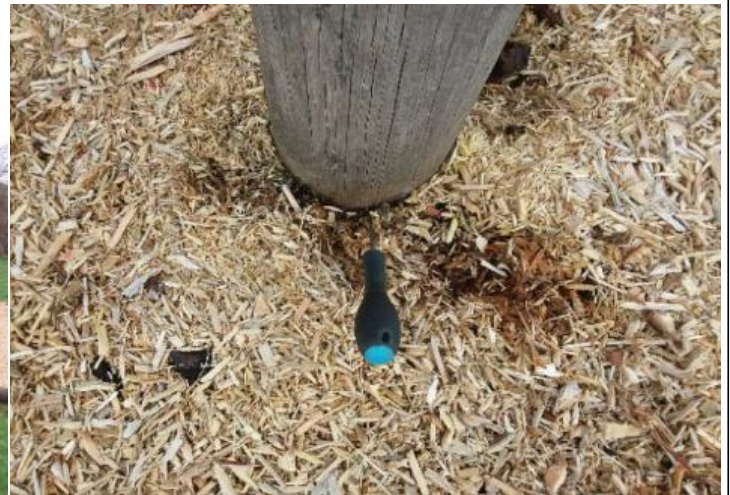
Finding: There is some evidence of rot in the posts **Action:** Monitor for any further deterioration and replace as required

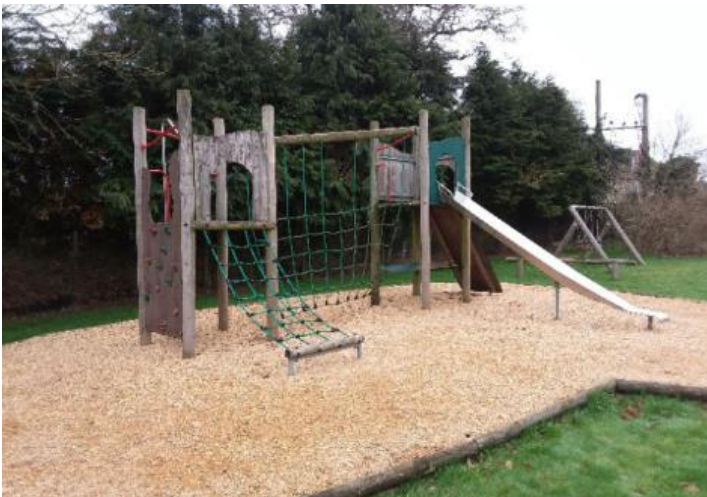
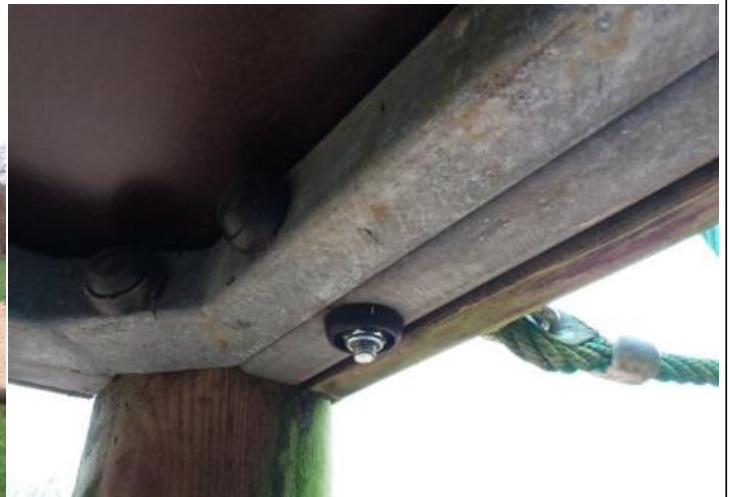
Finding: There is/are bolt cap covers missing or damaged on the item

Action: Replace missing or damaged bolt cap covers

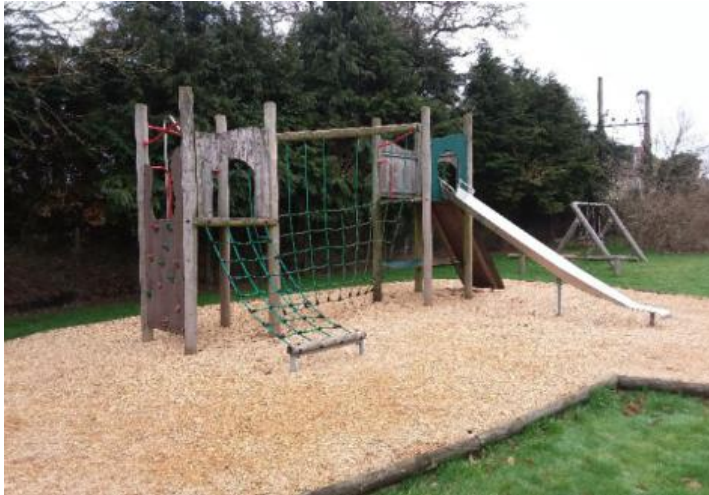
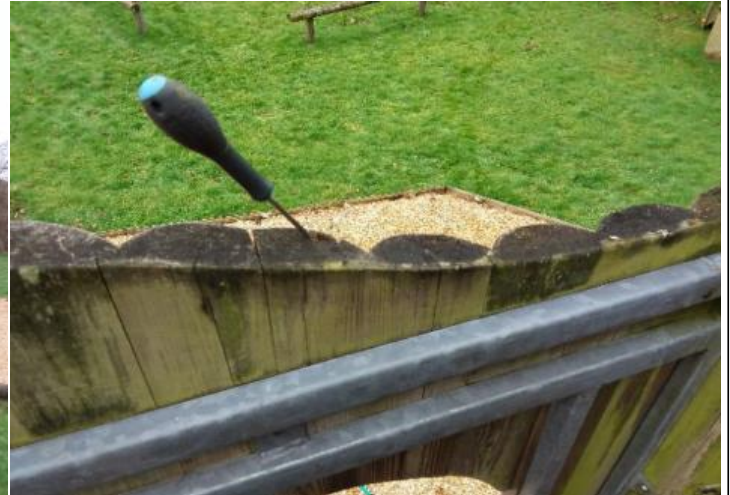
Finding: There is some evidence of rot in the timber

Action: Monitor for any further deterioration and replace as required

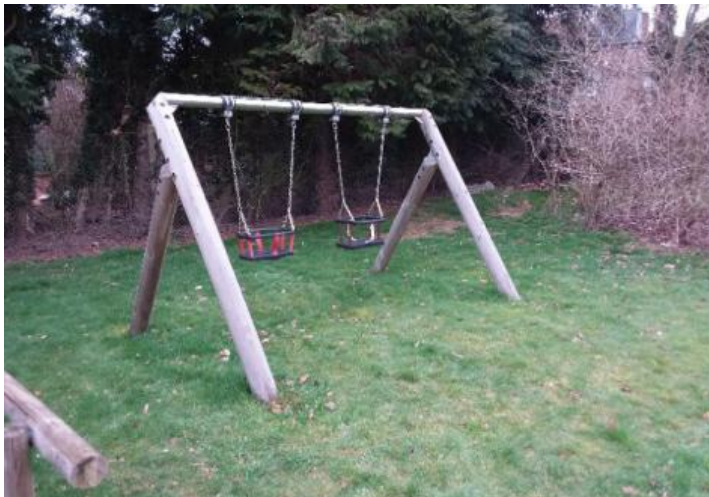
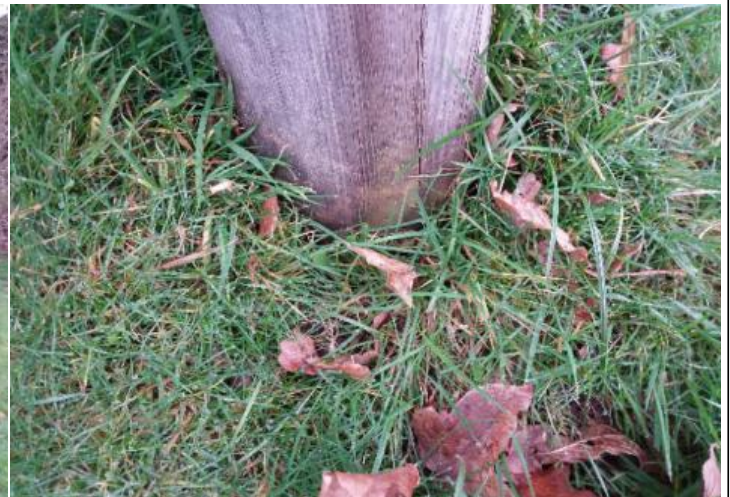
Finding: There is some strimmer / machinery damage apparent on the posts, this can penetrate the preservative applied to the timber and accelerate the rotting process

Action: Monitor for any deterioration (rot) and replace as required

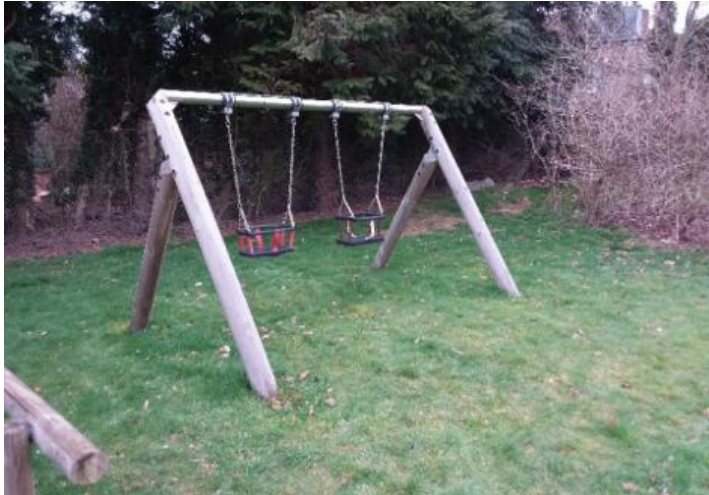
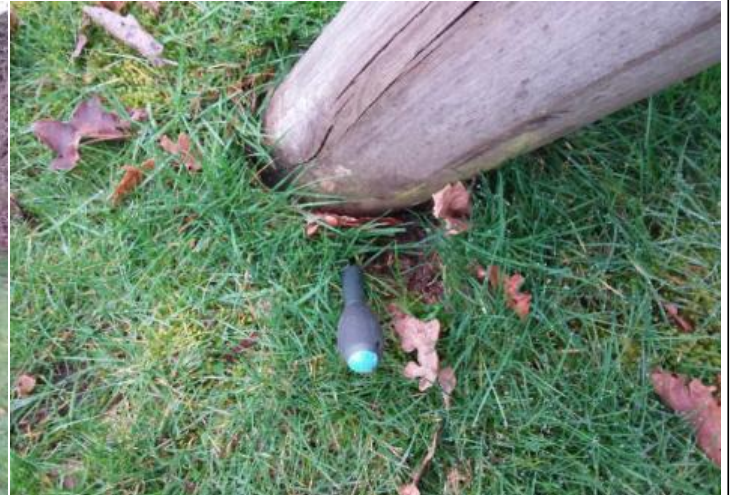
Finding: There is some evidence of rot in the posts

Action: Monitor for any further deterioration and replace as required

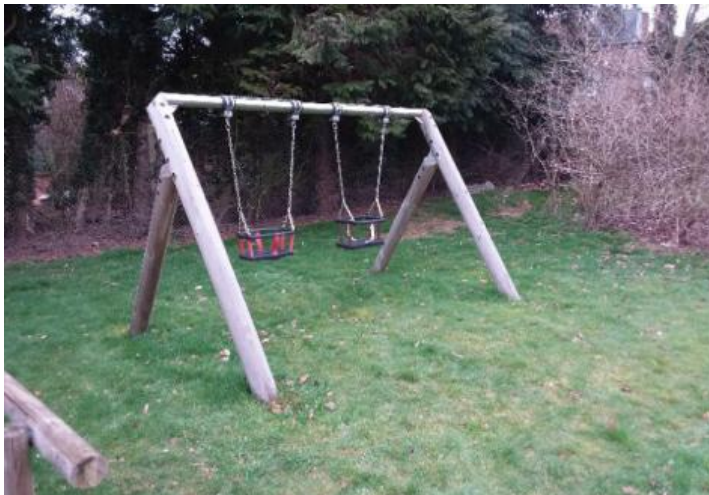
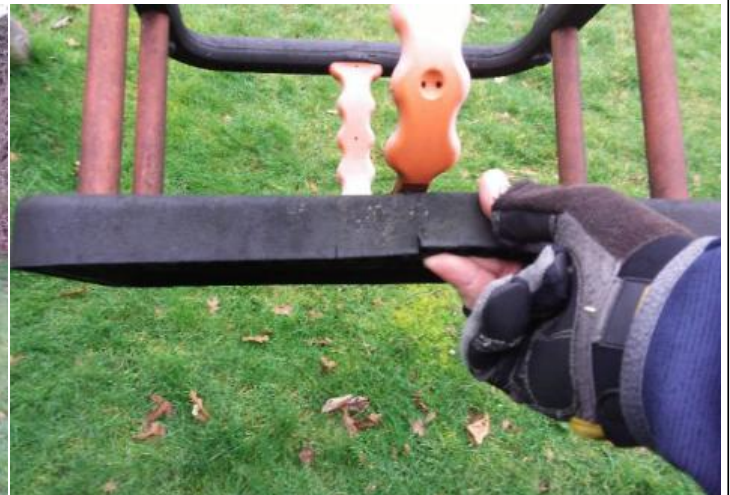
Finding: The seat has minor damage or wear

Action: Monitor for any further deterioration and replace as required

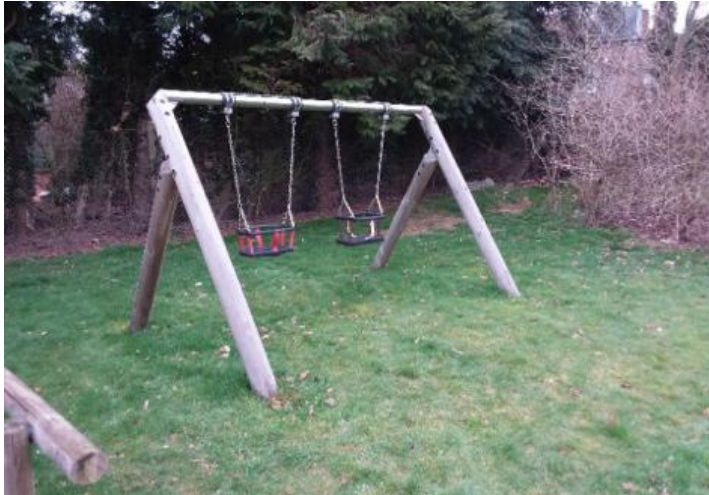
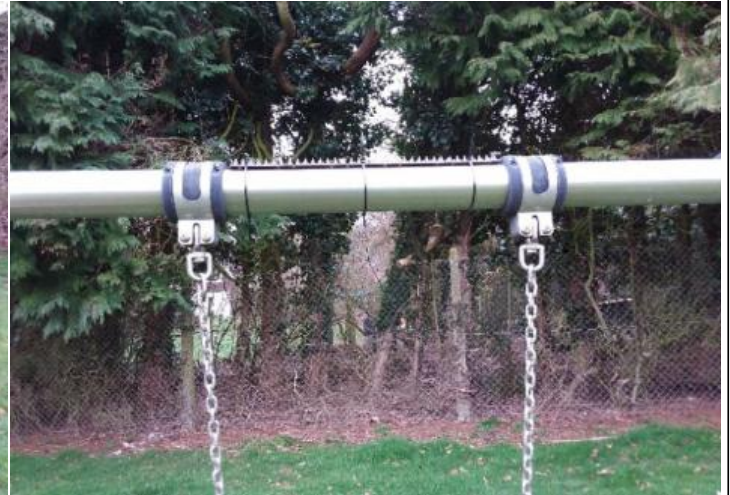
Finding: The Anti Wrap bearings are dry and not moving freely

Action: Lubricate bearings in accordance with the manufacturers recommendations

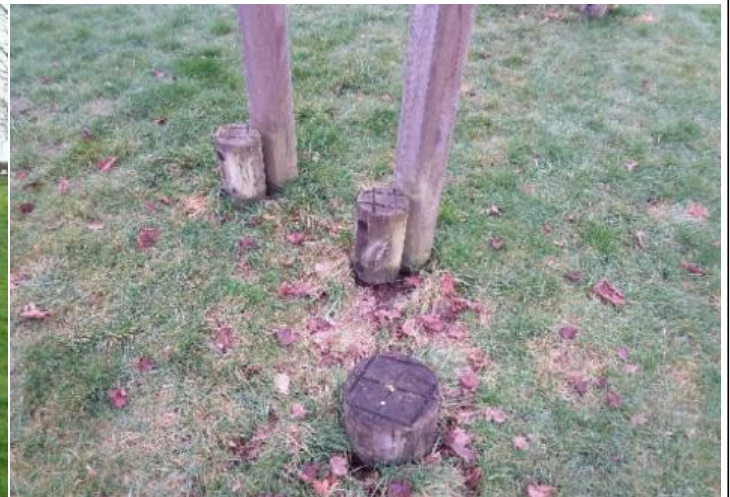
Finding: There is algae or moss on the surface of the equipment

Action: Clean and treat appropriately

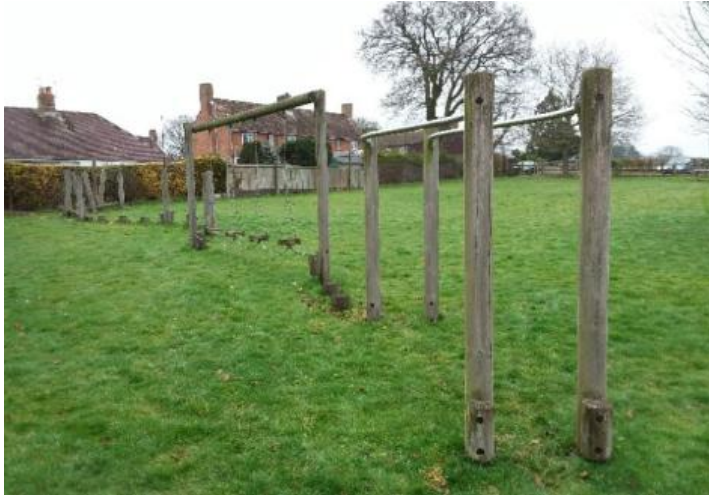
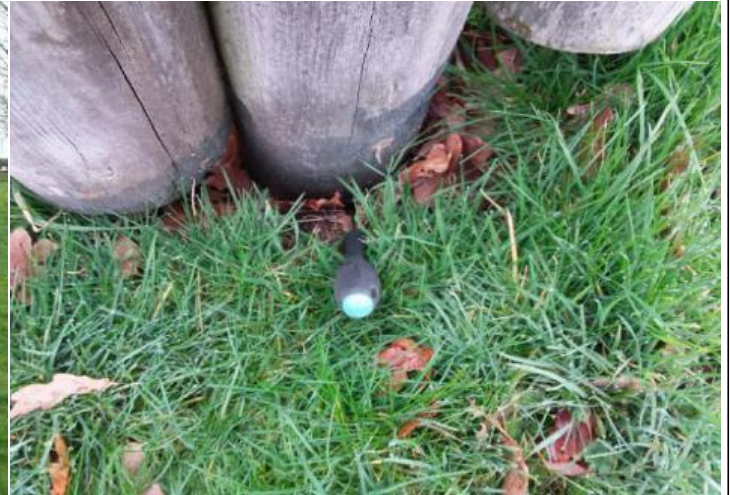
Finding: There is some evidence of rot in the timber

Action: Monitor for any further deterioration and replace as required

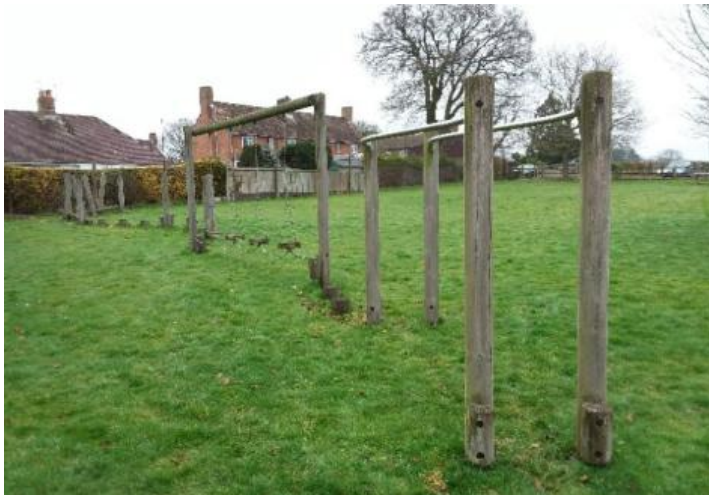
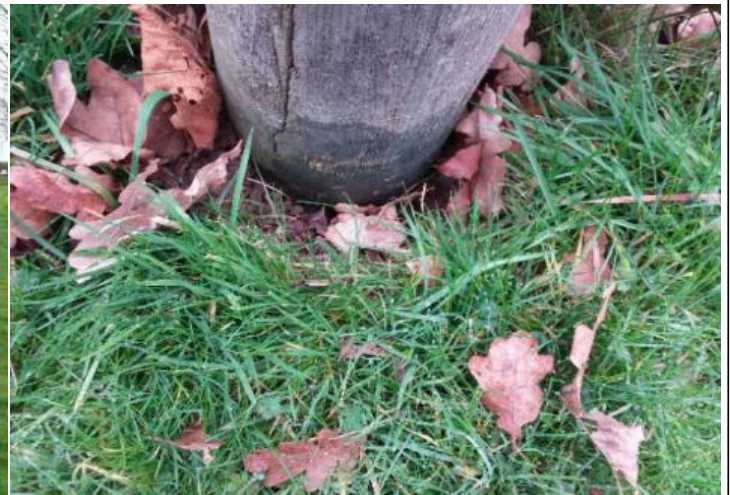
Finding: There is some strimmer / machinery damage apparent on the posts, this can penetrate the preservative applied to the timber and accelerate the rotting process

Action: Monitor for any deterioration (rot) and replace as required

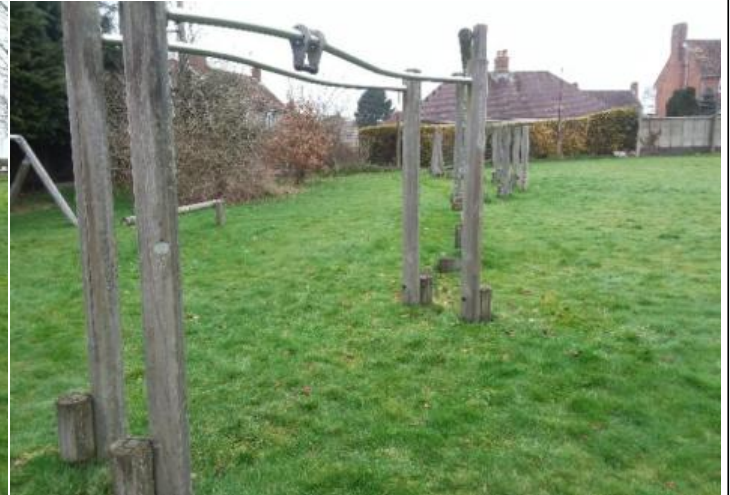
Finding: The item of equipment has a fall height exceeding 1.50 metres and grass has been provided as a safety surface

Action: Provide a suitable impact attenuating surface
