the **play inspection** company

Annual Inspection

Winchester City Council

The Jubilee RG (Bramdean and Hinton Ampner PC)

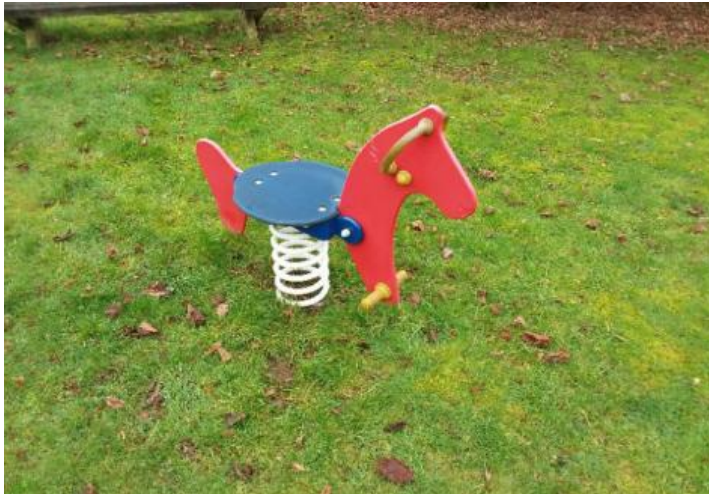
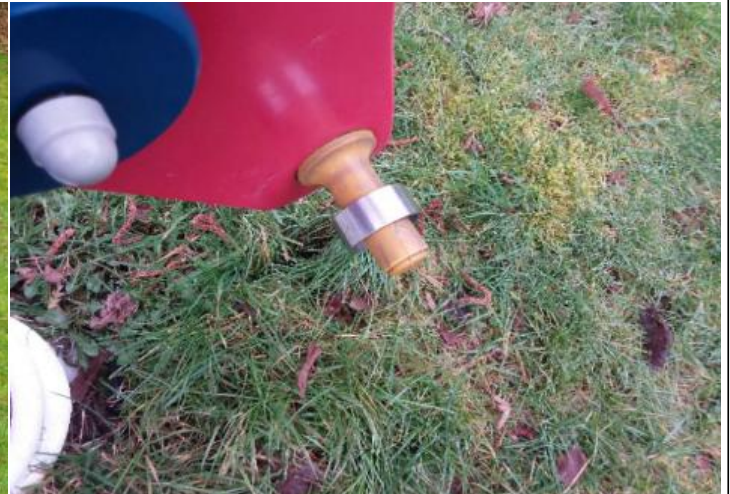
Finding: The end of handgrips and/or footrests have a cross section of less than 15cm² and fail to meet the requirements of BS EN 1176 Part 6; this is however, a relatively low risk failure and no remedial action is recommended

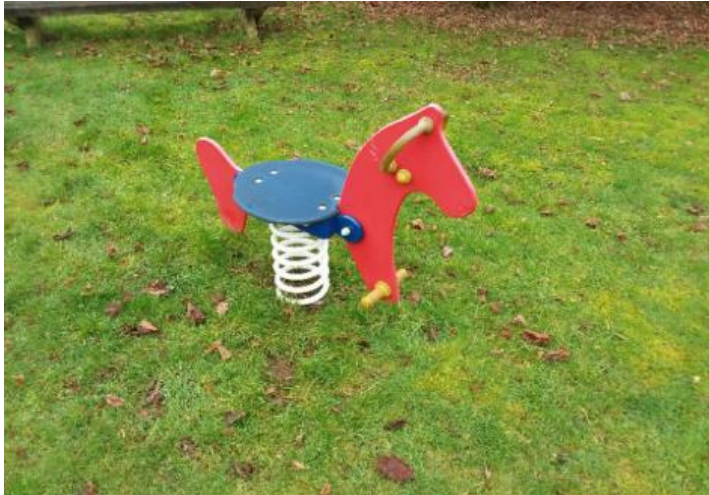
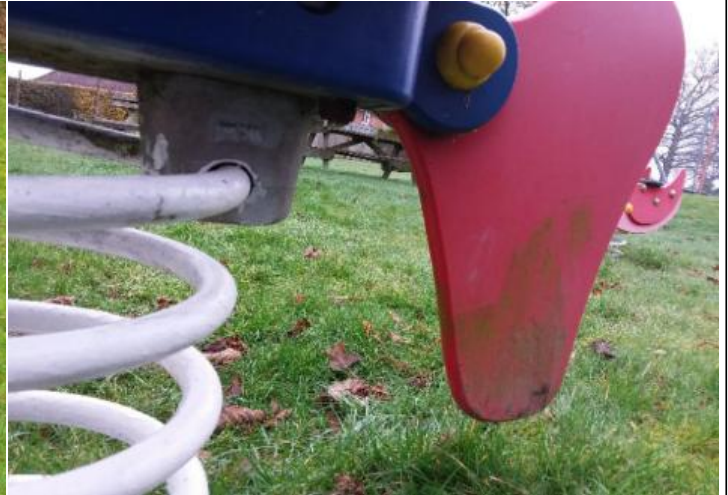
Finding: There is/are bolt cap covers missing or damaged on the item

Action: Replace missing or damaged bolt cap covers

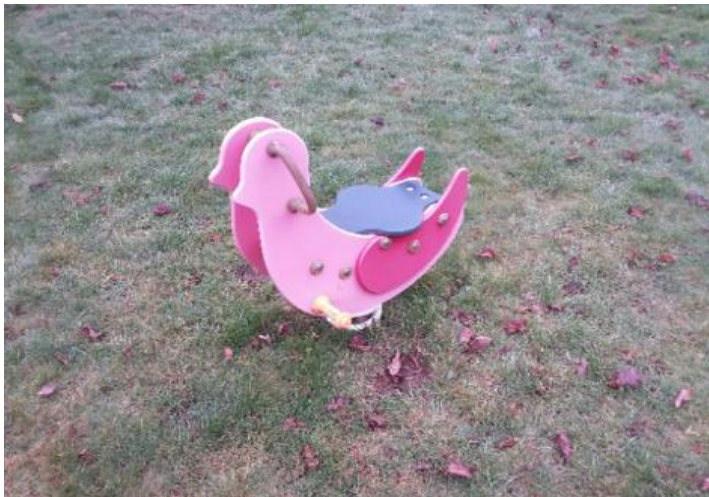
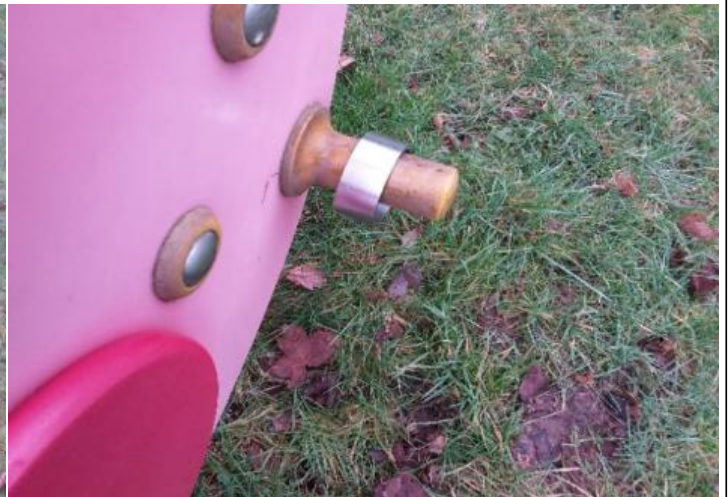
Finding: The end of handgrips and/or footrests have a cross section of less than 15cm² and fail to meet the requirements of BS EN 1176 Part 6; this is however, a relatively low risk failure and no remedial action is recommended
