Annual Inspection

Winchester City Council

The Jubilee RG (Bramdean and Hinton Ampner PC)

Off Woodlane Close, Bramdean, Winchester,
Hampshire, SO24 0JR

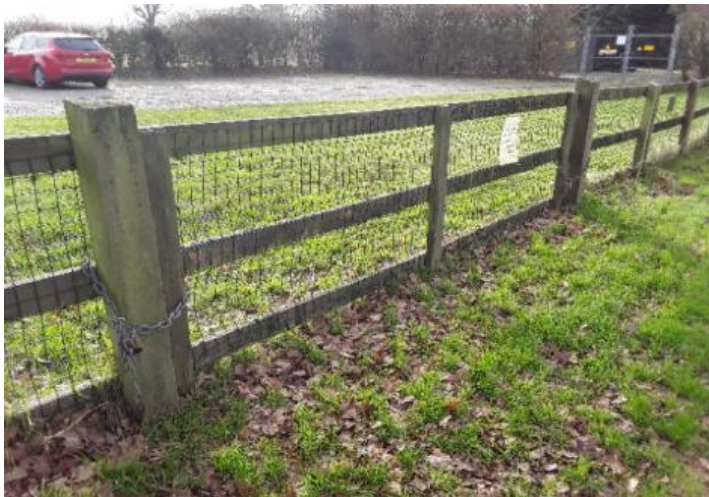
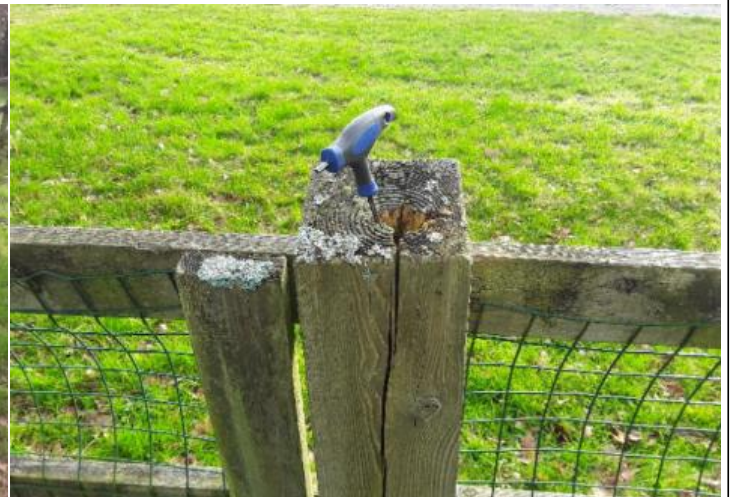
Item: Ancillary Items - Gate - Maintenance
Manufacturer: Owner/Operator

There is some evidence of rot in the posts - Monitor for any further deterioration and replace as required

Finding: There is some evidence of rot in the posts

Action: Monitor for any further deterioration and replace as required

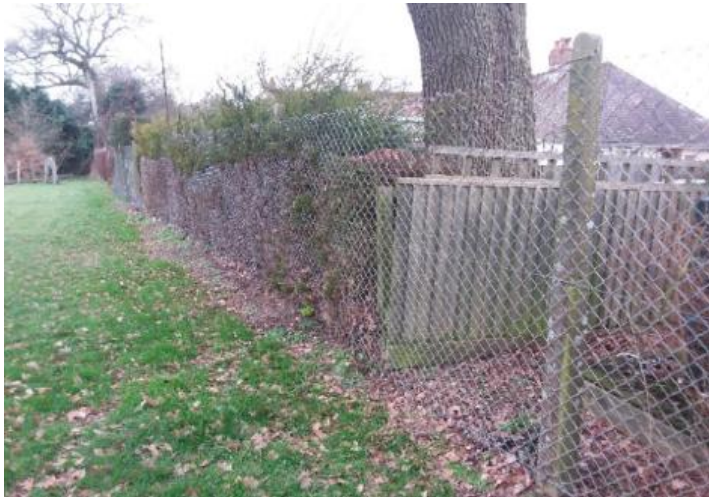
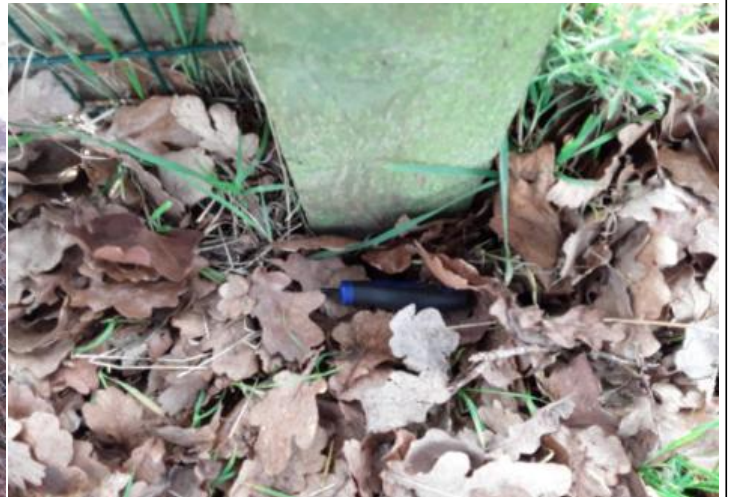
Item: Ancillary Items - Fence - Chainlink
Manufacturer: Owner/Operator

There are areas or parts of the timber on the structure that have rotted - Replace all affected timbers

Finding: There are areas or parts of the timber on the structure that have rotted

Action: Replace all affected timbers

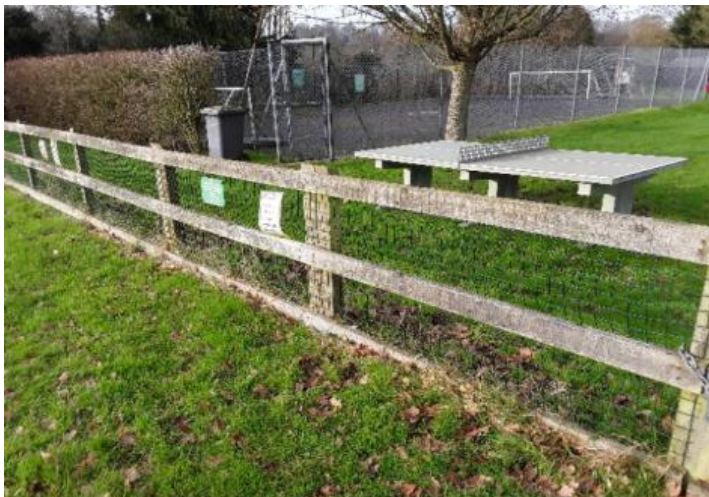
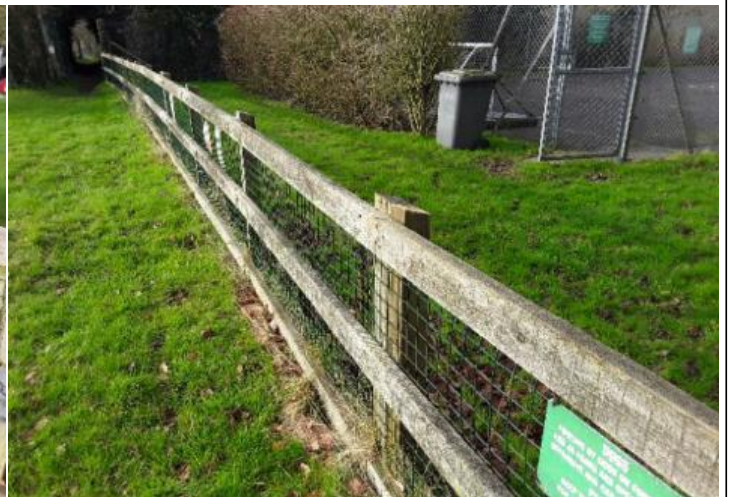
Item: Ancillary Items - Fence - Timber & Mesh Infill
Manufacturer: Owner/Operator

There are a number of loose posts around the fence - Monitor for any further deterioration and reset as required

Finding: There are a number of loose posts around the fence

Action: Monitor for any further deterioration and reset as required

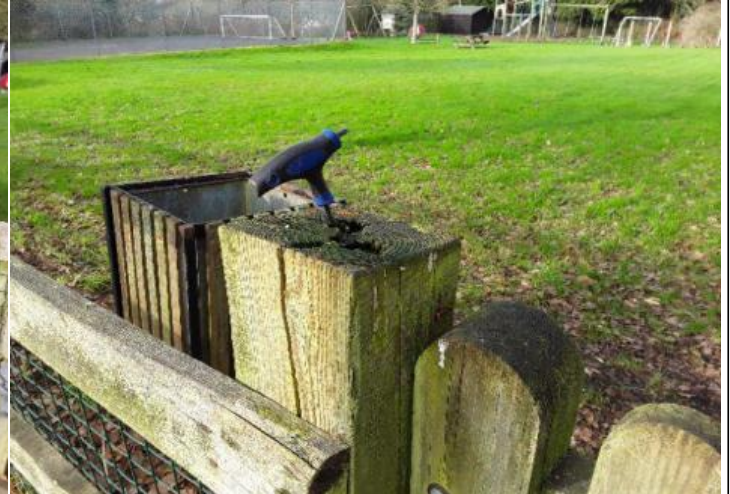
Item: Ancillary Items - Fence - Timber & Mesh Infill
Manufacturer: Owner/Operator

There are areas or parts of the timber on the structure that have rotted - Replace all affected timbers

Finding: There are areas or parts of the timber on the structure that have rotted

Action: Replace all affected timbers

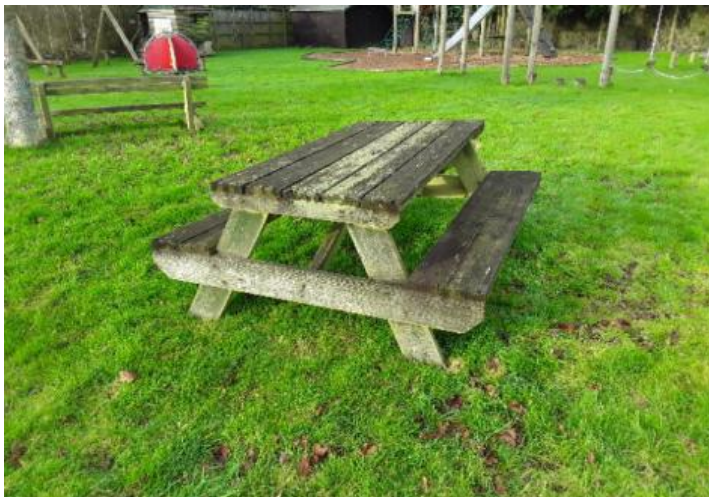
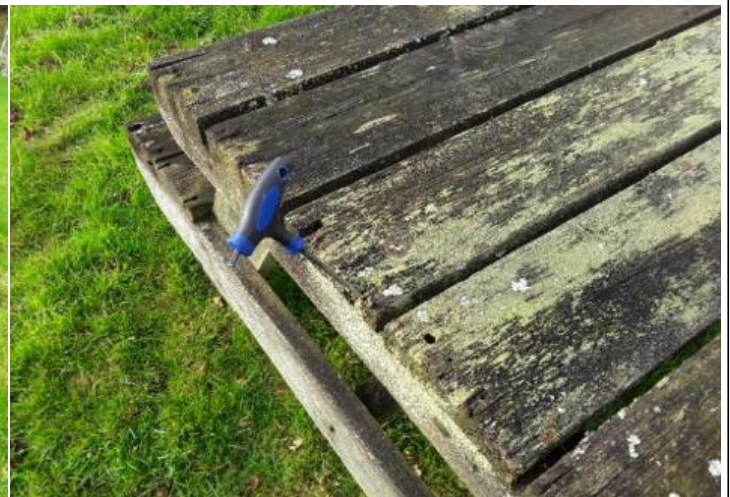
Item: Ancillary Items - Picnic Table
Manufacturer: Owner/Operator

There is some evidence of rot in the timber - Monitor for any further deterioration and replace as required

Finding: There is some evidence of rot in the timber

Action: Monitor for any further deterioration and replace as required

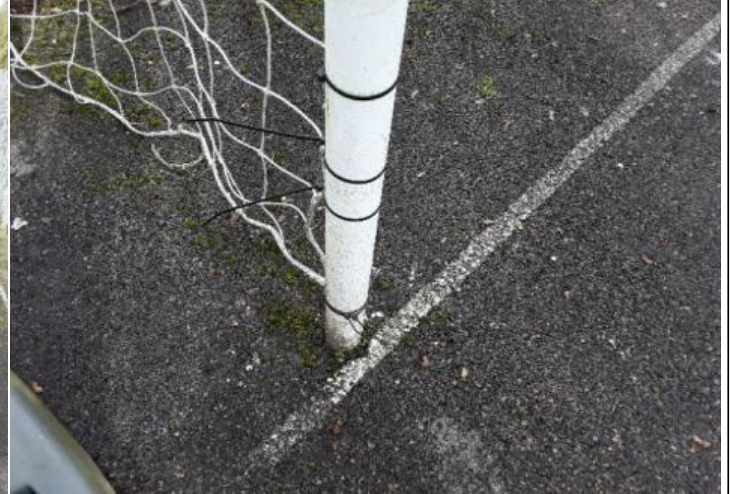
Item: Multi Use Games Area - Ball Games Area
Manufacturer: Unknown

The goal posts are slightly loose in the ground - Monitor for any further deterioration and repair as required

Finding: The goal posts are slightly loose in the ground

Action: Monitor for any further deterioration and repair as required

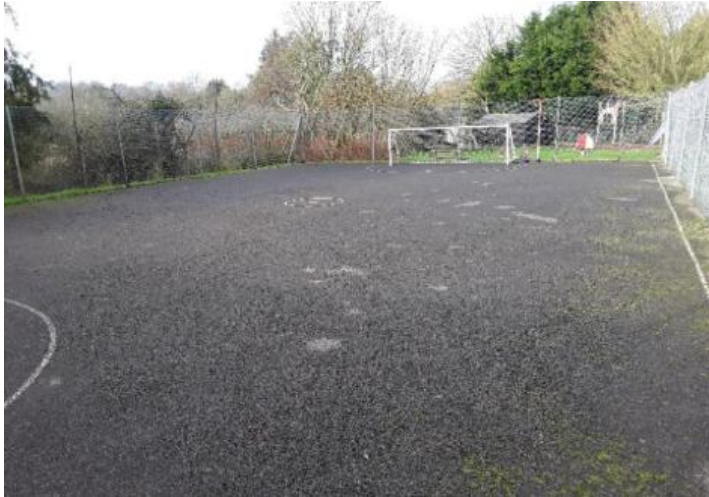
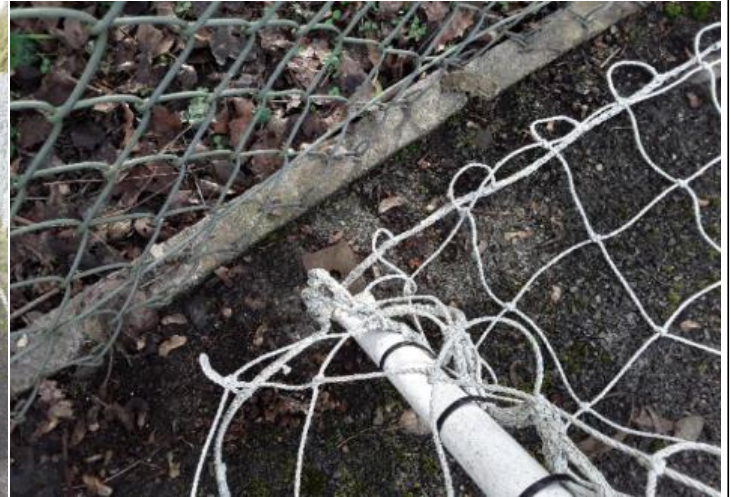
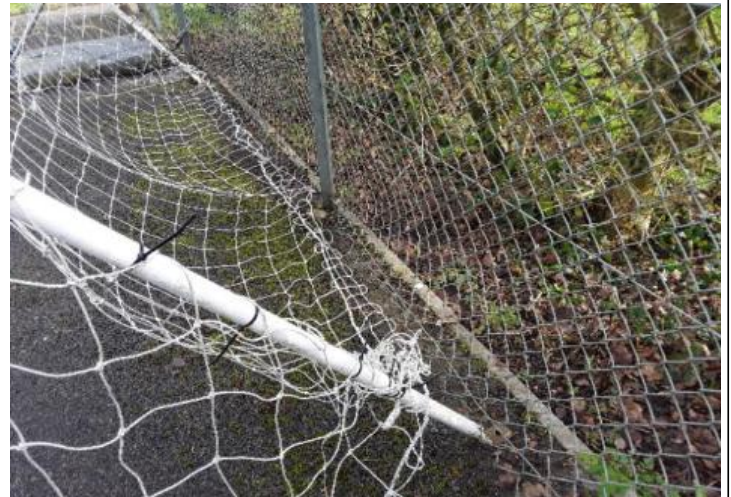
Item: Multi Use Games Area - Ball Games Area
Manufacturer: Unknown

There is or are fixings missing on the goals - Replace all missing fixings

Finding: There is or are fixings missing on the goals

Action: Replace all missing fixings

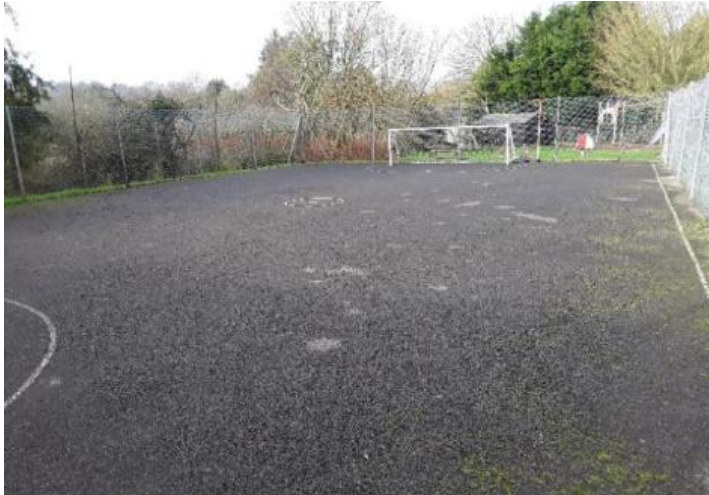
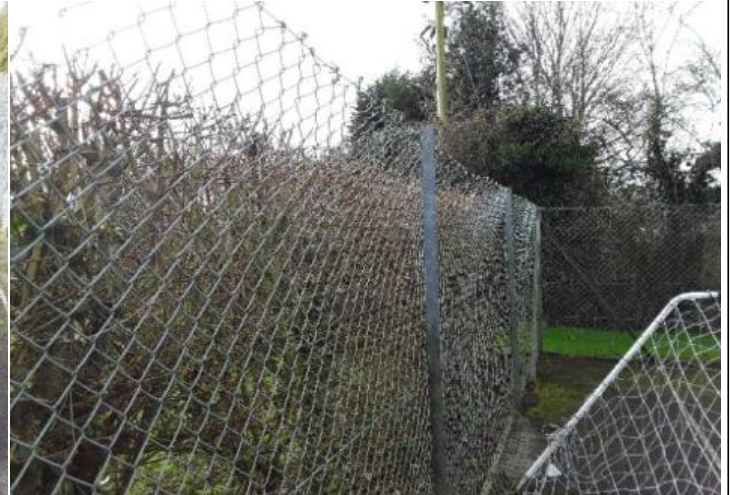
Item: Multi Use Games Area - Ball Games Area
Manufacturer: Unknown

There is some damage to the fence sections - Monitor for any further deterioration and repair as required

Finding: There is some damage to the fence sections

Action: Monitor for any further deterioration and repair as required

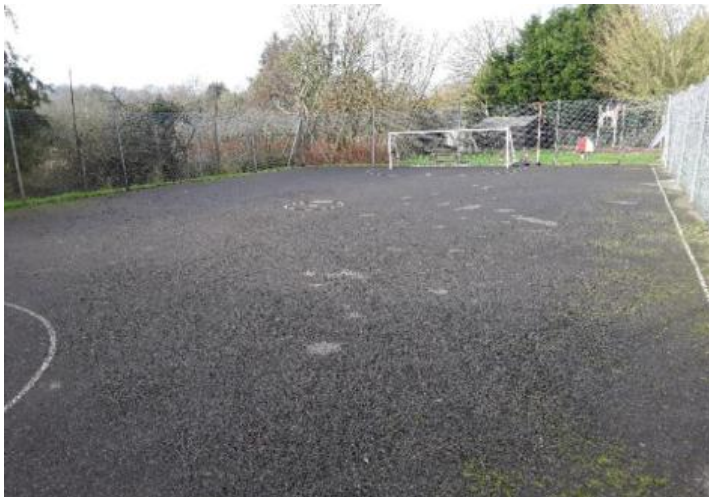
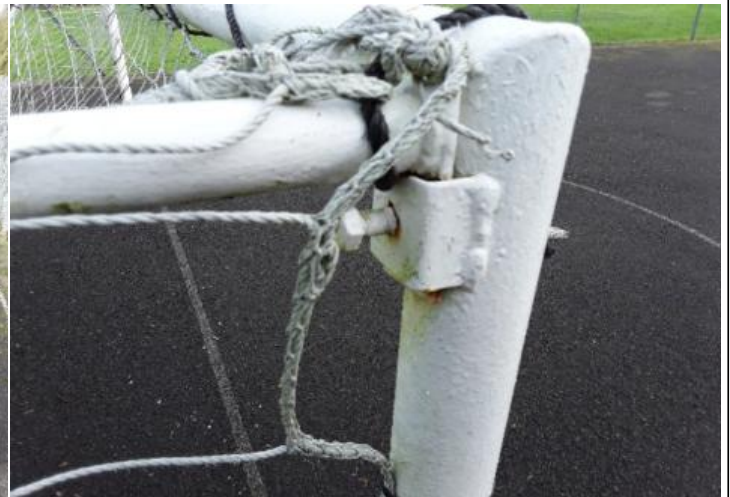
Item: Multi Use Games Area - Ball Games Area
Manufacturer: Unknown

A number of goal fixing(s) have worked loose - Secure all loose fixings

Finding: A number of goal fixing(s) have worked loose

Action: Secure all loose fixings

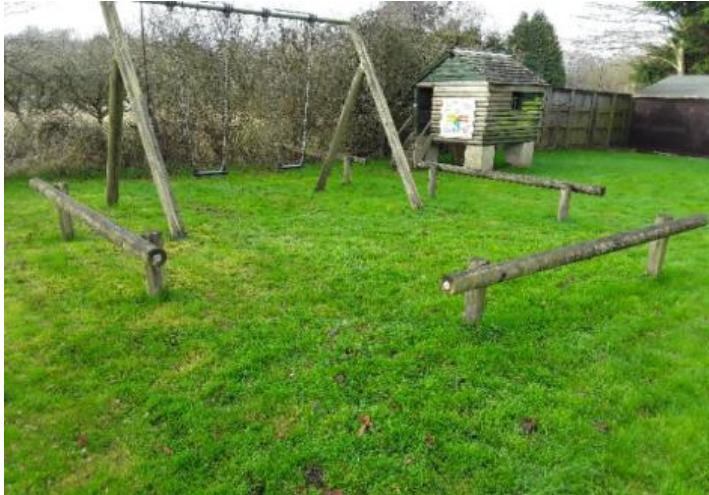
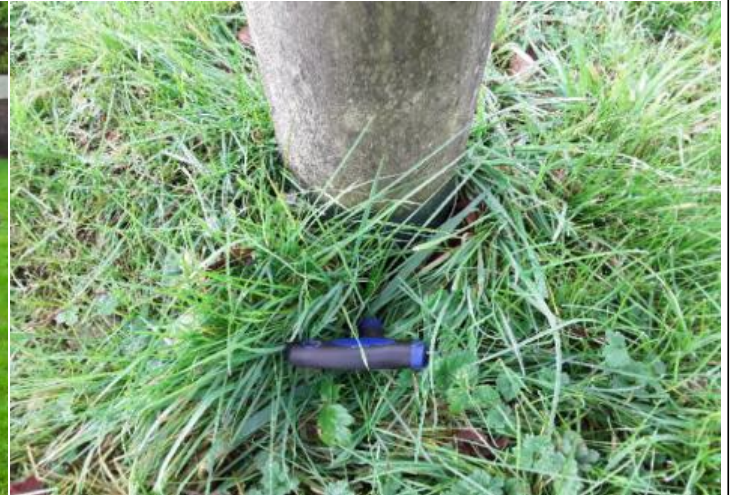
Item: Swings - Swing Barrier
Manufacturer: Playdale Playgrounds Ltd

There is some evidence of rot in the timber - Monitor for any further deterioration and replace as required

Finding: There is some evidence of rot in the timber

Action: Monitor for any further deterioration and replace as required

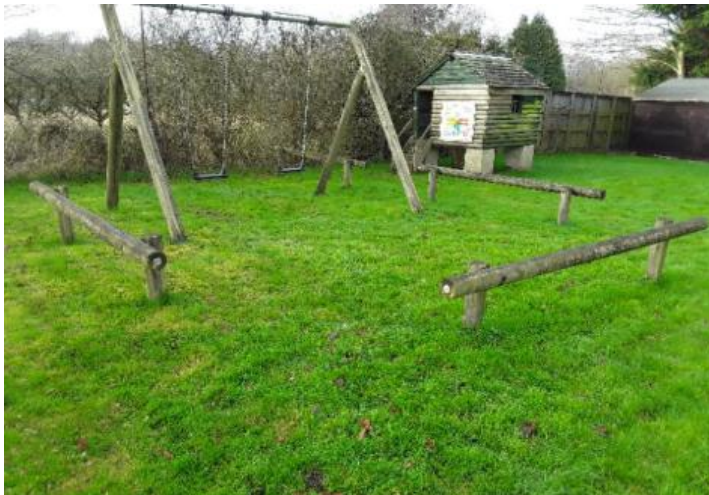
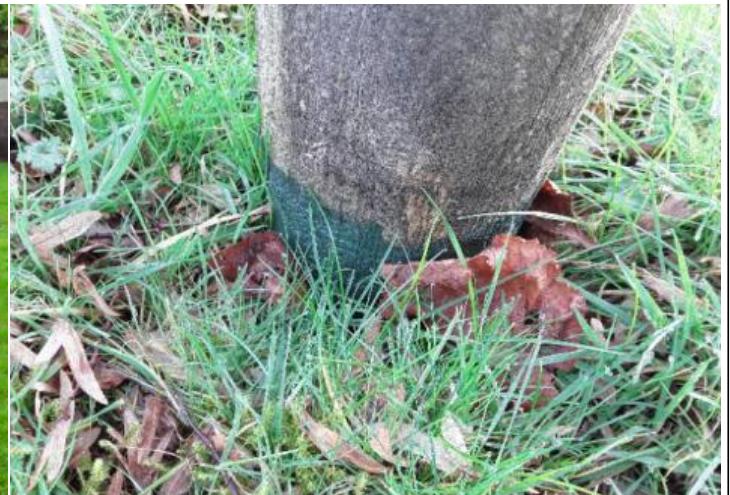
Item: Swings - Swing Barrier
Manufacturer: Playdale Playgrounds Ltd

There is some strimmer / machinery damage apparent on the posts, this can penetrate the preservative applied to the timber and accelerate the rotting process - Monitor for any deterioration (rot) and replace as required

Finding: There is some strimmer / machinery damage apparent on the posts, this can penetrate the preservative applied to the timber and accelerate the rotting process

Action: Monitor for any deterioration (rot) and replace as required

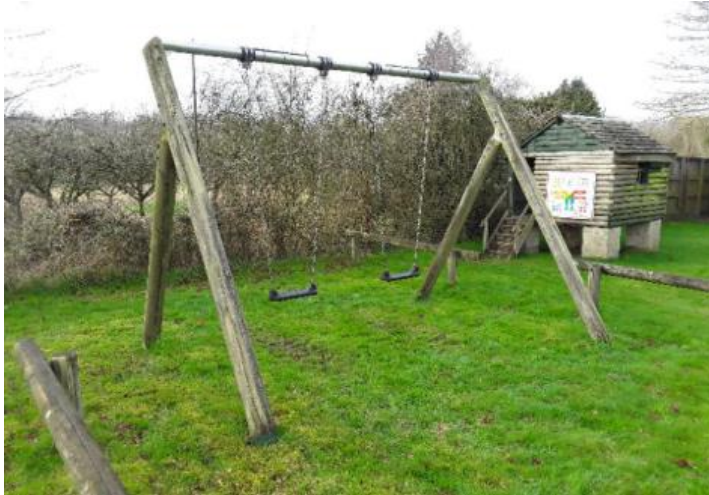
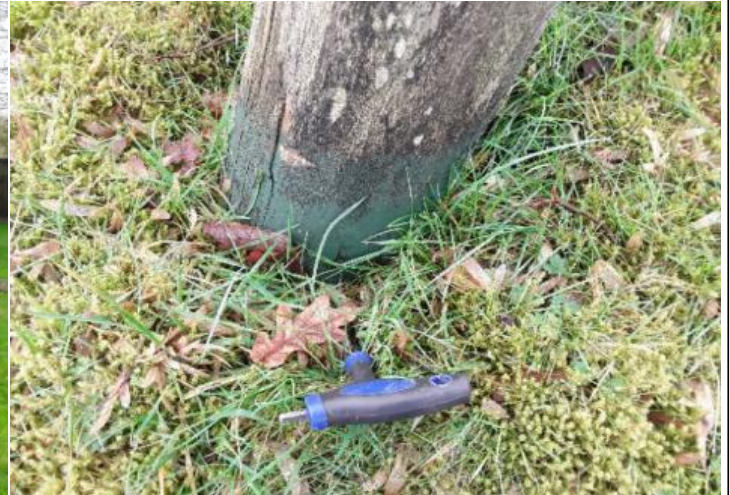
Item: Swings - 1 Bay 2 Seat (Flat)
Manufacturer: Playdale Playgrounds Ltd

There is some evidence of rot in the posts - Monitor for any further deterioration and replace as required

Finding: There is some evidence of rot in the posts

Action: Monitor for any further deterioration and replace as required

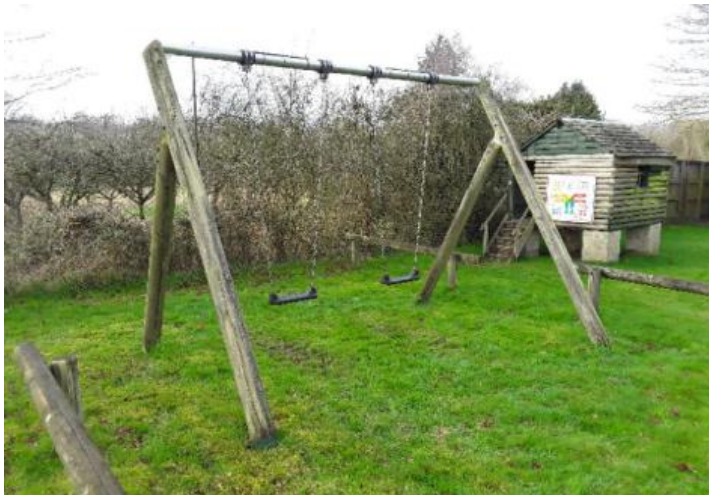
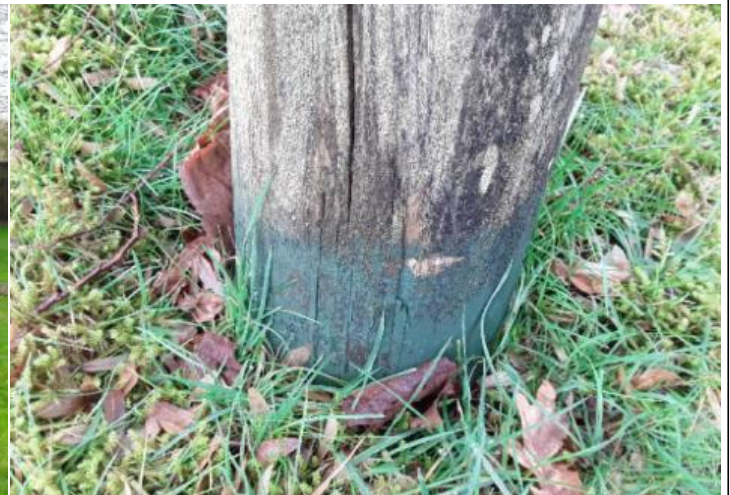
Item: Swings - 1 Bay 2 Seat (Flat)
Manufacturer: Playdale Playgrounds Ltd

There is some strimmer / machinery damage apparent on the posts, this can penetrate the preservative applied to the timber and accelerate the rotting process - Monitor for any deterioration (rot) and replace as required

Finding: There is some strimmer / machinery damage apparent on the posts, this can penetrate the preservative applied to the timber and accelerate the rotting process

Action: Monitor for any deterioration (rot) and replace as required

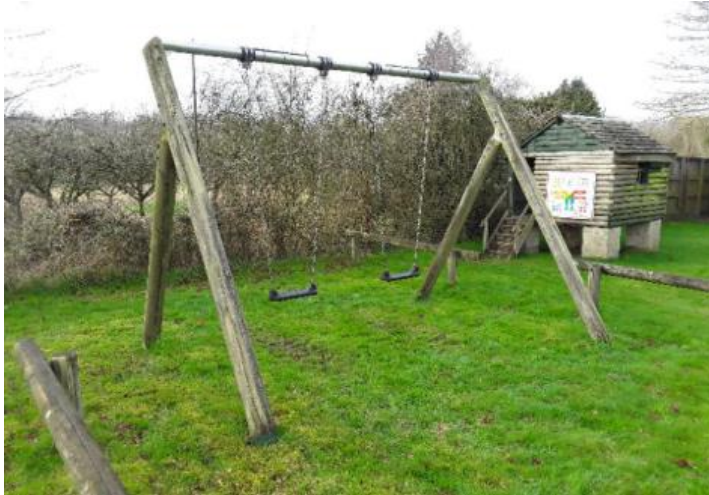
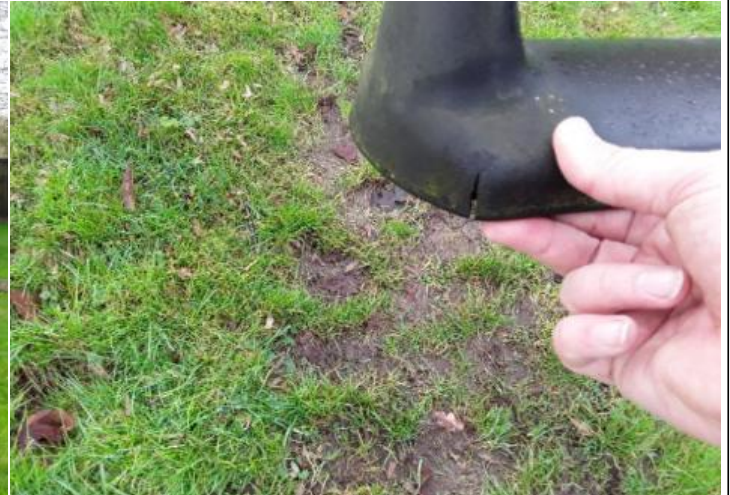
Item: Swings - 1 Bay 2 Seat (Flat)
Manufacturer: Playdale Playgrounds Ltd

The seat has minor damage or wear - Monitor for any further deterioration and replace as required

Finding: The seat has minor damage or wear

Action: Monitor for any further deterioration and replace as required

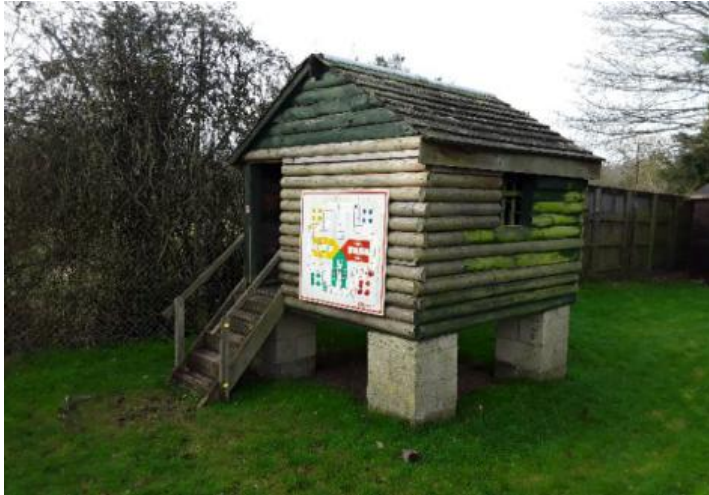
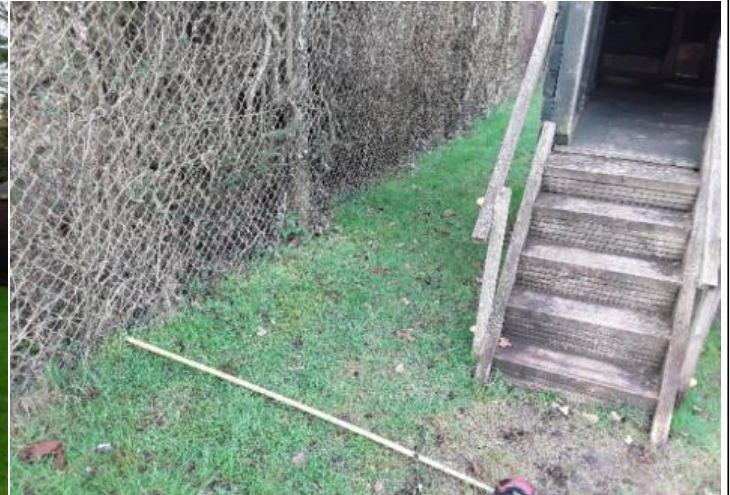
Item: Activity Equipment - Playhouse
Manufacturer: Unknown

The fencing forms a hard object within the falling space of the equipment and there is also insufficient surfacing provided - Monitor - no remedial work recommended

Finding: The fencing forms a hard object within the falling space of the equipment and there is also insufficient surfacing provided

Action: Monitor - no remedial work recommended

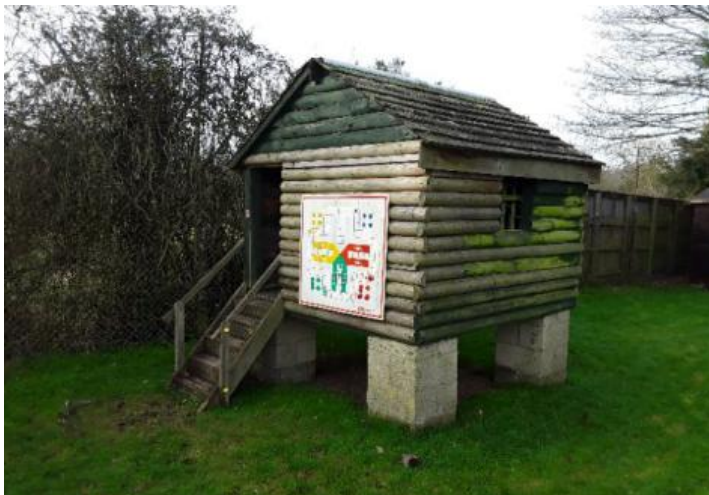
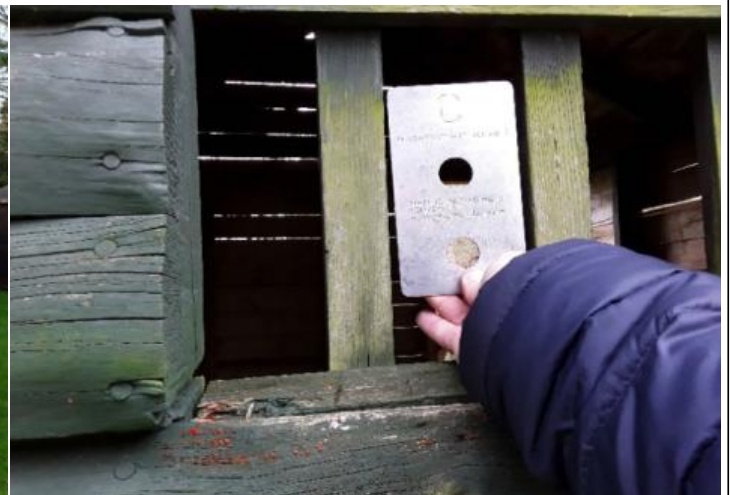
Item: Activity Equipment - Playhouse
Manufacturer: Unknown

The item fails to meet the requirements of BS EN 1176 Part 1 4.2.7.2 for head and neck entrapment in the framework - Monitor - No remedial work recommended

Finding: The item fails to meet the requirements of BS EN 1176 Part 1 4.2.7.2 for head and neck entrapment in the framework

Action: Monitor - No remedial work recommended

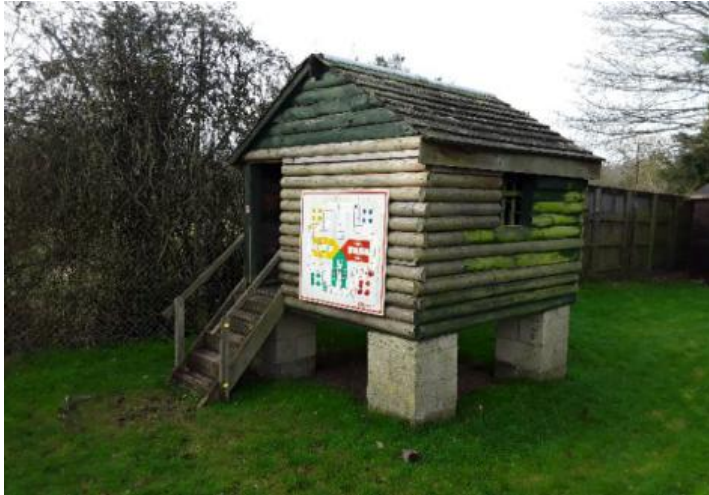
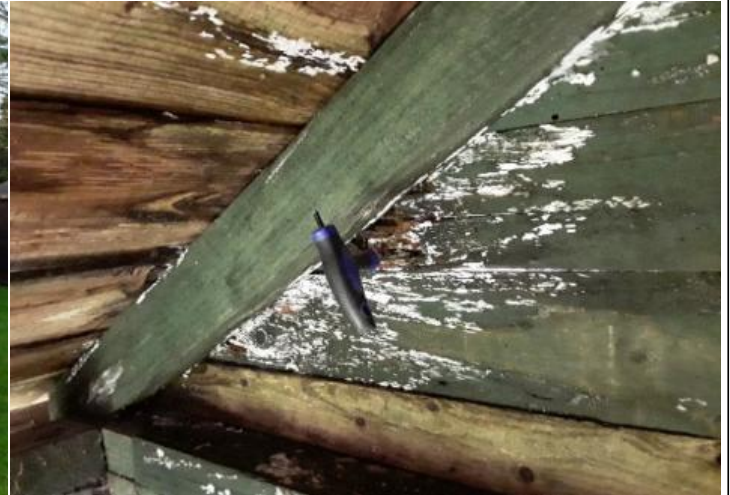
Item: Activity Equipment - Playhouse
Manufacturer: Unknown

There is some evidence of rot in the timber - Monitor for any further deterioration and replace as required

Finding: There is some evidence of rot in the timber

Action: Monitor for any further deterioration and replace as required

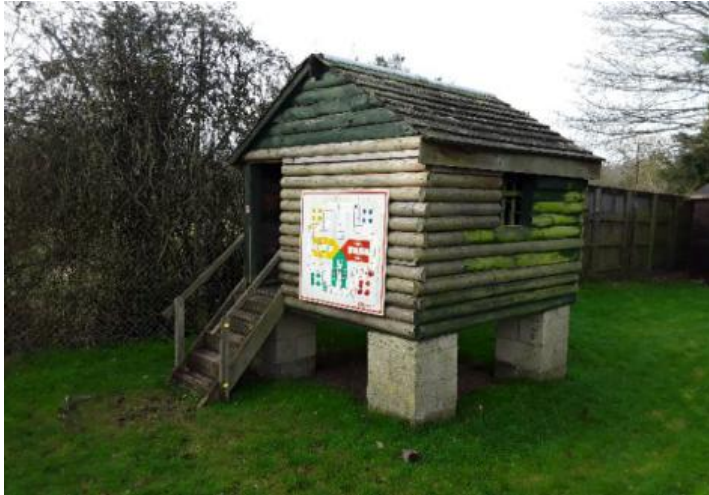
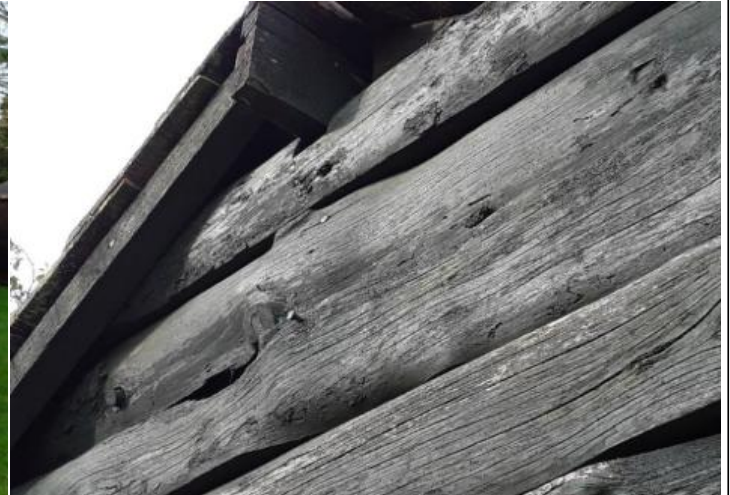
Item: Activity Equipment - Playhouse
Manufacturer: Unknown

A number of fixing(s) have worked loose - Secure all loose fixings

Finding: A number of fixing(s) have worked loose

Action: Secure all loose fixings

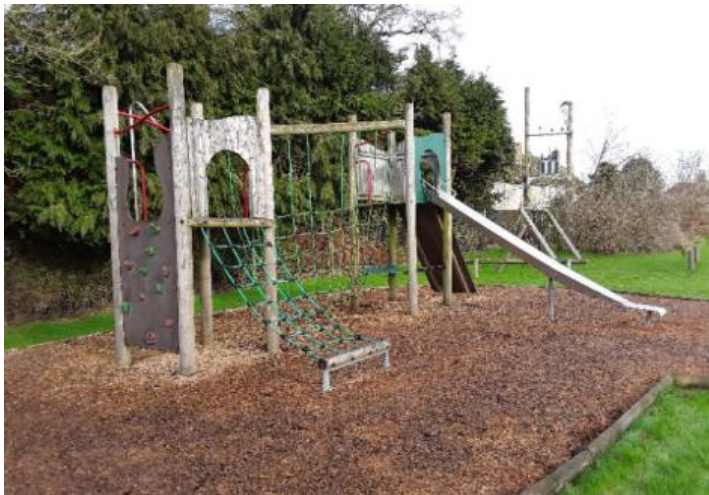
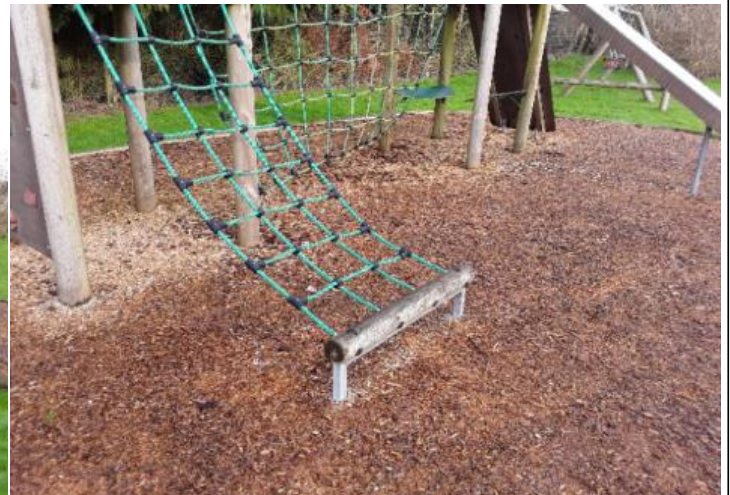
Item: Activity Equipment - Multi Play (Junior)
Manufacturer: Playdale Playgrounds Ltd

The base of the net forms a hard object within the falling space of the equipment in contravention of the requirements of BS EN 1176 Part 1 - Monitor - No remedial work recommended

Finding: The base of the net forms a hard object within the falling space of the equipment in contravention of the requirements of BS EN 1176 Part 1

Action: Monitor - No remedial work recommended

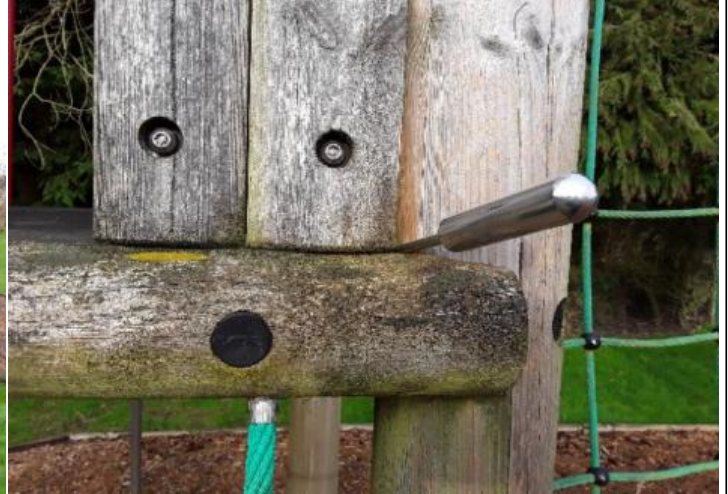
Item: Activity Equipment - Multi Play (Junior)
Manufacturer: Playdale Playgrounds Ltd

There is/are finger entrapment/s between barrier and post and the item fails to meet the requirements of BS EN 1176 Part 1 4.2.7.6 Entrapment of fingers - Monitor - No remedial work recommended

Finding: There is/are finger entrapment/s between barrier and post and the item fails to meet the requirements of BS EN 1176 Part 1 4.2.7.6 Entrapment of fingers

Action: Monitor - No remedial work recommended

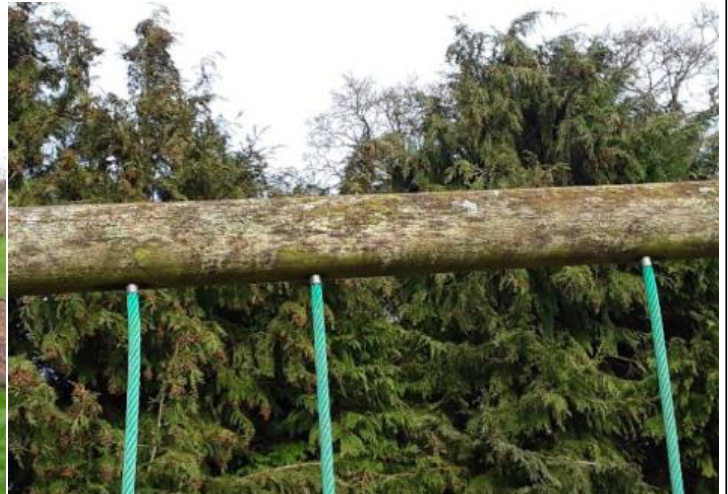
Item: Activity Equipment - Multi Play (Junior)
Manufacturer: Playdale Playgrounds Ltd

There is algae or moss on the surface of the equipment that can lead to the onset of rot - Clean and treat appropriately

Finding: There is algae or moss on the surface of the equipment that can lead to the onset of rot

Action: Clean and treat appropriately

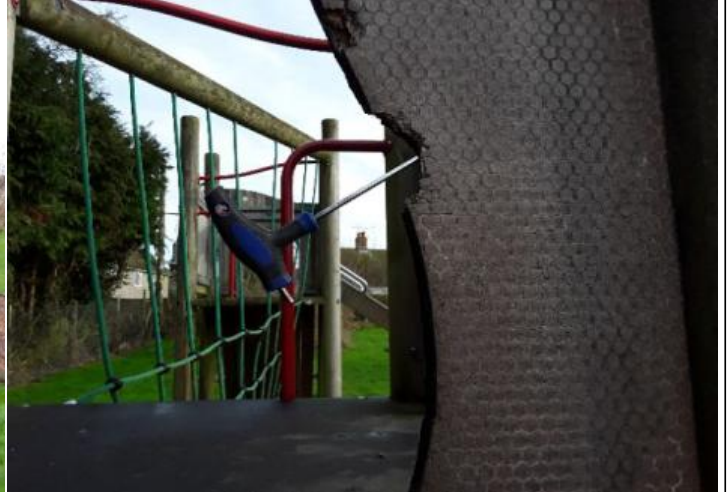
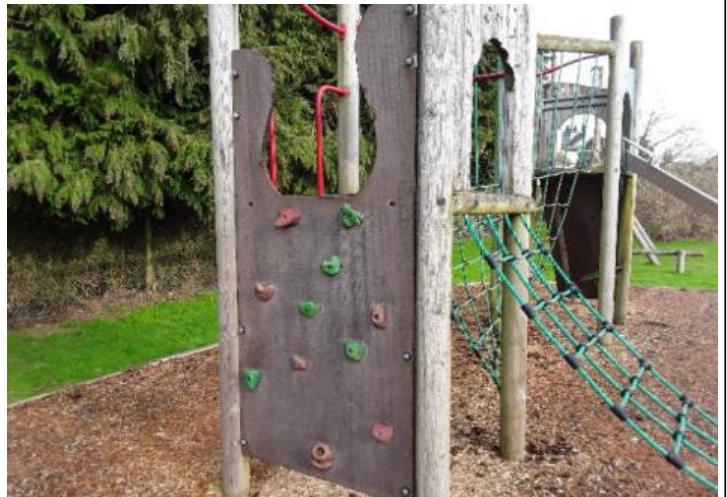
Item: Activity Equipment - Multi Play (Junior)
Manufacturer: Playdale Playgrounds Ltd

There are areas or parts of the climbing panel that have rotted - Replace all affected timbers

Finding: There are areas or parts of the climbing panel that have rotted

Action: Replace all affected timbers

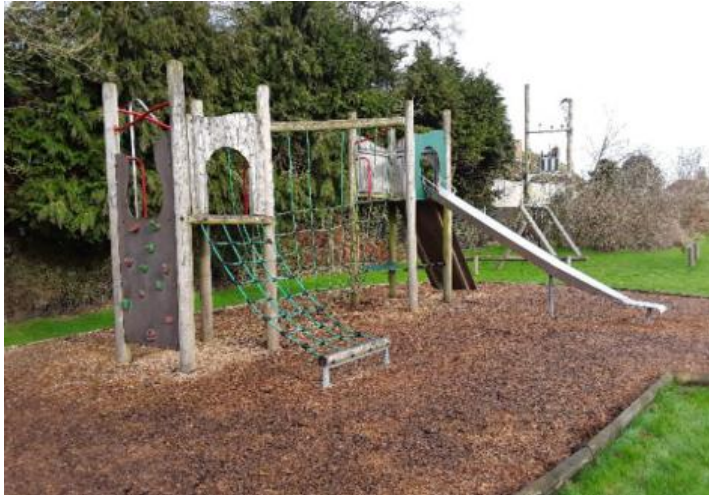
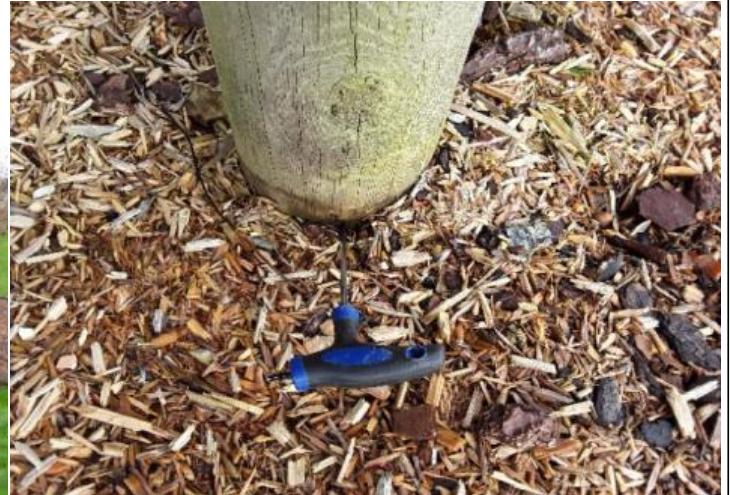
Item: Activity Equipment - Multi Play (Junior)
Manufacturer: Playdale Playgrounds Ltd

There is some evidence of rot in the posts - Monitor for any further deterioration and replace as required

Finding: There is some evidence of rot in the posts

Action: Monitor for any further deterioration and replace as required

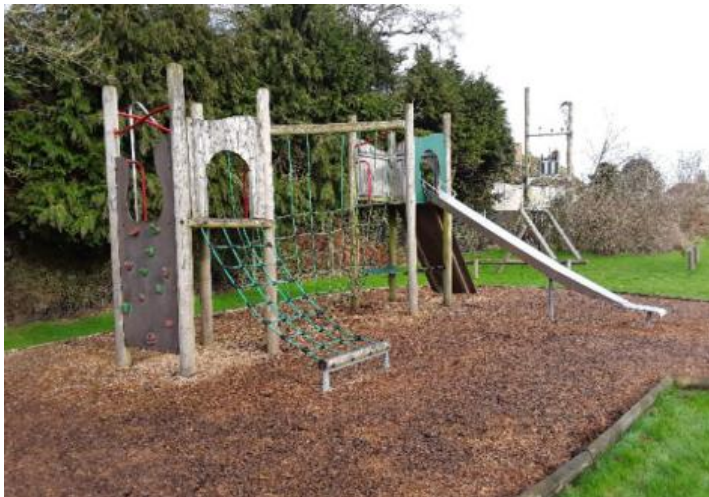
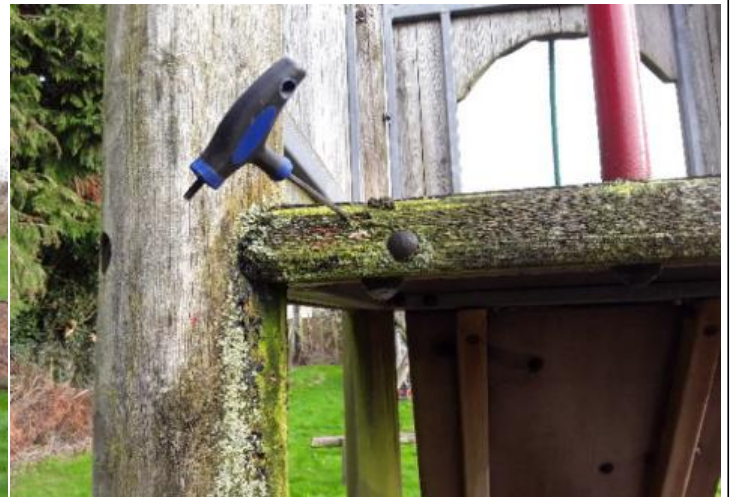
Item: Activity Equipment - Multi Play (Junior)
Manufacturer: Playdale Playgrounds Ltd

There is some evidence of rot in the timber - Monitor for any further deterioration and replace as required

Finding: There is some evidence of rot in the timber

Action: Monitor for any further deterioration and replace as required

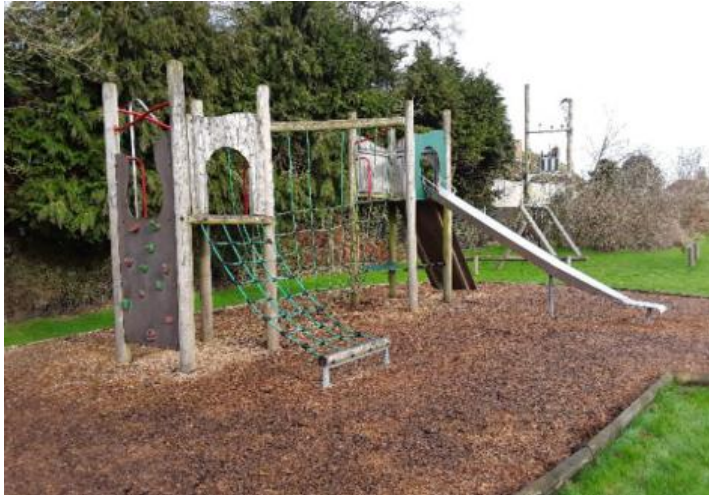
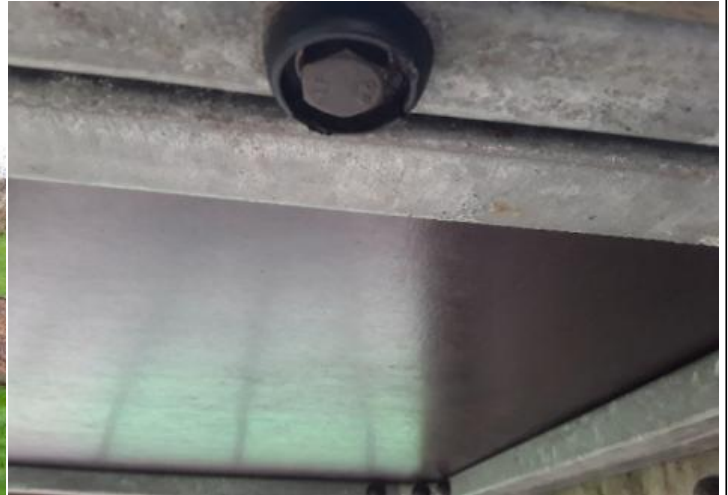
Item: Activity Equipment - Multi Play (Junior)
Manufacturer: Playdale Playgrounds Ltd

There is/are bolt cap covers missing or damaged on the item - Replace missing or damaged bolt cap covers

Finding: There is/are bolt cap covers missing or damaged on the item

Action: Replace missing or damaged bolt cap covers

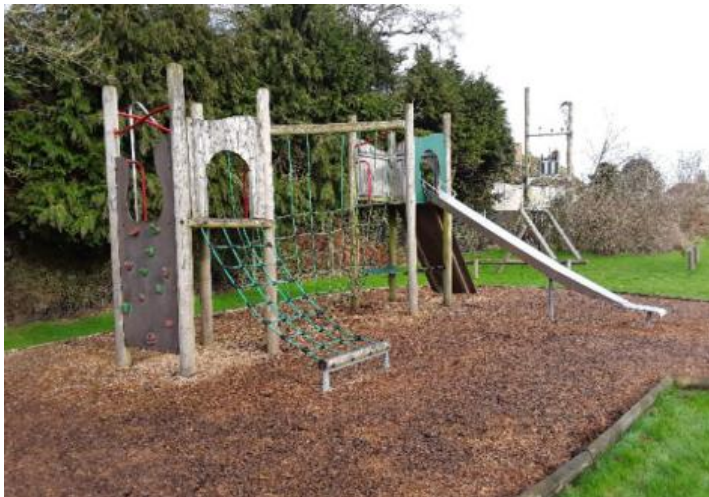
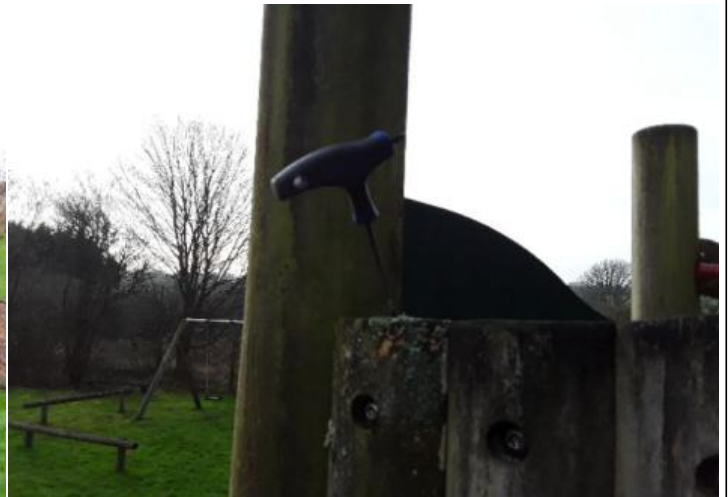
Item: Activity Equipment - Multi Play (Junior)
Manufacturer: Playdale Playgrounds Ltd

There is some evidence of rot in the barriers - Monitor for any further deterioration and replace as required

Finding: There is some evidence of rot in the barriers

Action: Monitor for any further deterioration and replace as required

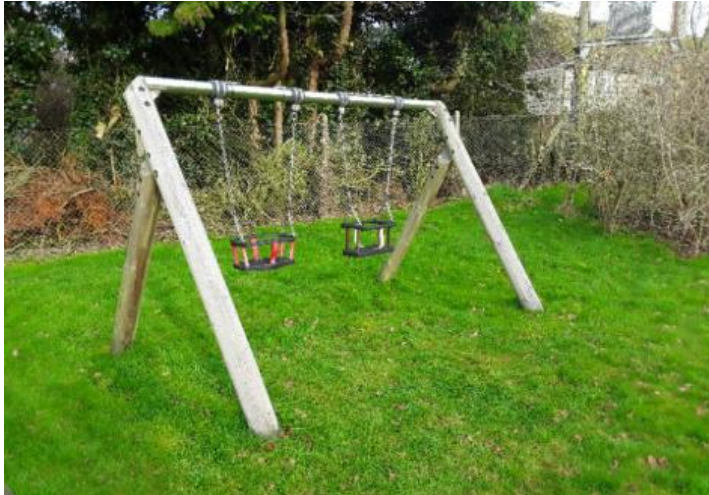
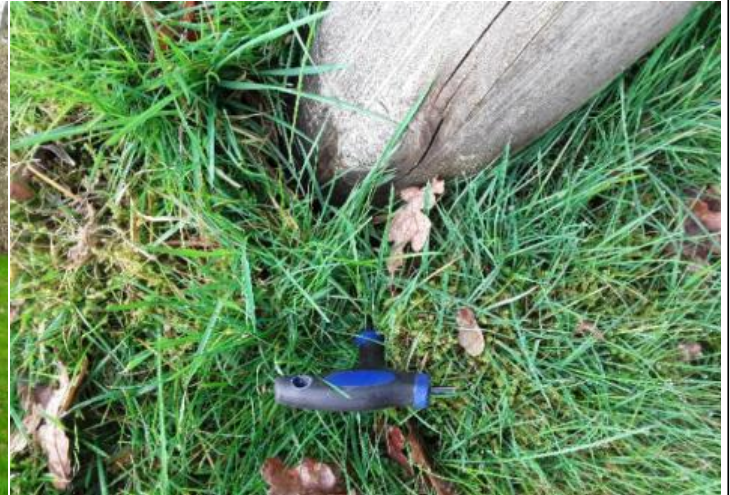
Item: Swings - 1 Bay 2 Seat (Cradle)
Manufacturer: Playdale Playgrounds Ltd

There is some evidence of rot in the posts - Monitor for any further deterioration and replace as required

Finding: There is some evidence of rot in the posts

Action: Monitor for any further deterioration and replace as required

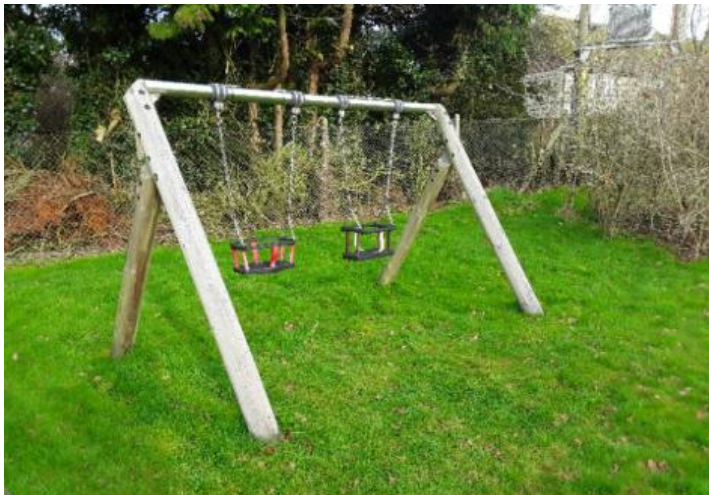
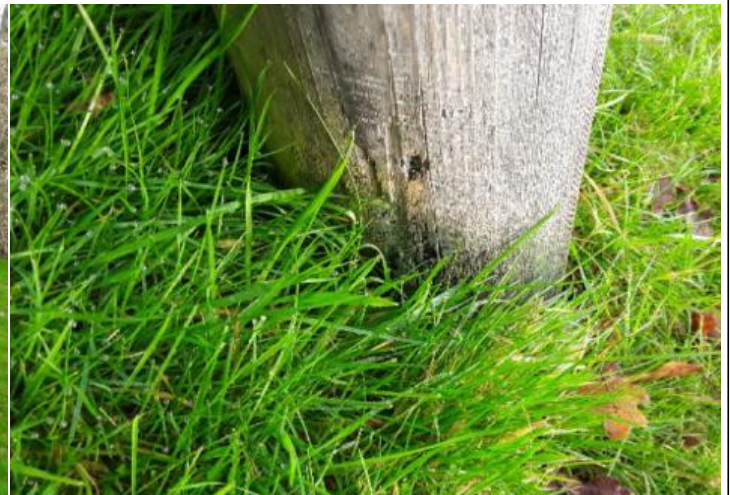
Item: Swings - 1 Bay 2 Seat (Cradle)
Manufacturer: Playdale Playgrounds Ltd

There is some strimmer / machinery damage apparent on the posts, this can penetrate the preservative applied to the timber and accelerate the rotting process - Monitor for any deterioration (rot) and replace as required

Finding: There is some strimmer / machinery damage apparent on the posts, this can penetrate the preservative applied to the timber and accelerate the rotting process

Action: Monitor for any deterioration (rot) and replace as required

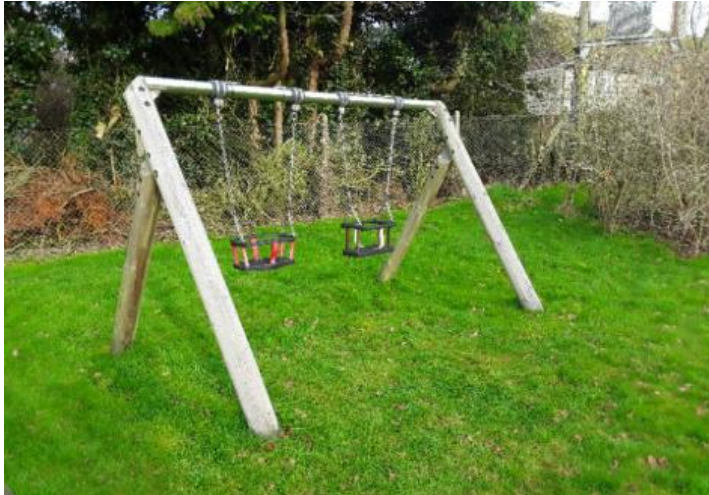
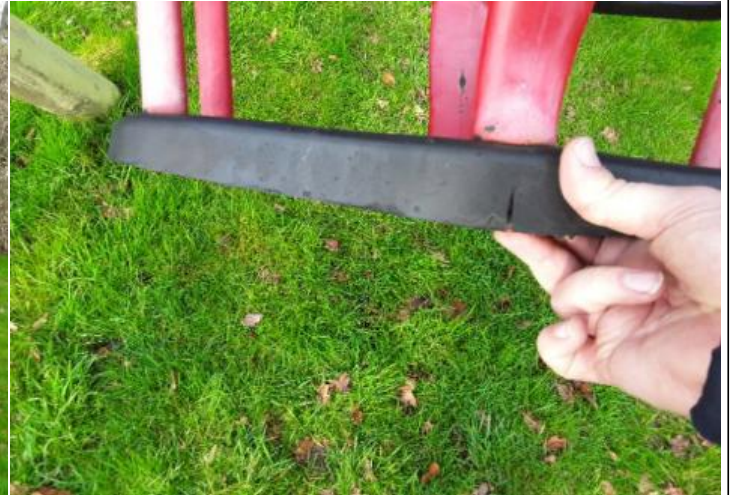
Item: Swings - 1 Bay 2 Seat (Cradle)
Manufacturer: Playdale Playgrounds Ltd

The seat has minor damage or wear - Monitor for any further deterioration and replace as required

Finding: The seat has minor damage or wear

Action: Monitor for any further deterioration and replace as required
