Annual Inspection

Winchester City Council

The Jubilee RG (Bramdean and Hinton Ampner PC)

Off Woodlane Close, Bramdean, Winchester,
Hampshire, SO24 0JR

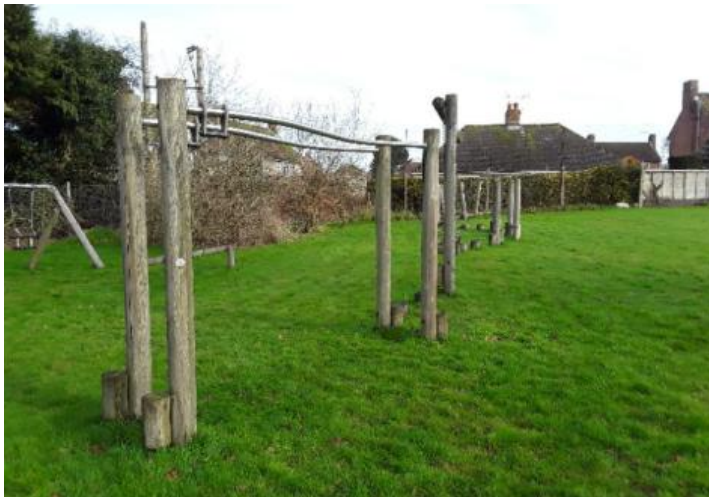
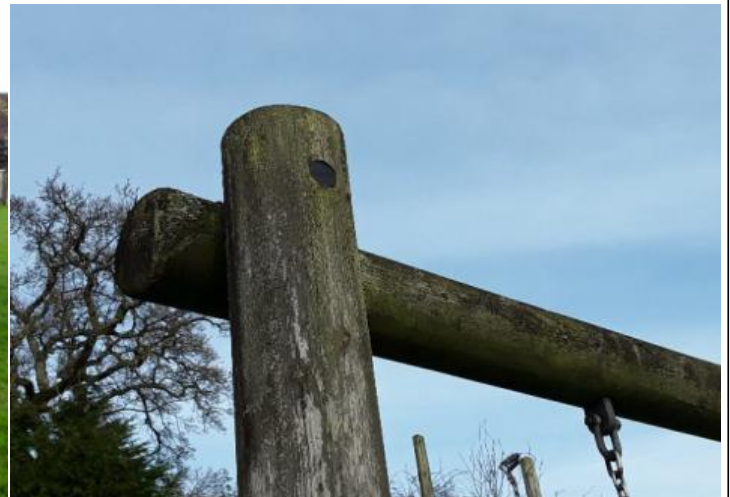
Item: Activity Equipment - Activity Trail
Manufacturer: Playdale Playgrounds Ltd

There is algae or moss on the surface of the equipment that can lead to the onset of rot - Clean and treat appropriately

Finding: There is algae or moss on the surface of the equipment that can lead to the onset of rot

Action: Clean and treat appropriately

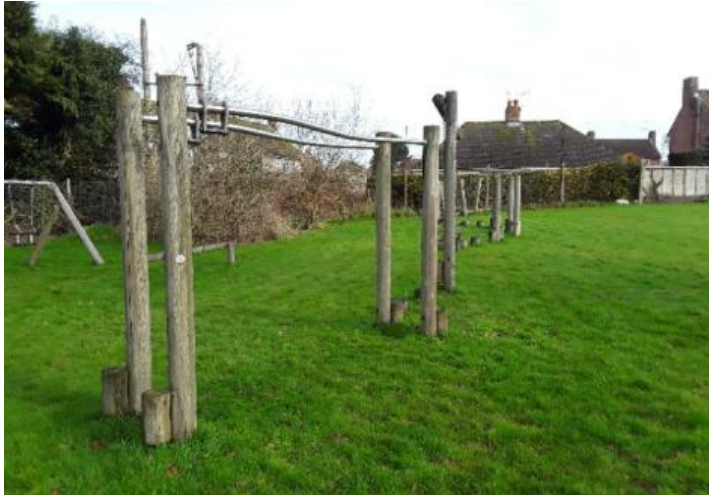
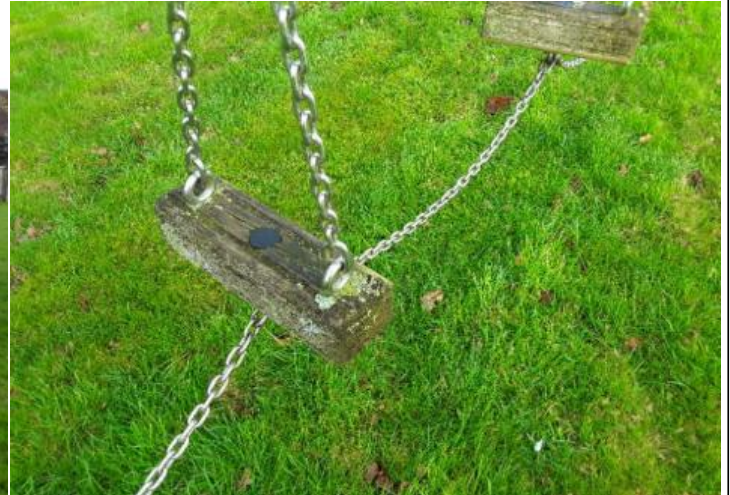
Item: Activity Equipment - Activity Trail
Manufacturer: Playdale Playgrounds Ltd

There is algae or moss on the surface of the equipment resulting in slippery conditions - Clean and treat appropriately

Finding: There is algae or moss on the surface of the equipment resulting in slippery conditions

Action: Clean and treat appropriately

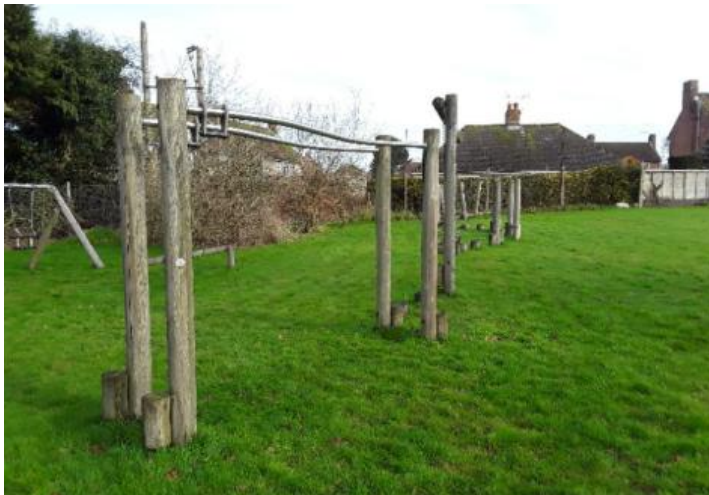
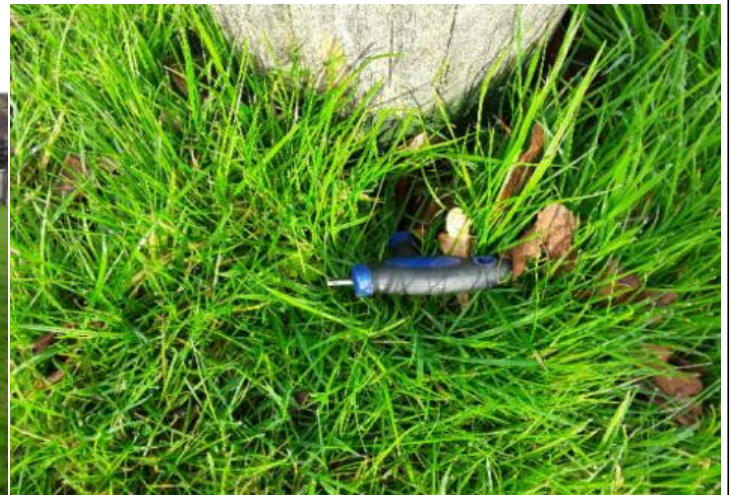
Item: Activity Equipment - Activity Trail
Manufacturer: Playdale Playgrounds Ltd

There is some evidence of rot in the timber - Monitor for any further deterioration and replace as required

Finding: There is some evidence of rot in the timber

Action: Monitor for any further deterioration and replace as required

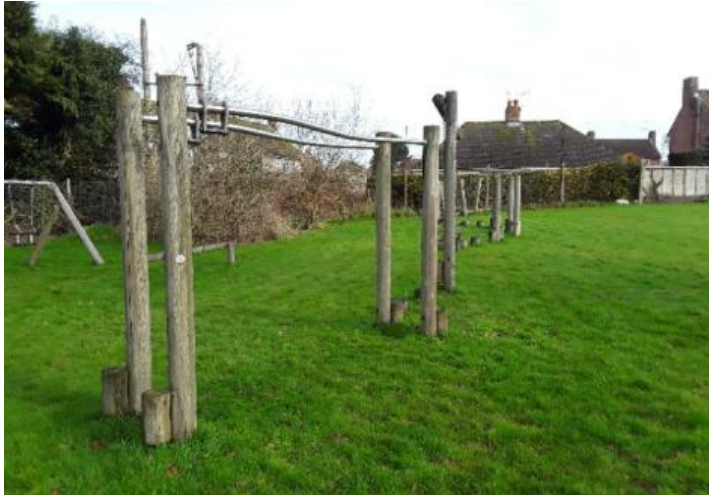
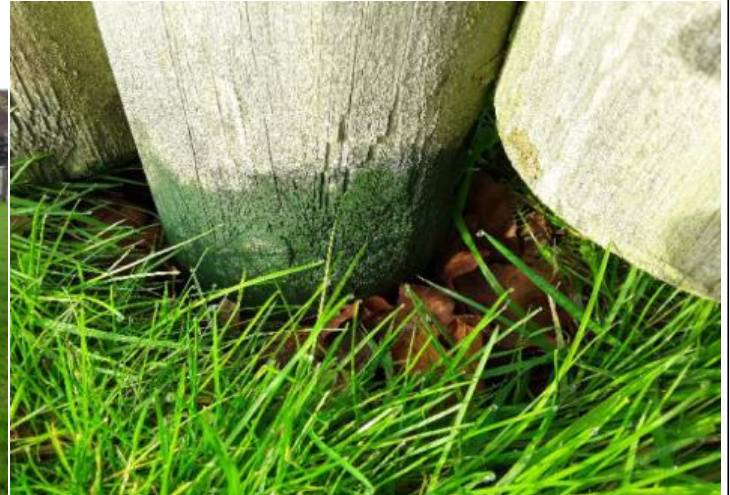
Item: Activity Equipment - Activity Trail
Manufacturer: Playdale Playgrounds Ltd

There is some strimmer / machinery damage apparent on the posts, this can penetrate the preservative applied to the timber and accelerate the rotting process - Monitor for any deterioration (rot) and replace as required

Finding: There is some strimmer / machinery damage apparent on the posts, this can penetrate the preservative applied to the timber and accelerate the rotting process

Action: Monitor for any deterioration (rot) and replace as required

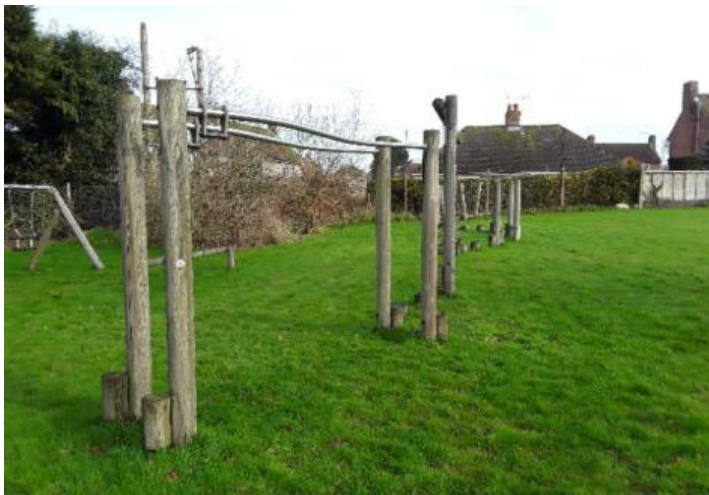
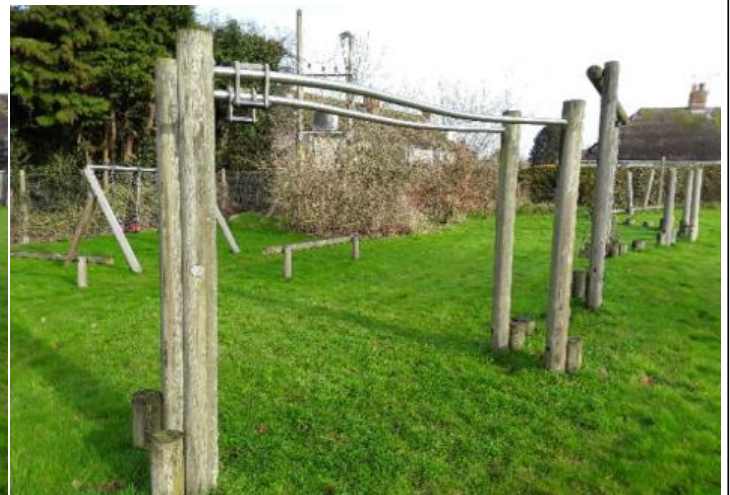
Item: Activity Equipment - Activity Trail
Manufacturer: Playdale Playgrounds Ltd

The item of equipment has a fall height exceeding 1.50 metres and grass has been provided as a safety surface - Monitor - no remedial action recommended

Finding: The item of equipment has a fall height exceeding 1.50 metres and grass has been provided as a safety surface

Action: Monitor - no remedial action recommended

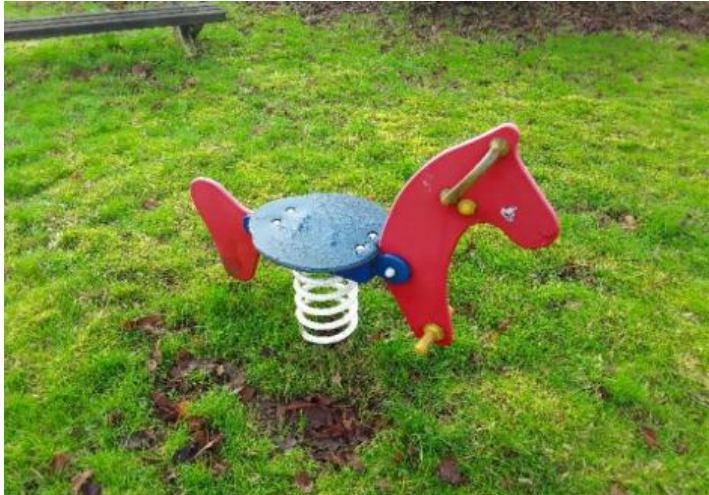
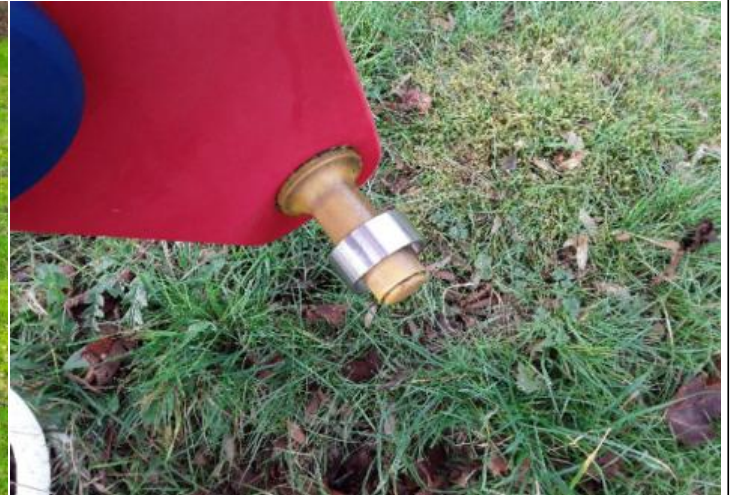
Item: Rocking Equipment - Spring Horse
Manufacturer: Ledon

The end of handgrips and/or footrests have a cross section of less than 15cm² and fail to meet the requirements of BS EN 1176 Part 6 - Monitor - No remedial work recommended

Finding: The end of handgrips and/or footrests have a cross section of less than 15cm² and fail to meet the requirements of BS EN 1176 Part 6
Action: Monitor - No remedial work recommended

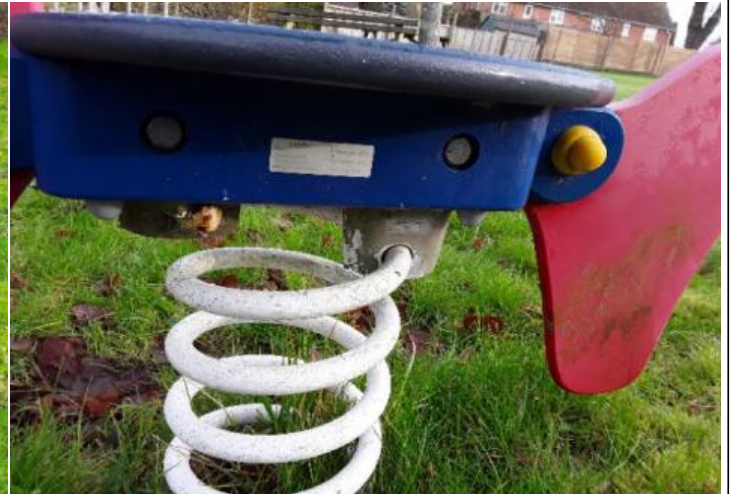
Item: Rocking Equipment - Spring Horse
Manufacturer: Ledon

There is/are bolt cap covers missing or damaged on the item - Replace missing or damaged bolt cap covers

Finding: There is/are bolt cap covers missing or damaged on the item
Action: Replace missing or damaged bolt cap covers

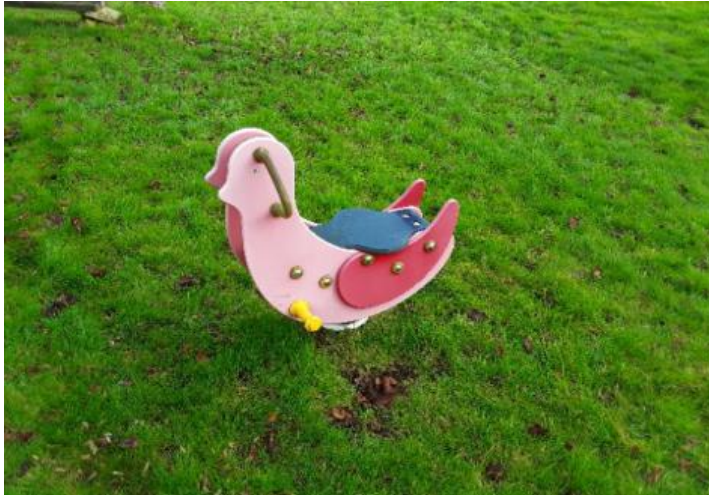
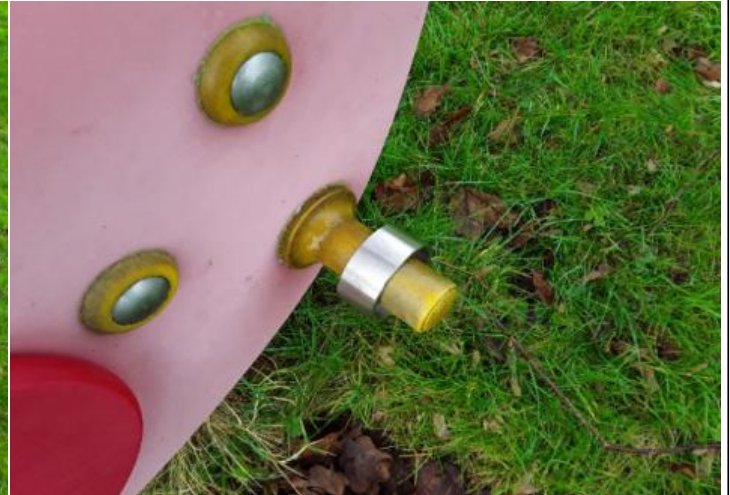
Item: Rocking Equipment - Spring Chicken
Manufacturer: Ledon

The end of handgrips and/or footrests have a cross section of less than 15cm² and fail to meet the requirements of BS EN 1176 Part 6 - Monitor - No remedial work recommended

Finding: The end of handgrips and/or footrests have a cross section of less than 15cm² and fail to meet the requirements of BS EN 1176 Part 6
Action: Monitor - No remedial work recommended
