## Annual Inspection

Winchester City Council

The Jubilee RG (Bramdean and Hinton Ampner PC)  
Off Woodlane Close, Bramdean, Winchester, Hampshire

Annual Inspection - 12 May 2016 at 09:40 Inspector: Matt Clay (RPII Annual Inspector)

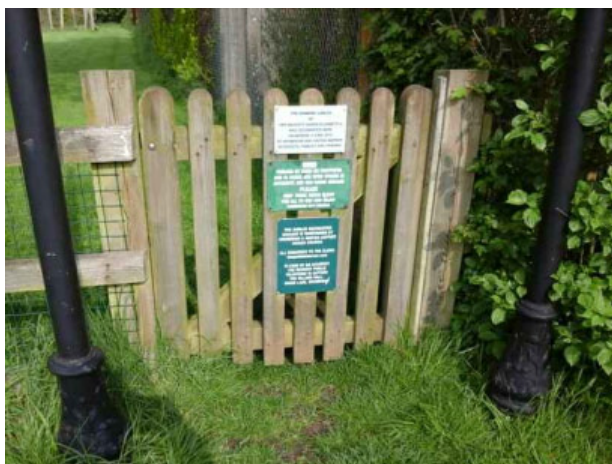
The gate is not a contrasting colour to the fencing making it difficult for users with impaired sight to distinguish it from the fence - We would recommend that the gates are painted a distinguishable colour to that of the fence

The opening between the gate and the post is less than 12mm and could trap users fingers - Adjust gate to ensure a 12mm opening all around

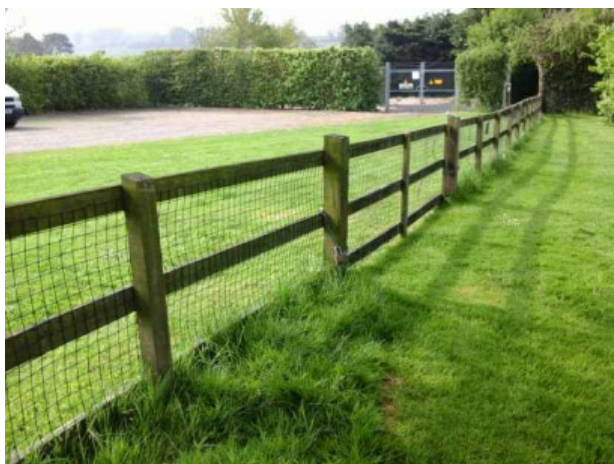
There are a number of loose posts around the fence - Monitor for any further deterioration and reset as required

There are areas or parts of the timber on the structure that have rotted - Replace all affected timbers

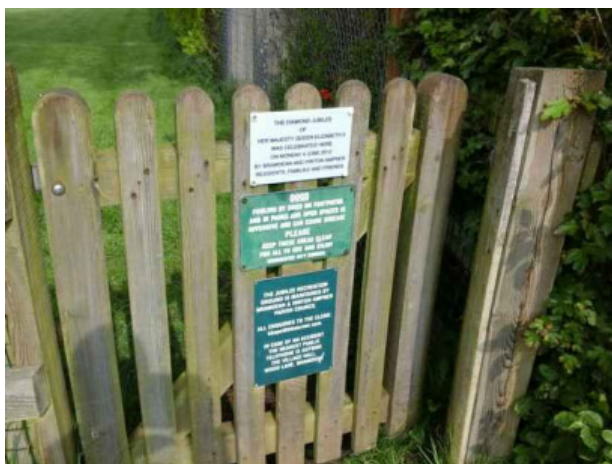
It is recommended that information signs with emergency contact details are installed at each entrance/exit point to the playground - Provide in accordance with the recommendations set out in BS EN 1176

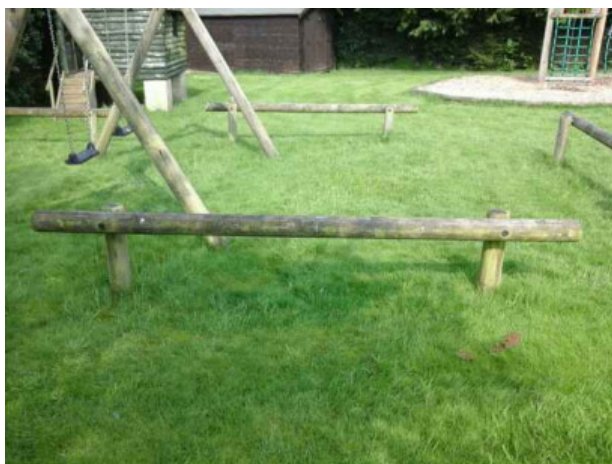
There is some strimmer damage apparent on the posts, this can penetrate the preservative applied to the timber and accelerate the rotting process - Monitor for any deterioration (rot) and replace as required

The timber has a number of air cracks apparent, the splits will have penetrated the preservative applied to the timber and allow water ingress to the unprotected areas - Monitor for any deterioration (rot) and replace as required

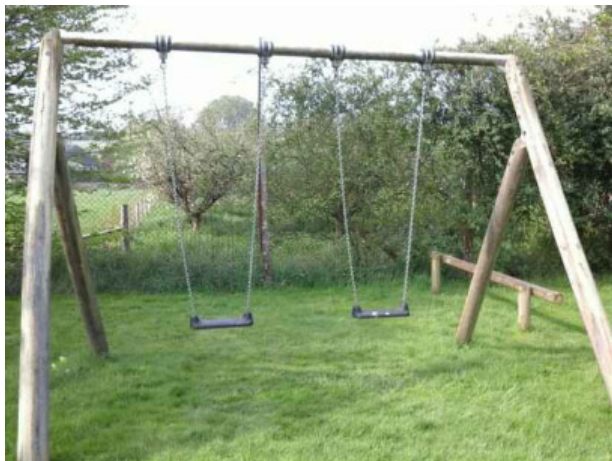
There is some strimmer damage apparent on the posts, this can penetrate the preservative applied to the timber and accelerate the rotting process - Monitor for any deterioration (rot) and replace as required

The timber has a number of air cracks apparent, the splits will have penetrated the preservative applied to the timber and allow water ingress to the unprotected areas - Monitor for any deterioration (rot) and replace as required

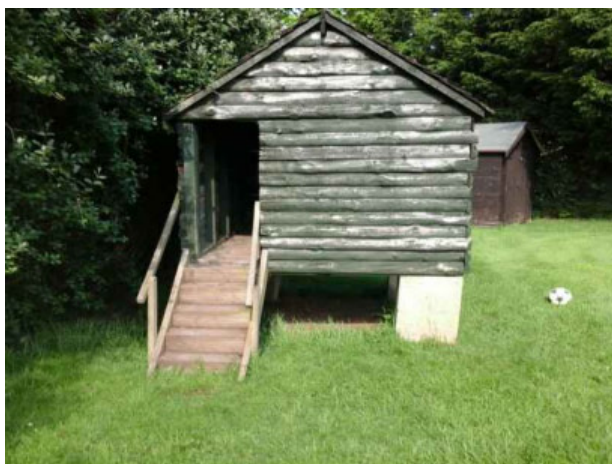
There is some evidence of rot in the timber - Monitor for any further deterioration and replace as required

A number of fixing(s) have worked loose - Secure all loose fixings

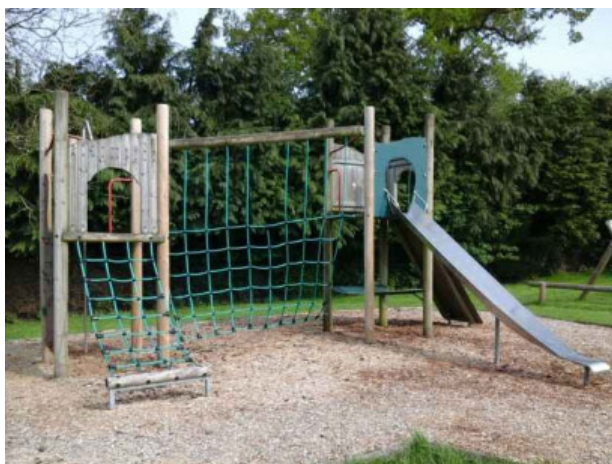
The lower timber forms a hard object within the falling space of the equipment in contravention of the requirements of BS EN 1176 Part 1 - Monitor use

The timber has a number of air cracks apparent, the splits will have penetrated the preservative applied to the timber and allow water ingress to the unprotected areas - Monitor for any deterioration (rot) and replace as required

Parts of the timber are rough or splintered - Remove all rough or sharp edges

There is/are finger entrapment/s in the barrier corners and the item fails to meet the requirements of BS EN 1176:2008 Part 1 4.2.7.6 Entrapment of fingers - Monitor use

A number of fixing(s) have worked loose on the barriers - Secure all loose fixings

There is some evidence of rot in the timber - Monitor for any further deterioration and replace as required

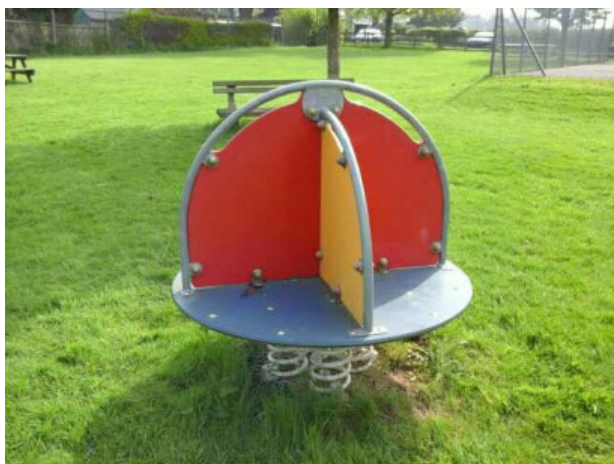
The grass mats are silted up, the soil is compacted and the area will become very slippery when the soil is wet. - Lift and relay the mats

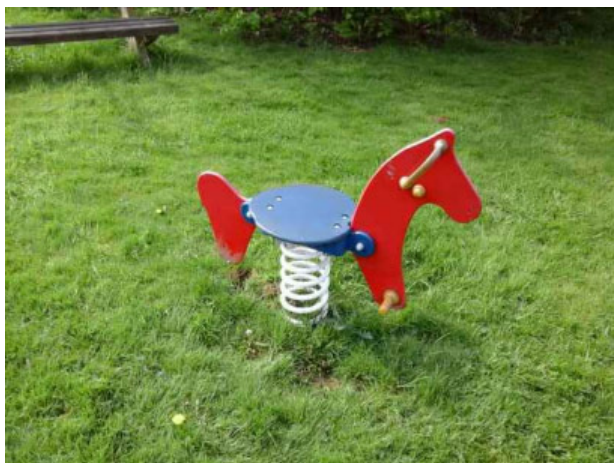
The end of handgrips and/or footrests have a cross section of less than 15cm<sup>2</sup> and fail to meet the requirements of BS EN 1176:2008 Part 6 - This is a relatively low risk failure and no remedial action is recommended

There is/are bolt cap covers missing or damaged on the item - Replace missing or damaged bolt cap covers

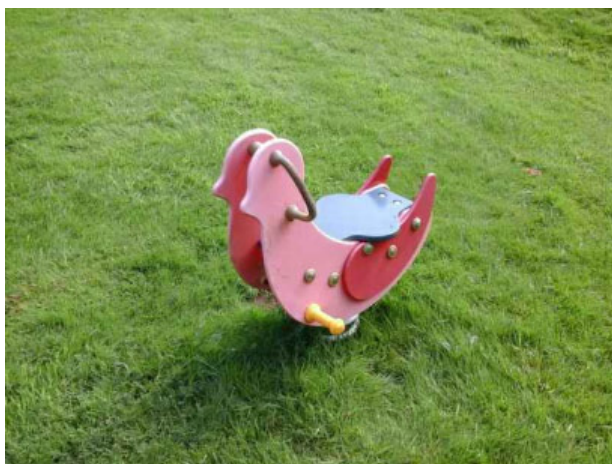
The end of handgrips and/or footrests have a cross section of less than 15cm<sup>2</sup> and fail to meet the requirements of BS EN 1176:2008 Part 6 - This is a relatively low risk failure and no remedial action is recommended

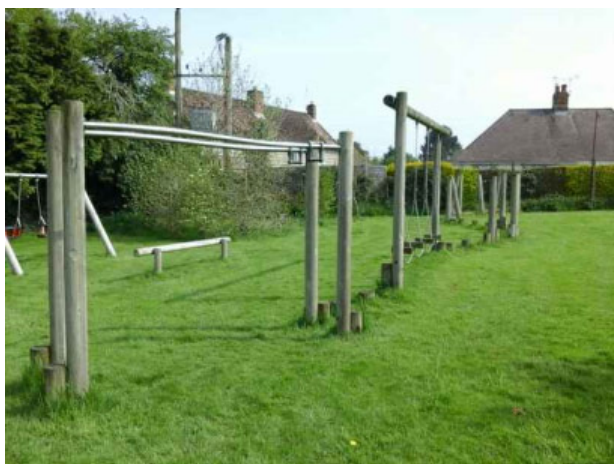
A number of fixing(s) have worked loose on the monkey bars - Secure all loose fixings

There is some graffiti present - Remove the graffiti

There is some strimmer damage apparent on the posts, this can penetrate the preservative applied to the timber and accelerate the rotting process - Monitor for any deterioration (rot) and replace as required

The item is slightly loose in its foundations on the stilts - Monitor for any further deterioration and repair as required

There is some evidence of rot in the timber - Monitor for any further deterioration and replace as required

The timber has a number of air cracks apparent, the splits will have penetrated the preservative applied to the timber and allow water ingress to the unprotected areas - Monitor for any deterioration (rot) and replace as required

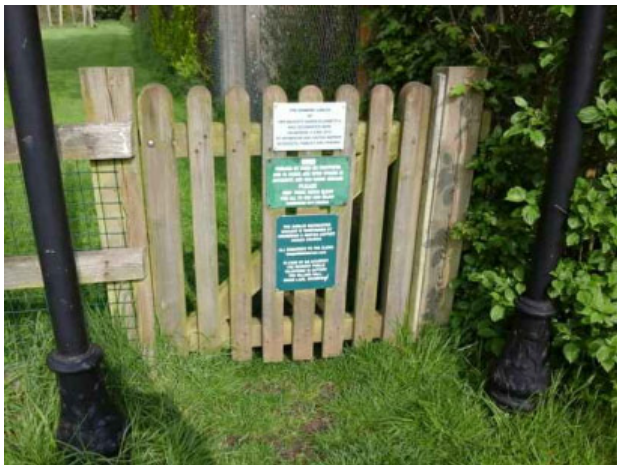
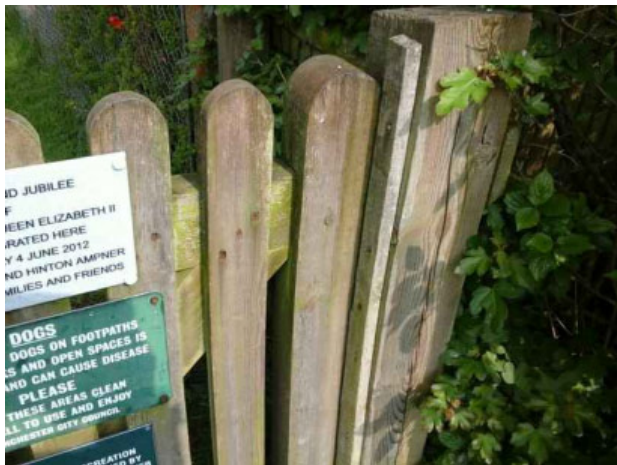
<b>Finding:</b>	The opening between the gate and the post is less than 12mm and could trap users fingers		<b>Action:</b> Adjust gate to ensure a 12mm opening all around

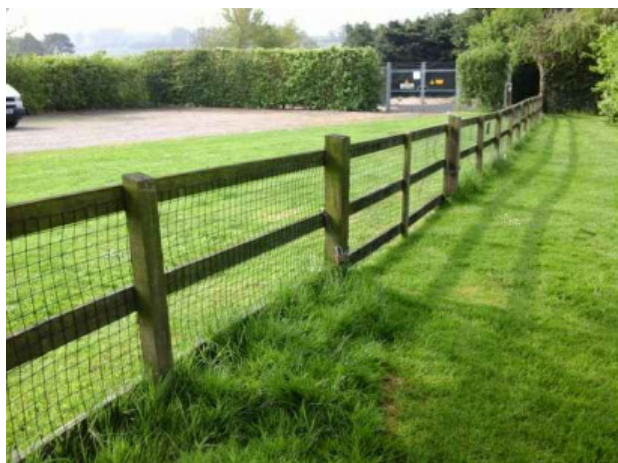
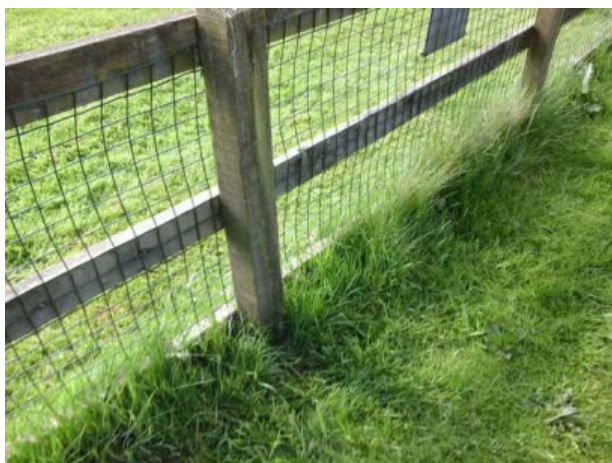
**Finding:** There are a number of loose posts around the fence  
**Action:** Monitor for any further deterioration and reset as required

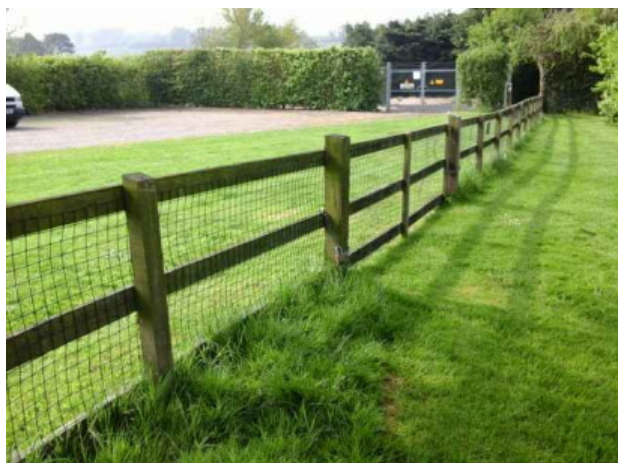
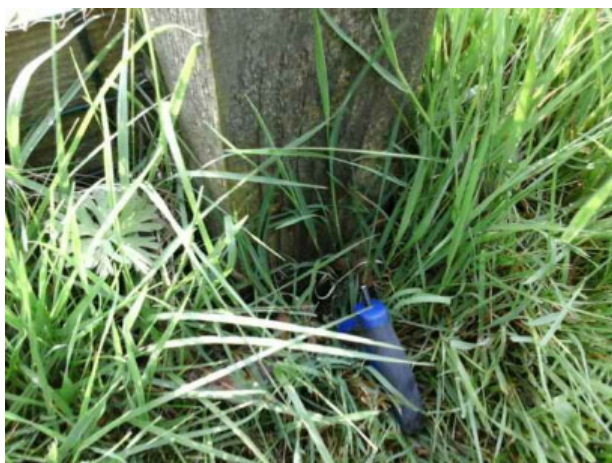
**Finding:** There are areas or parts of the timber on the structure that have rotted  
**Action:** Replace all affected timbers

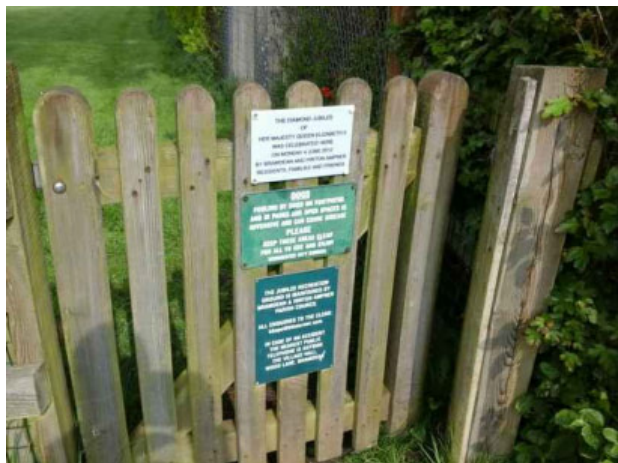
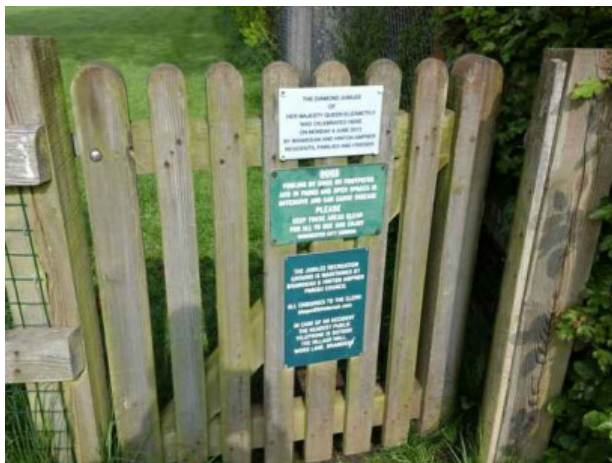
**Finding:** It is recommended that information signs with emergency contact details are installed at each entrance/exit point to the playground

**Action:** Provide in accordance with the recommendations set out in BS EN 1176

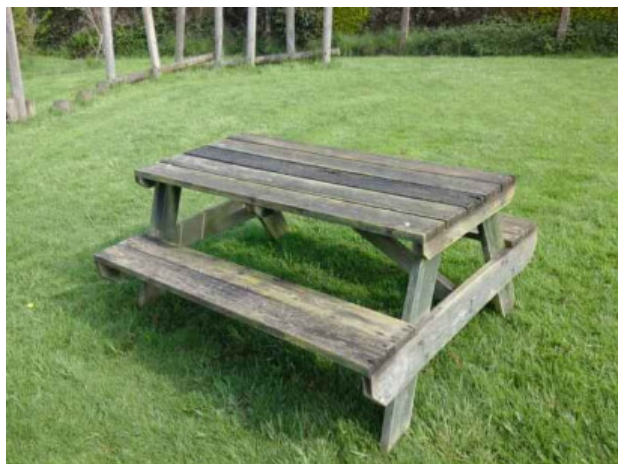
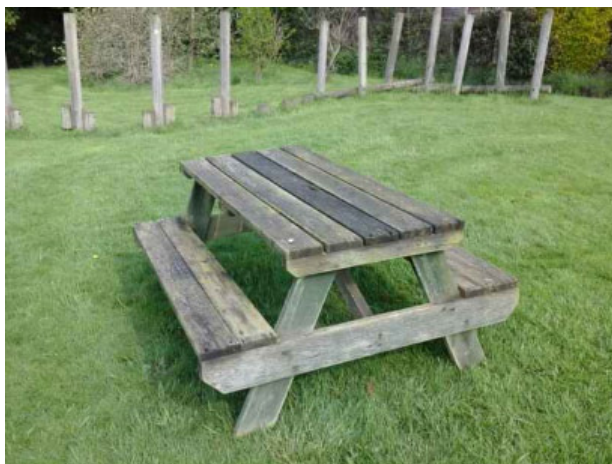
**Finding:** The bench is not securely fixed to the surface and there is some possibility of the item tipping or rolling over

**Action:** Secure the bench to the ground

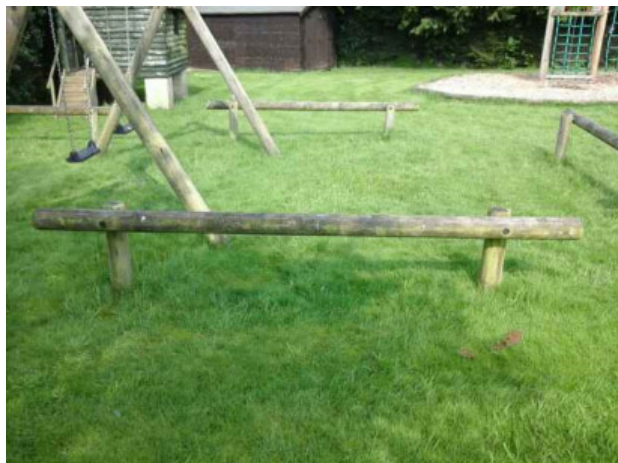
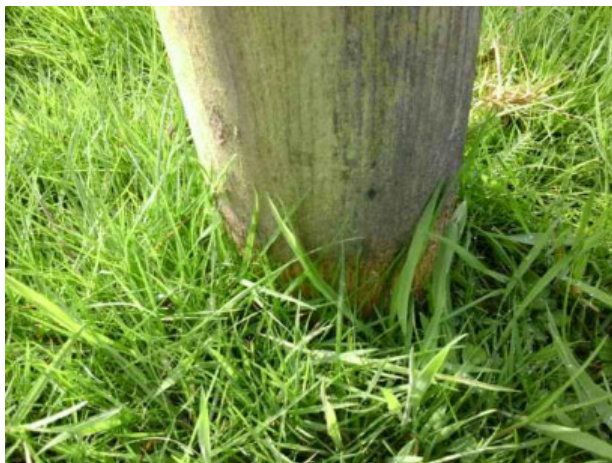
**Finding:** There is some strimmer damage apparent on the posts, this can penetrate the preservative applied to the timber and accelerate the rotting process

**Action:** Monitor for any deterioration (rot) and replace as required

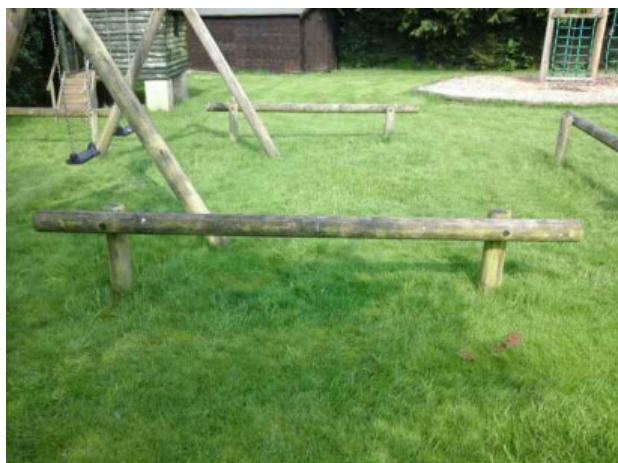
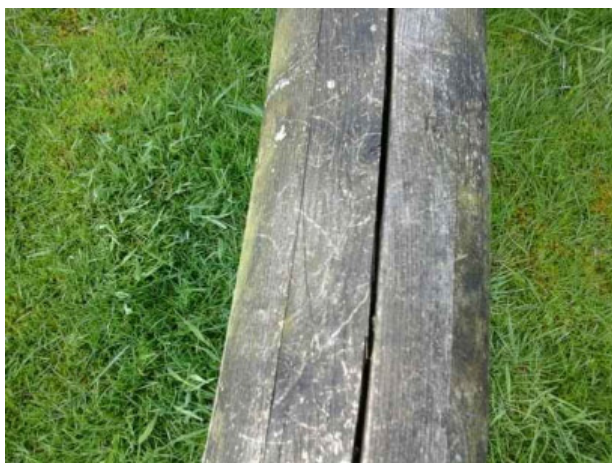
**Finding:** The timber has a number of air cracks apparent, the splits will have penetrated the preservative applied to the timber and allow water ingress to the unprotected areas

**Action:** Monitor for any deterioration (rot) and replace as required

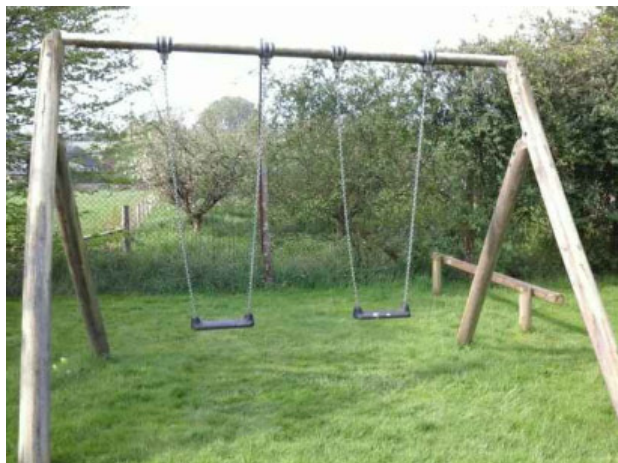
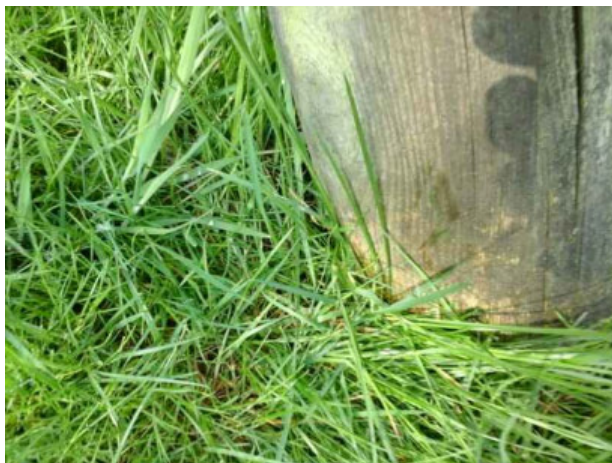
**Finding:** There is some strimmer damage apparent on the posts, this can penetrate the preservative applied to the timber and accelerate the rotting process

**Action:** Monitor for any deterioration (rot) and replace as required

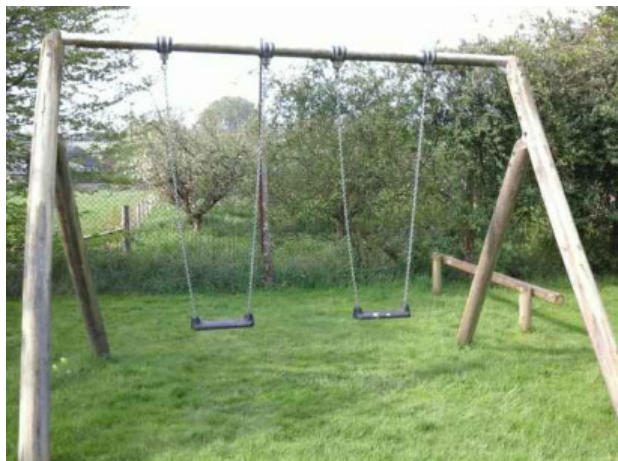
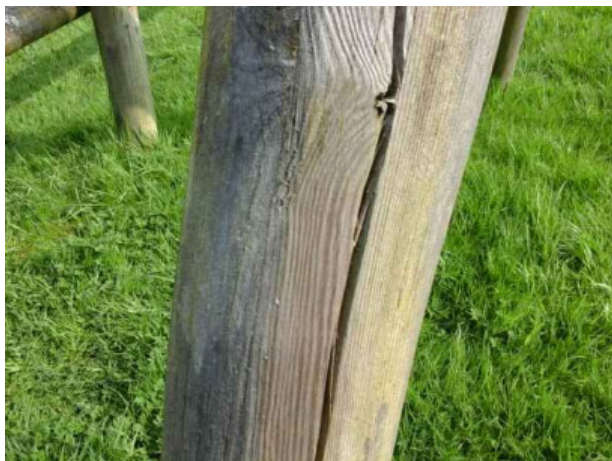
**Finding:** The timber has a number of air cracks apparent, the splits will have penetrated the preservative applied to the timber and allow water ingress to the unprotected areas

**Action:** Monitor for any deterioration (rot) and replace as required

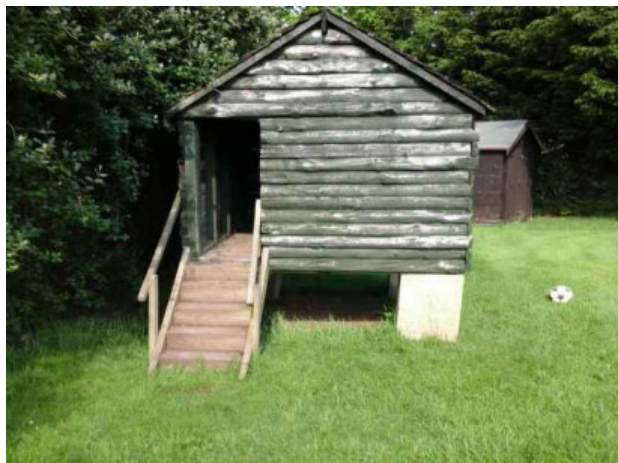
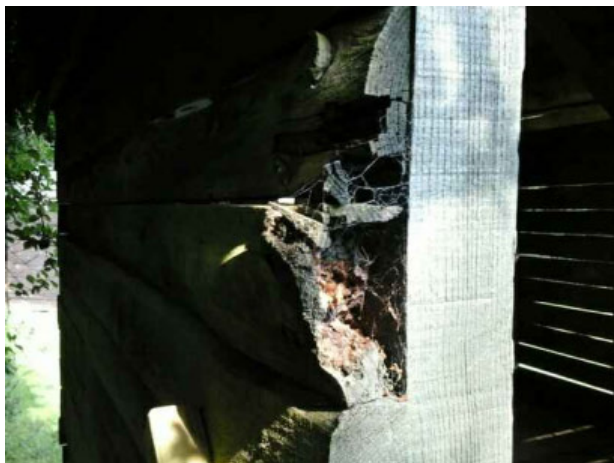
**Finding:** There is some evidence of rot in the timber

**Action:** Monitor for any further deterioration and replace as required

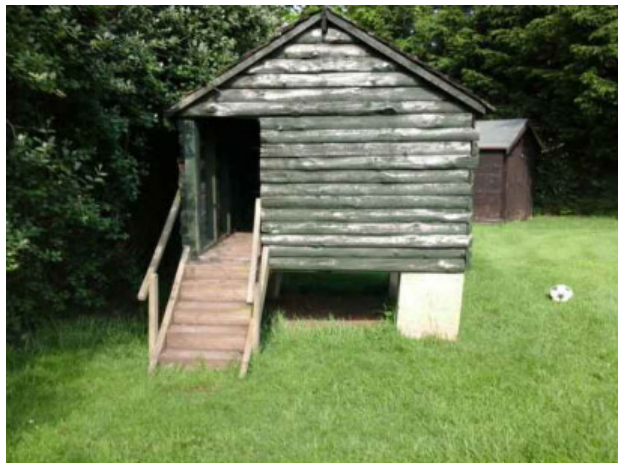
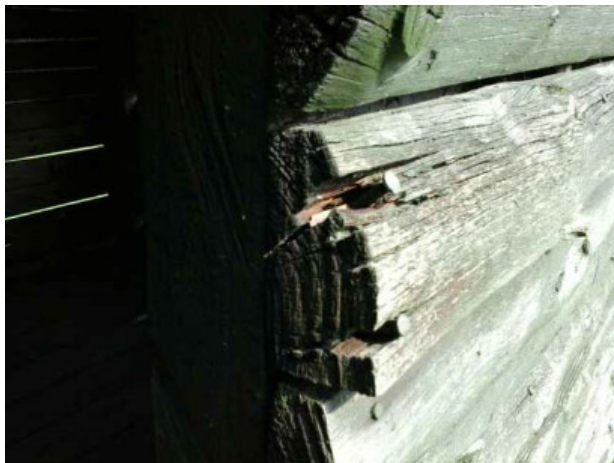
**Finding:** A number of fixing(s) have worked loose

**Action:** Secure all loose fixings

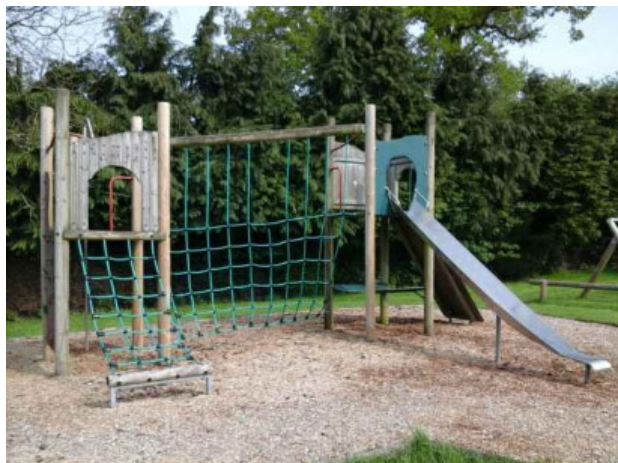
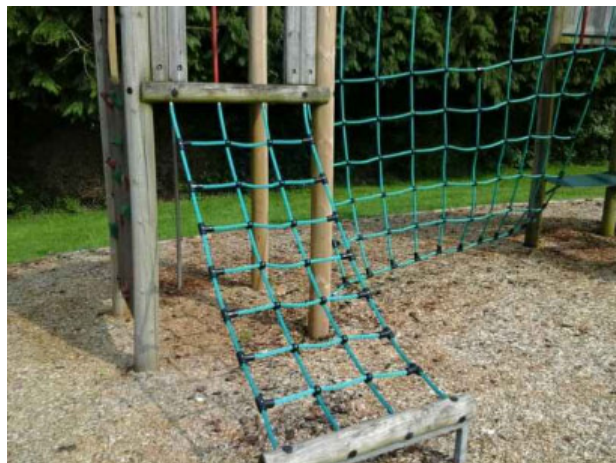
**Finding:** The lower timber forms a hard object within the falling space of the equipment in contravention of the requirements of BS EN 1176 Part 1

**Action:** Monitor use

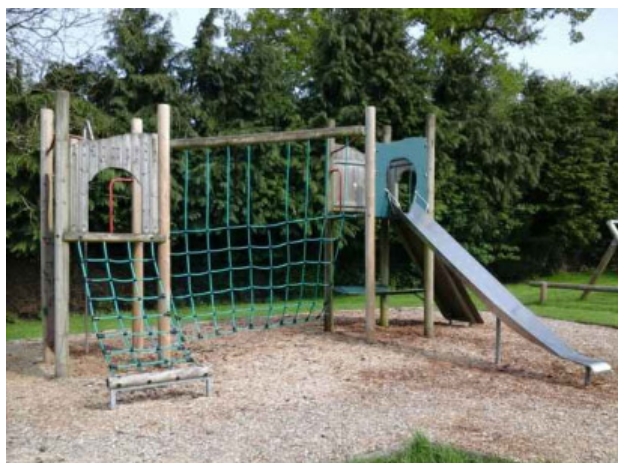
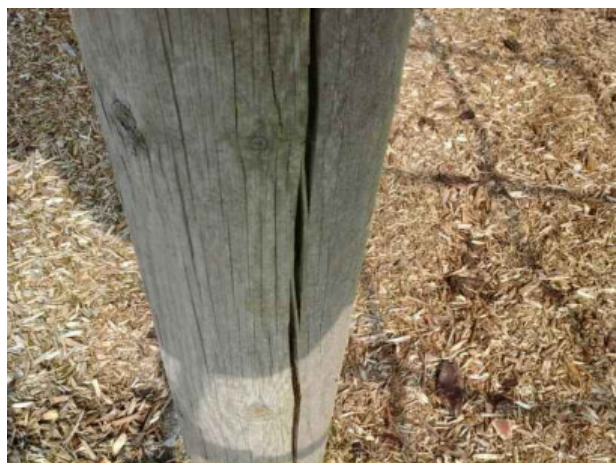
**Finding:** The timber has a number of air cracks apparent, the splits will have penetrated the preservative applied to the timber and allow water ingress to the unprotected areas

**Action:** Monitor for any deterioration (rot) and replace as required

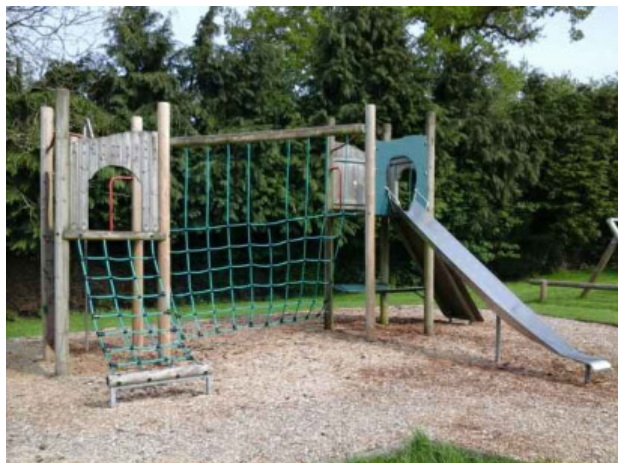
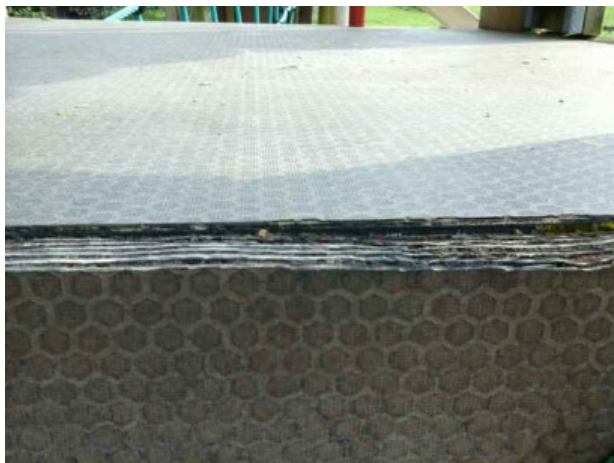
**Finding:** Parts of the timber are rough or splintered

**Action:** Remove all rough or sharp edges

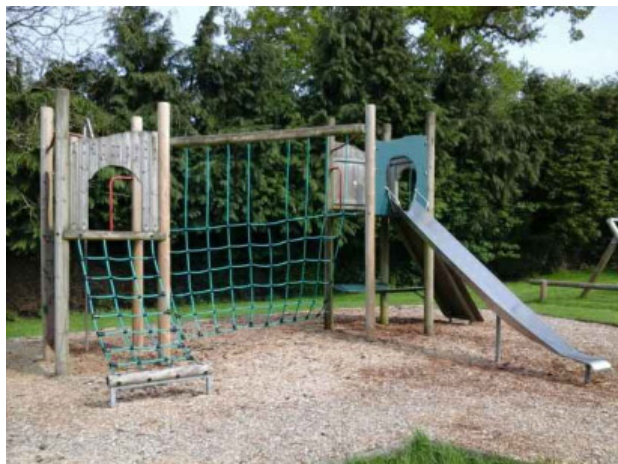
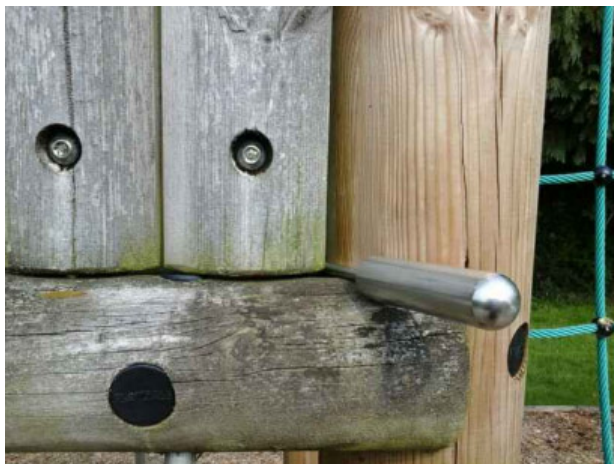
**Finding:** There is/are finger entrapment/s in the barrier corners and the item fails to meet the requirements of BS EN 1176:2008 Part 1 4.2.7.6 Entrapment of fingers

**Action:** Monitor use

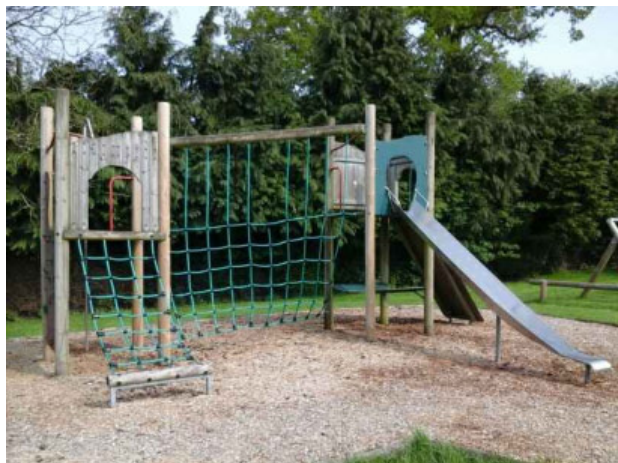
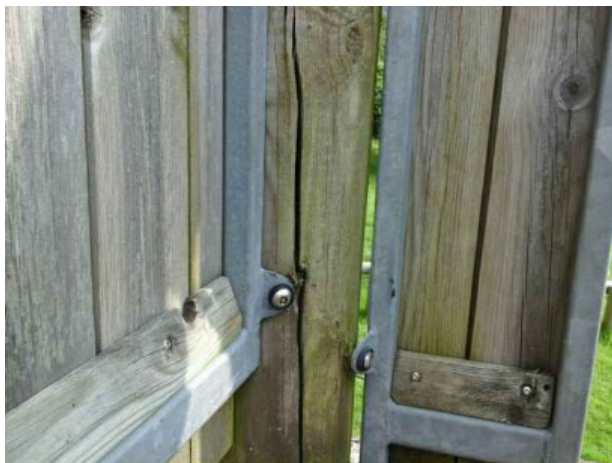
**Finding:** A number of fixing(s) have worked loose on the barriers

**Action:** Secure all loose fixings

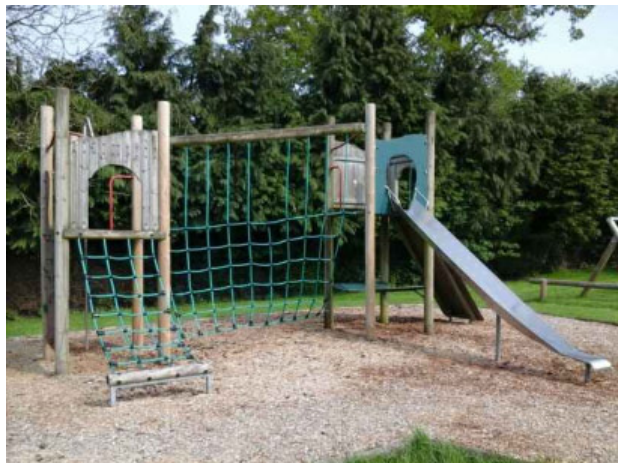
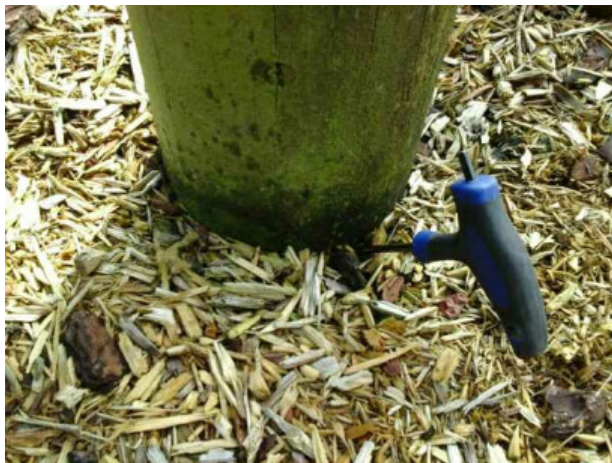
**Finding:** There is some evidence of rot in the timber

**Action:** Monitor for any further deterioration and replace as required

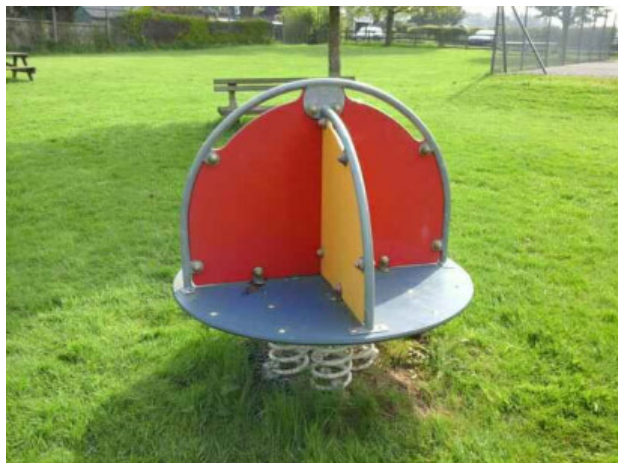
**Finding:** The grass mats are silted up, the soil is compacted and the area will become very slippery when the soil is wet.

**Action:** Lift and relay the mats

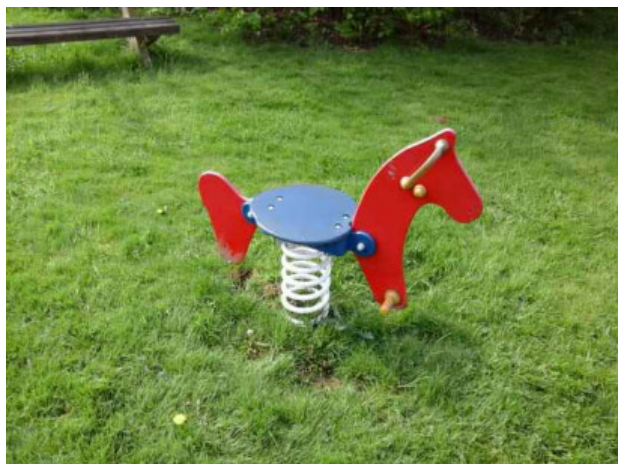
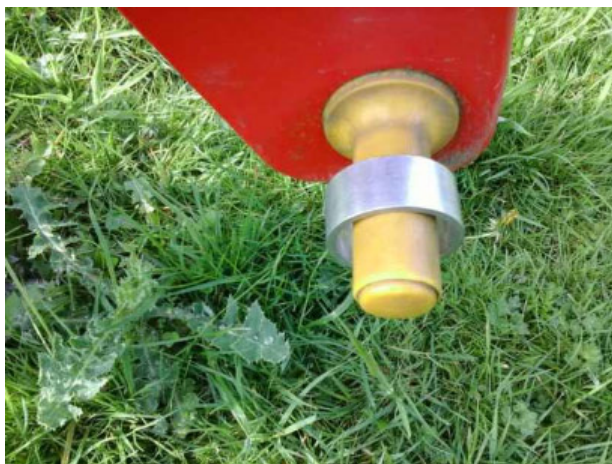
**Finding:** The end of handgrips and/or footrests have a cross section of less than 15cm<sup>2</sup> and fail to meet the requirements of BS EN 1176:2008 Part 6

**Action:** This is a relatively low risk failure and no remedial action is recommended

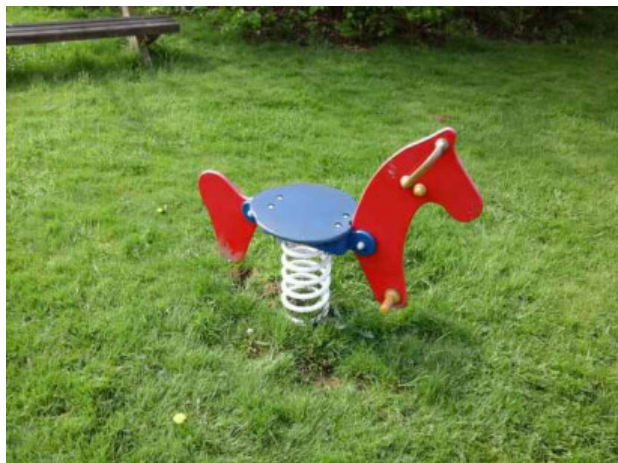
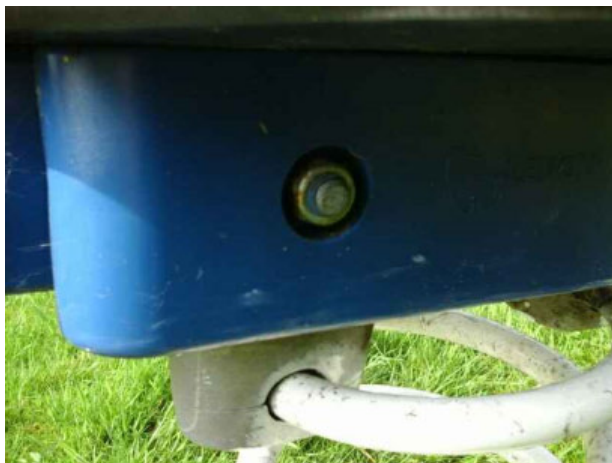
**Finding:** There is/are bolt cap covers missing or damaged on the item

**Action:** Replace missing or damaged bolt cap covers

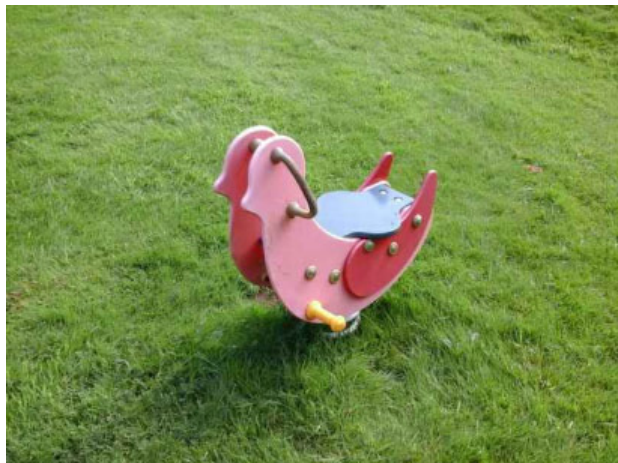
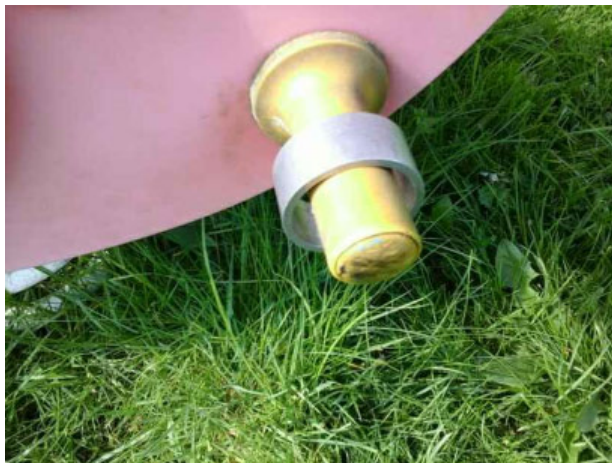
**Finding:** The end of handgrips and/or footrests have a cross section of less than 15cm<sup>2</sup> and fail to meet the requirements of BS EN 1176:2008 Part 6

**Action:** This is a relatively low risk failure and no remedial action is recommended

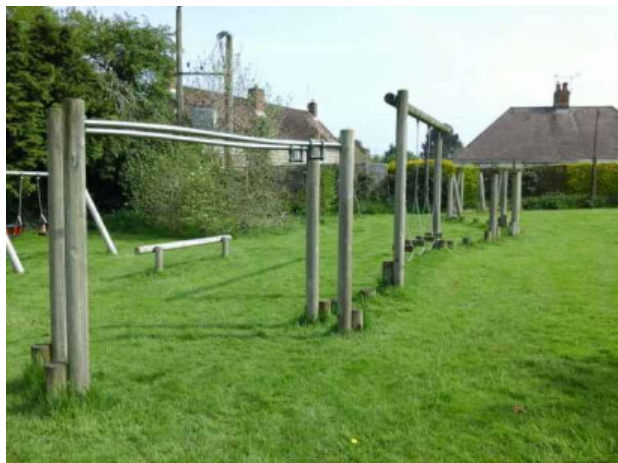
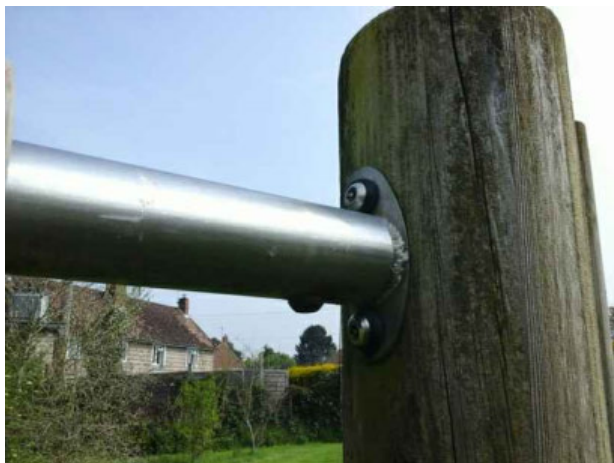
**Finding:** A number of fixing(s) have worked loose on the monkey bars

**Action:** Secure all loose fixings

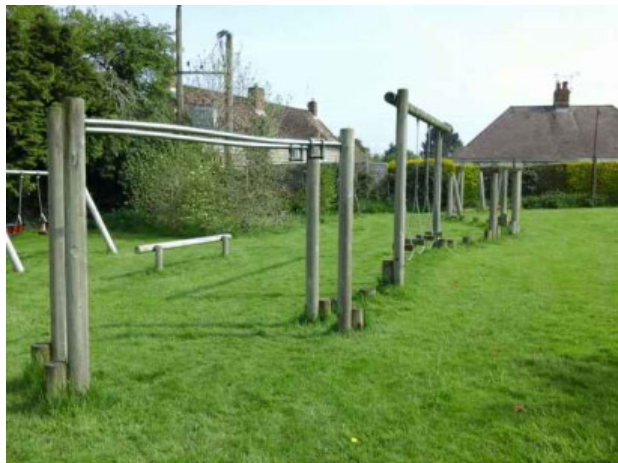
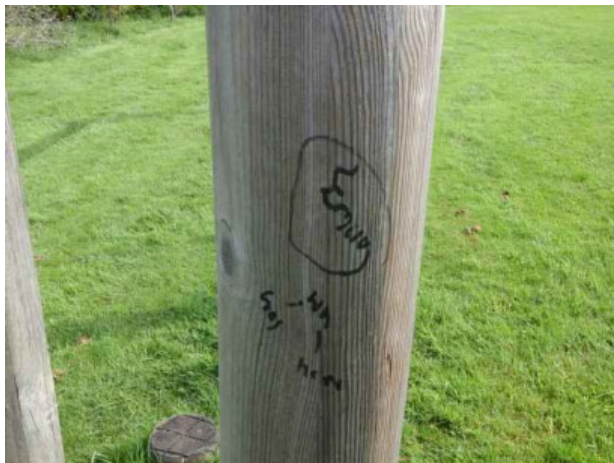
**Finding:** There is some graffiti present

**Action:** Remove the graffiti

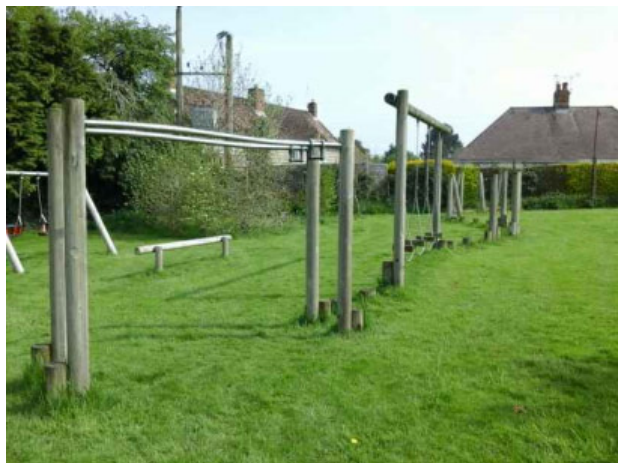
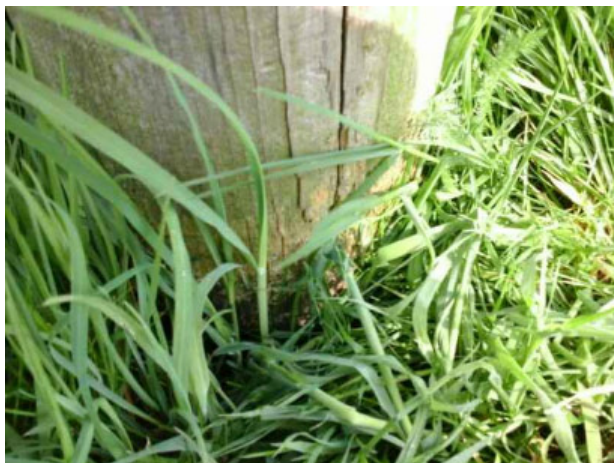
**Finding:** There is some strimmer damage apparent on the posts, this can penetrate the preservative applied to the timber and accelerate the rotting process

**Action:** Monitor for any deterioration (rot) and replace as required

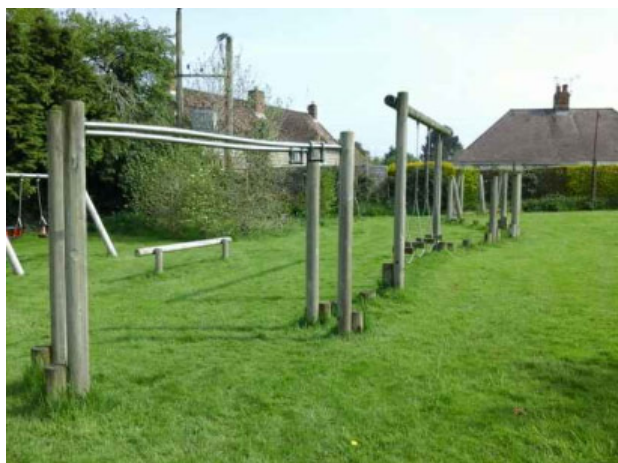
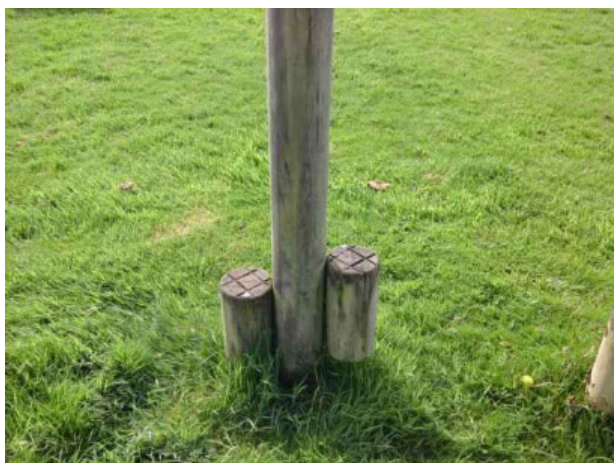
**Finding:** The item is slightly loose in its foundations on the stilts

**Action:** Monitor for any further deterioration and repair as required

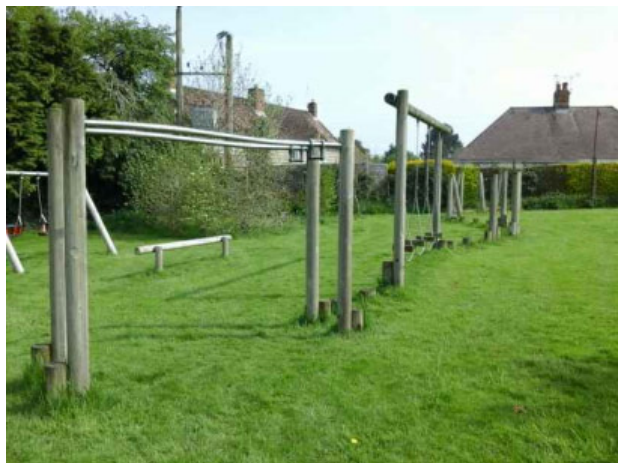
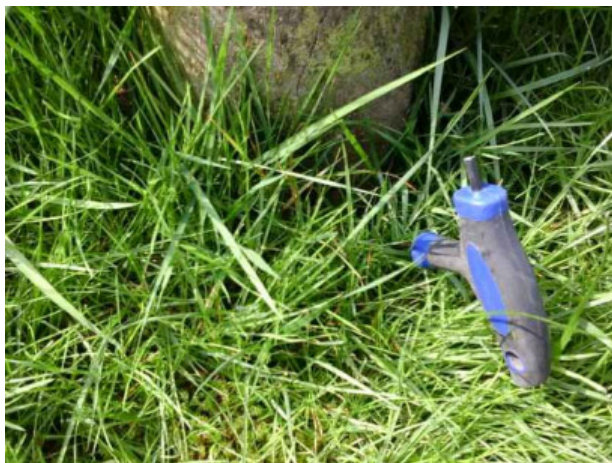
**Finding:** There is some evidence of rot in the timber

**Action:** Monitor for any further deterioration and replace as required

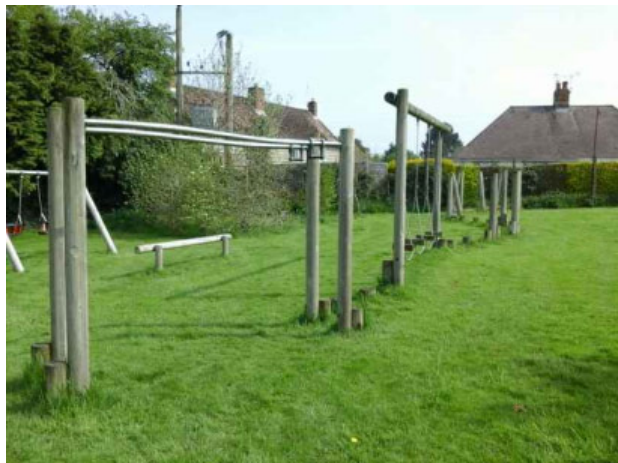
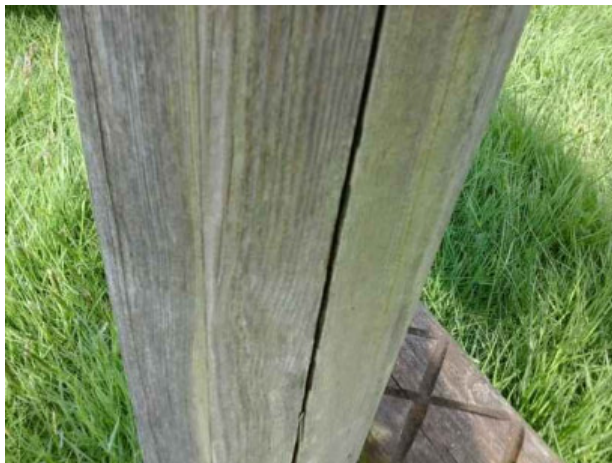
**Finding:** The timber has a number of air cracks apparent, the splits will have penetrated the preservative applied to the timber and allow water ingress to the unprotected areas

**Action:** Monitor for any deterioration (rot) and replace as required
