# PLAY AREA SAFETY INSPECTION REPORT

Bramdean & Hinton Ampner Parish Council

29 May 2017

Site Owner : **Bramdean & Hinton Ampner Parish Council**  
Site Name : Bramdean & Hinton Ampner PC - Jubilee Recreation Ground  
Date of Inspection : 29 May 2017  
Inspected by : Didrik Wold

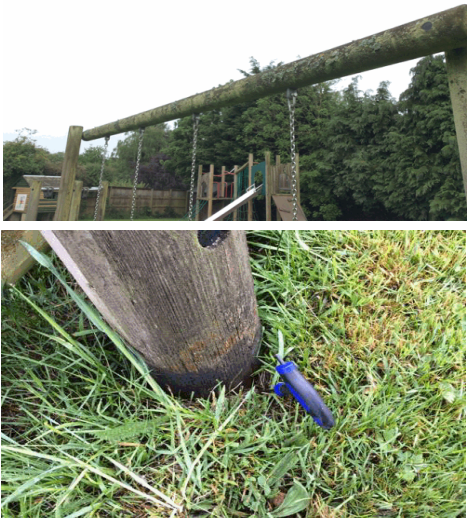
Comments, action or control required		Risk Level	Risk Score ‡
<b>Equipment</b>			
Finding :	There is decay to timber components which may affect structural integrity . Due to the increased problem of timber rot, especially in posts in contact with the ground, we do not recommend replacing rotten supports with timber posts which are directly set in the ground.	Medium	8
Finding Date :	29/05/2017		
Notes :	There is varying degrees of rot in several posts and signs of rot in overhead beam. Several pieces of timber have been previously replaced.

Task :	Replace decayed components where possible, and plan replacement of item. Check on a routine basis, especially at ground or foundation level		
<b>Surfacing - Grass</b>			
No remedial maintenance work is required at this time.			
<b>The overall risk for this item at the time of inspection:</b>		Medium	8
‡ For Risk Score see Report Notes

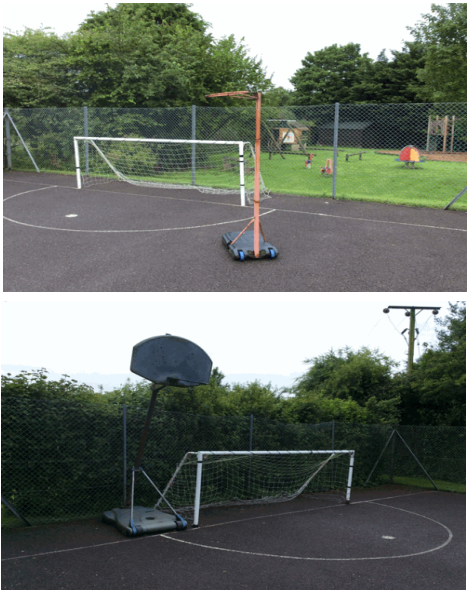
Recommended Maintenance and Risk Assessment Evaluation		Risk Level	Risk Score
Comments, action or control required			
Equipment			
Finding :	Item - Damaged	Low	4
Finding Date :	29/05/2017		
Notes :	Minor damage to fencing - monitor use.

<p>Finding : Monitor</p> <p>Finding Date : 29/05/2017</p> <p>Notes : Area contains portable equipment which can be moved / misused. Risks may vary depending on use.</p> <div data-bbox="628 371 1096 958">

Task :	Repair item

</div> <p>Task : Monitor and check on a routine basis</p>	Medium	8
<p><b>Surfacing - Tarmac</b></p> <p>No remedial maintenance work is required at this time.</p>		
<p><b>The overall risk for this item at the time of inspection:</b></p> <p>‡ For Risk Score see Report Notes</p>	Medium	8

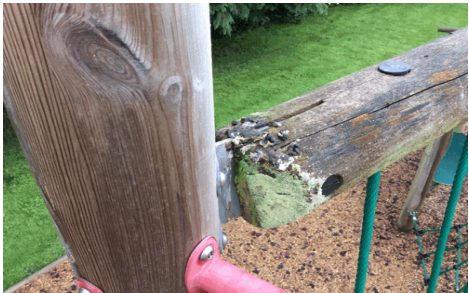
Comments, action or control required		Risk Level	Risk Score ±
<b>Equipment</b>			
Finding :	Bird fouling present	Medium	8
Finding Date :	29/05/2017

Task :	It is recommended that play equipment is regularly checked for bird fouling- If found the affected items should be cleaned with a disinfectant solution		
Finding :	The free space and / or falling space contains obstacles or equipment parts that are not permitted.	Low	6
Finding Date :	29/05/2017		
Notes :	Beam at base of net.

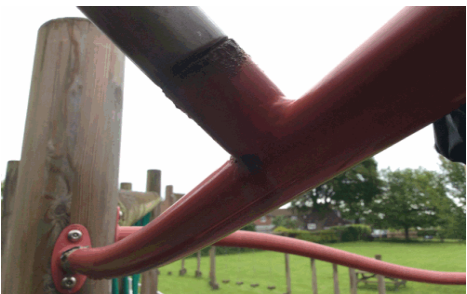
<p>Finding : Paintwork in poor condition</p> <p>Finding Date : 29/05/2017</p> <p>Notes : Top of fireman's pole.</p>	Low	6

<p>Task : De-scale and coat with lead free paint, using appropriate precautions</p>		
<p>Finding : Laminate damaged</p>	Low	6
<p>Finding Date : 29/05/2017</p>

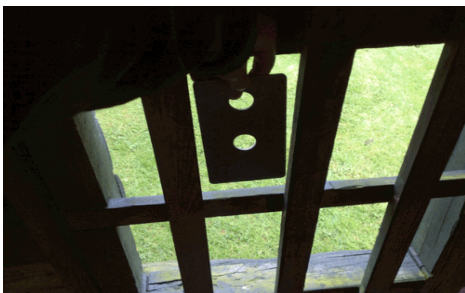
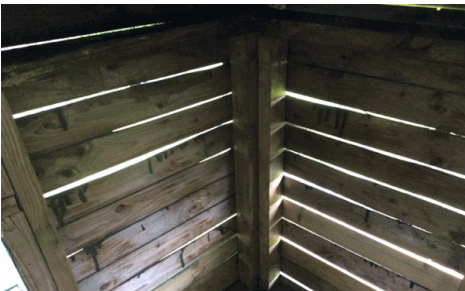
Comments, action or control required		Risk Level	Risk Score ‡
<b>Equipment</b>			
Finding :	Monitor	Low	6
Finding Date :	29/05/2017		
Notes :	There are minor finger entrapments between timber slats and minor head entrapments in window opening. These shouldn't pose any problems since there is no fall height involved - monitor use and consider changes if deemed necessary in light of experience.

Task :	Monitor and check on a routine basis		
<b>Surfacing - Grass</b>			
No remedial maintenance work is required at this time.			
<b>The overall risk for this item at the time of inspection:</b>		Low	6
‡ For Risk Score see Report Notes

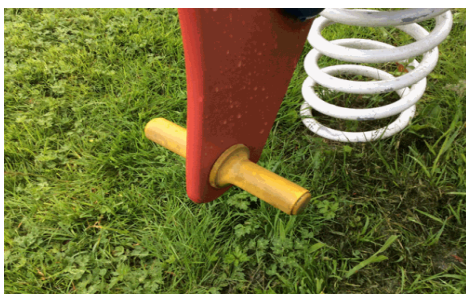
Recommended Maintenance and Risk Assessment Evaluation		Risk Level	Risk Score ‡
Equipment			
Finding :	When tested with the 44 mm diameter ring gauge the footrests project beyond the outer face of the gauge.	Low	6
Finding Date :	29/05/2017

Task :	No action required given the risk assessment		
Surfacing - Misc Grass Matting			
No remedial maintenance work is required at this time.			
The overall risk for this item at the time of inspection:		Low	6
‡ For Risk Score see Report Notes

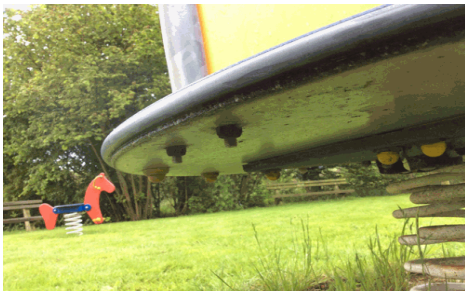
Comments, action or control required		Risk Level	Risk Score ‡
<b>Equipment</b>			
Finding :	Item - Cap(s) missing	Low	6
Finding Date :	29/05/2017		
Notes :	Projecting bolt threads under platform - at a minimum cut back excess thread length.

Task :	Replace		
<b>Surfacing - Misc Grass Matting</b>			
No remedial maintenance work is required at this time.			
<b>The overall risk for this item at the time of inspection:</b>		Low	6
‡ For Risk Score see Report Notes

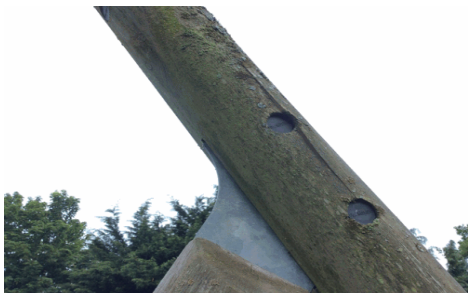
Recommended Maintenance and Risk Assessment Evaluation		Risk Level	Risk Score ‡
Equipment			
Finding :	Timber - Not in Good Condition	Low	6
Finding Date :	29/05/2017		
Notes :	Split in timber near fixing points - monitor for further deterioration.

Task :	No action given the risk assessment		
Surfacing - Misc Grass Matting			
No remedial maintenance work is required at this time.			
The overall risk for this item at the time of inspection: ‡ For Risk Score see Report Notes		Low	6
