## Annual Inspection

Winchester City Council

The Jubilee RG (Bramdean and Hinton Ampner PC)

Annual Inspection - 08 February 2018 at 09:25 Inspector: Richard Sewell (RPII Annual Inspector)

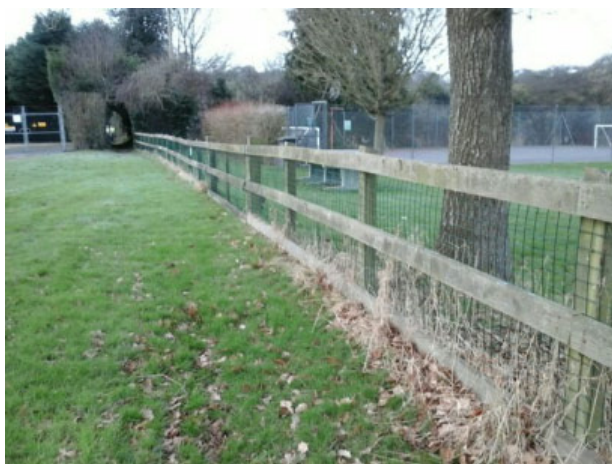
There are a number of loose posts around the fence - Monitor for any further deterioration and reset as required

There are areas or parts of the timber on the structure that have rotted - Replace all affected timbers

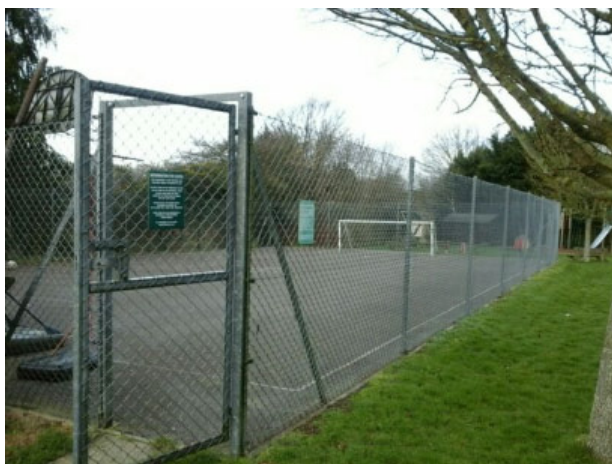
Minor damage to fence - Repair as required

Fixings are damaged and/or have sharp edges - Repair or replace as required

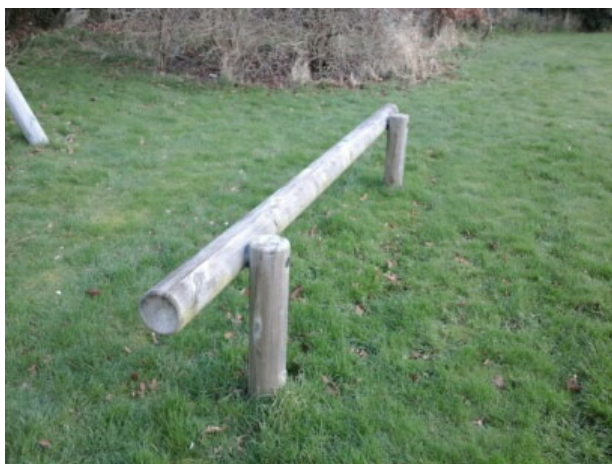
The timber has a number of air cracks apparent, the splits will have penetrated the preservative applied to the timber and allow water ingress to the unprotected areas - Monitor for any deterioration (rot) and replace as required

There is some strimmer damage apparent on the posts, this can penetrate the preservative applied to the timber and accelerate the rotting process - Monitor for any deterioration (rot) and replace as required

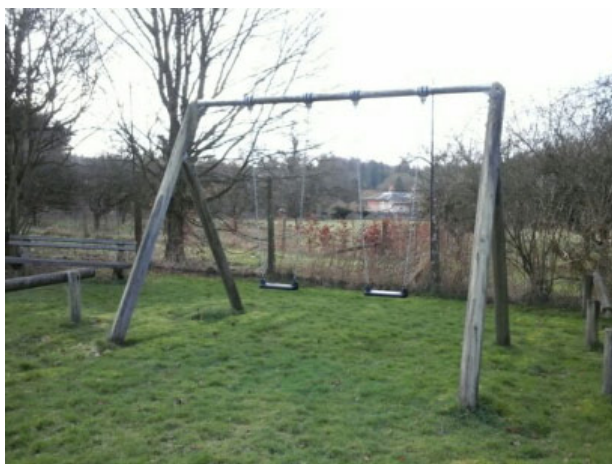
There is some strimmer damage apparent on the posts, this can penetrate the preservative applied to the timber and accelerate the rotting process - Monitor for any deterioration (rot) and replace as required

The timber has a number of air cracks apparent, the splits will have penetrated the preservative applied to the timber and allow water ingress to the unprotected areas - Monitor for any deterioration (rot) and replace as required

The grass mats are silted up and the soil is compacted; this may have an effect on the impact absorbing properties of the surface - Lift and relay mats or test impact absorbing properties to ensure the correct surface qualities are maintained for the equipment

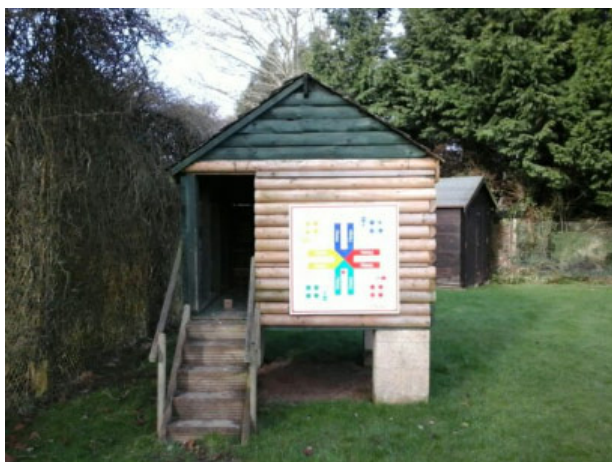
The item fails to meet the requirements of BS EN 1176:2008 Part 1 4.2.7.2 for head and neck entrapment in the windows - Monitor use

There are projecting bolt thread(s) present - Remove excess thread length and deburr or provide cap

This equipment has not been designed or installed to meet with the requirements of BS EN 1176 for public playground equipment; we have however used our knowledge of these standards to assist in forming the basis of our risk assessment for the equipment and our report. - Monitor use and review the use of the equipment and risk assessment regularly

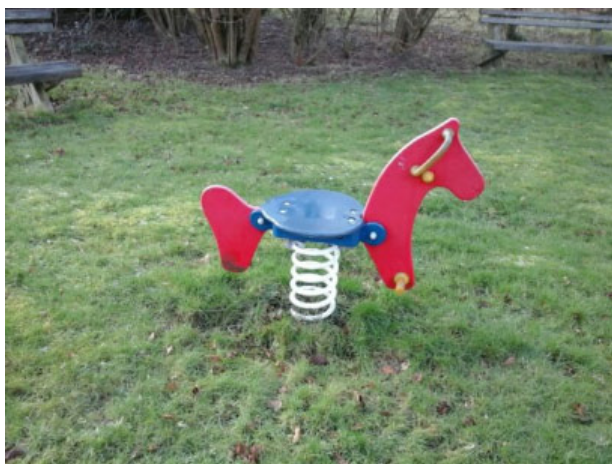
The end of handgrips and/or footrests have a cross section of less than 15cm<sup>2</sup> and fail to meet the requirements of BS EN 1176:2008 Part 6 - This is a relatively low risk failure and no remedial action is recommended

There is/are bolt cap covers missing or damaged on the item - Replace missing or damaged bolt cap covers

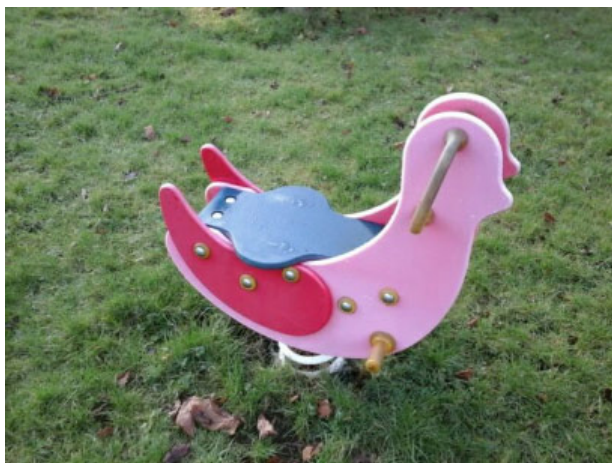
The end of handgrips and/or footrests have a cross section of less than 15cm<sup>2</sup> and fail to meet the requirements of BS EN 1176:2008 Part 6 - This is a relatively low risk failure and no remedial action is recommended

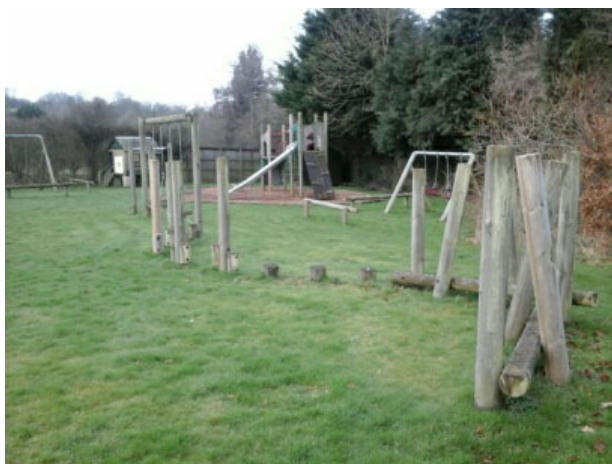
The timber has a number of air cracks apparent, the splits will have penetrated the preservative applied to the timber and allow water ingress to the unprotected areas - Monitor for any deterioration (rot) and replace as required

There is some evidence of rot in the timber - Monitor for any further deterioration and replace as required

There is some strimmer damage apparent on the posts, this can penetrate the preservative applied to the timber and accelerate the rotting process - Monitor for any deterioration (rot) and replace as required

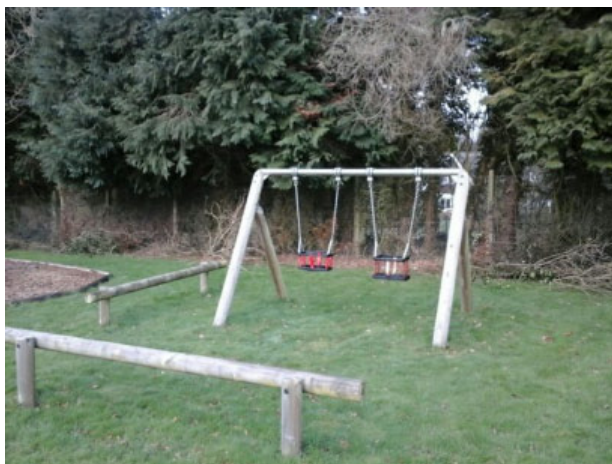
The timber has a number of air cracks apparent, the splits will have penetrated the preservative applied to the timber and allow water ingress to the unprotected areas - Monitor for any deterioration (rot) and replace as required

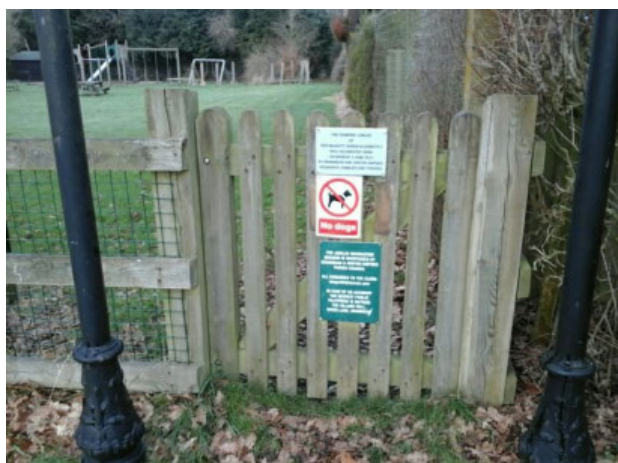
**Finding:** The opening between the gate and the post is less than 12mm and could trap users fingers

**Action:** Adjust gate to ensure a 12mm opening all around

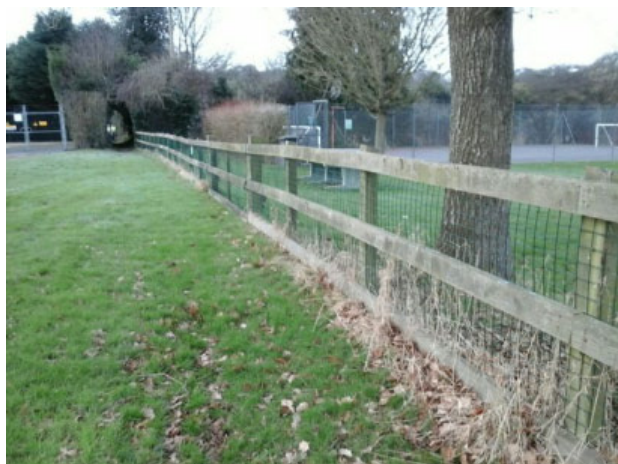
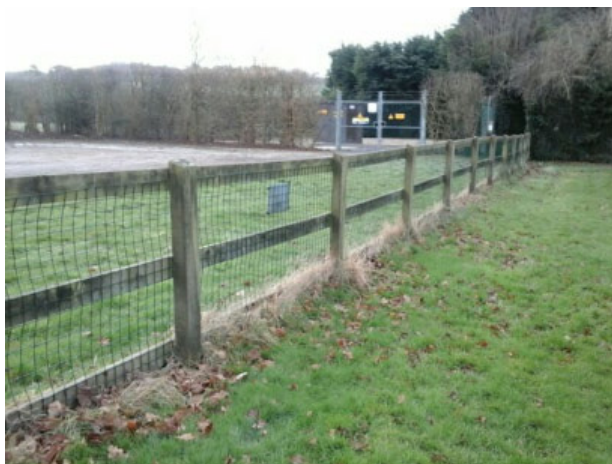
**Finding:** There are a number of loose posts around the fence

**Action:** Monitor for any further deterioration and reset as required

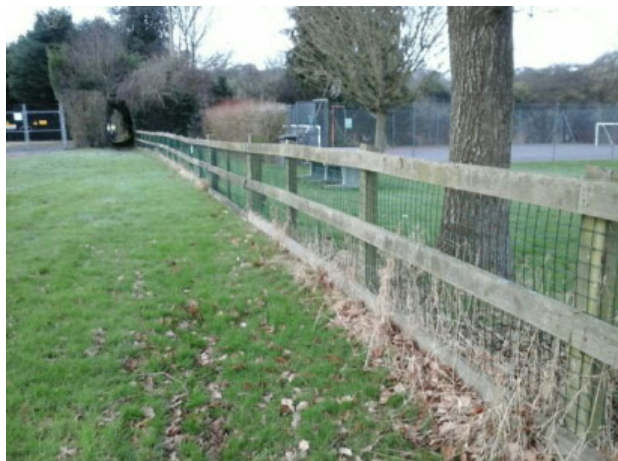
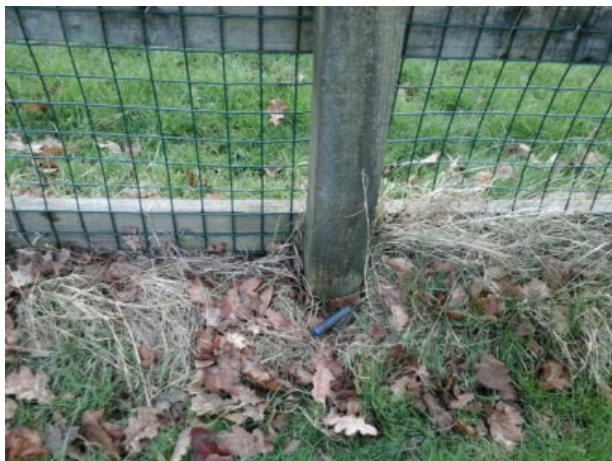
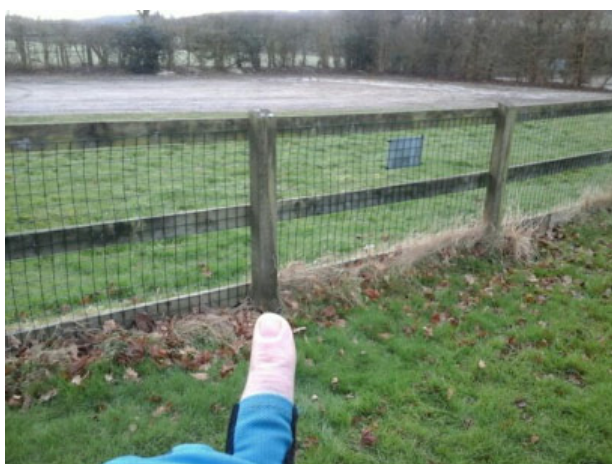
**Finding:** There are areas or parts of the timber on the structure that have rotted

**Action:** Replace all affected timbers

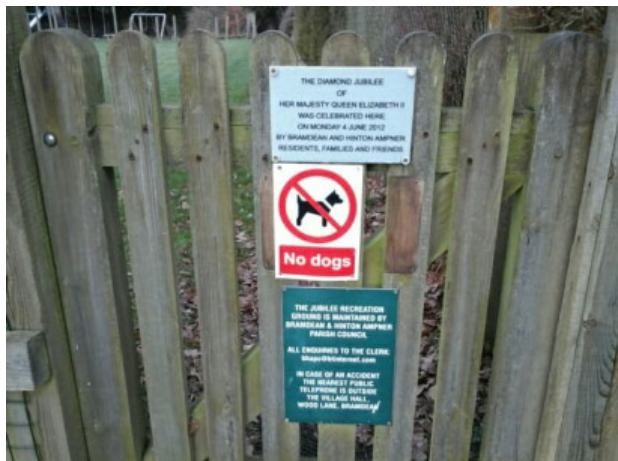
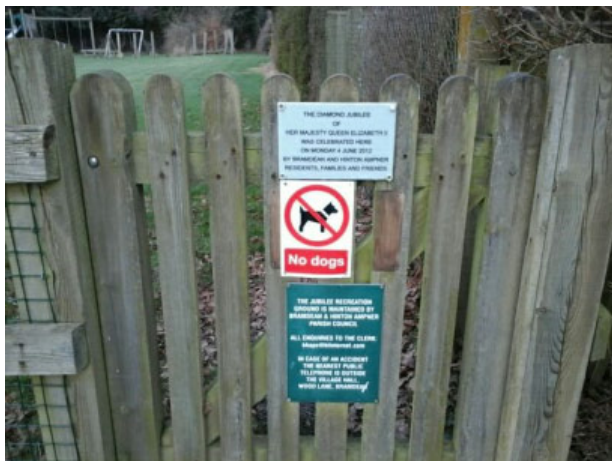
**Finding:** It is recommended that information signs with emergency contact details are installed at each entrance/exit point to the playground

**Action:** Provide in accordance with the recommendations set out in BS EN 1176

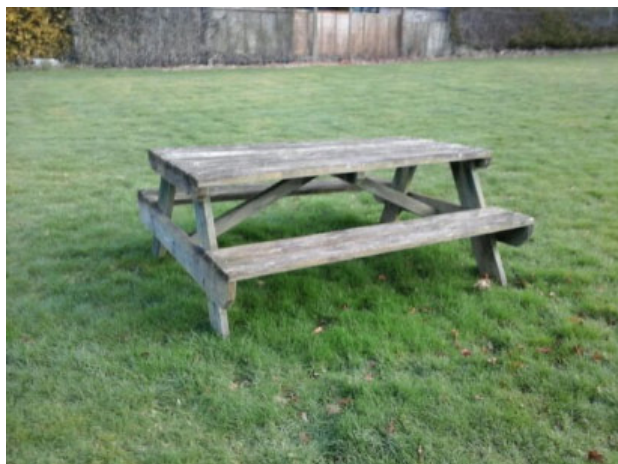
**Finding:** The bench is not securely fixed to the surface and there is some possibility of the item tipping or rolling over

**Action:** Secure the bench to the ground

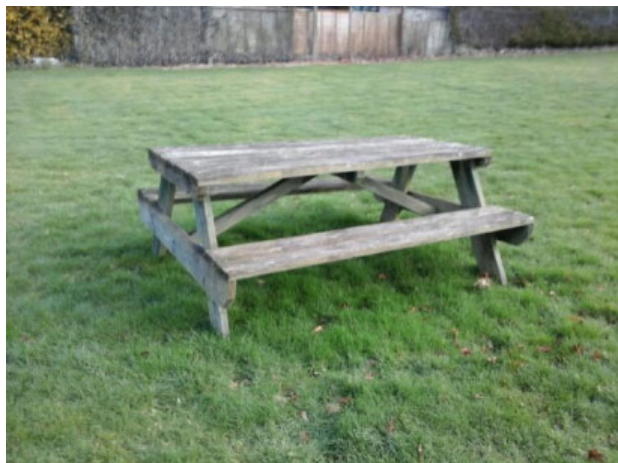
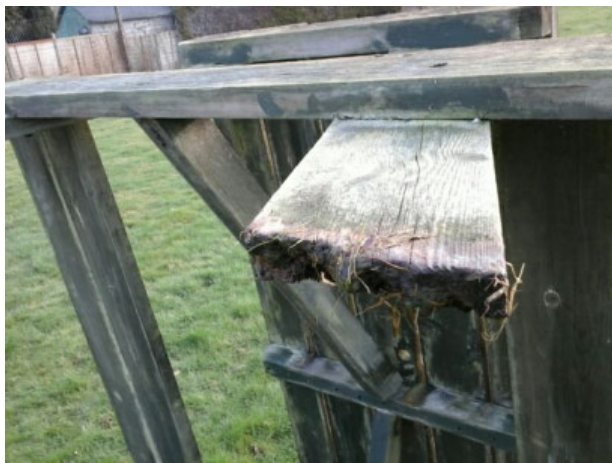
**Finding:** There is some evidence of rot in the timber in the legs

**Action:** Monitor for any further deterioration and replace as required

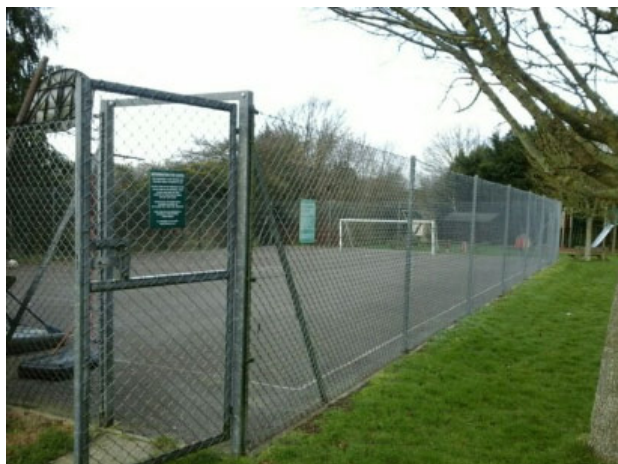
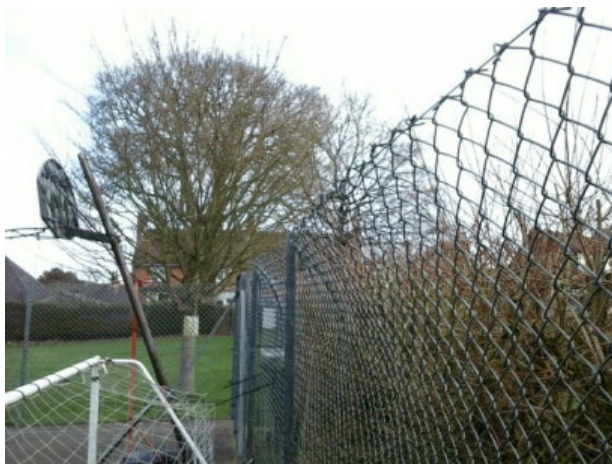
**Finding:** Minor damage to fence

**Action:** Repair as required

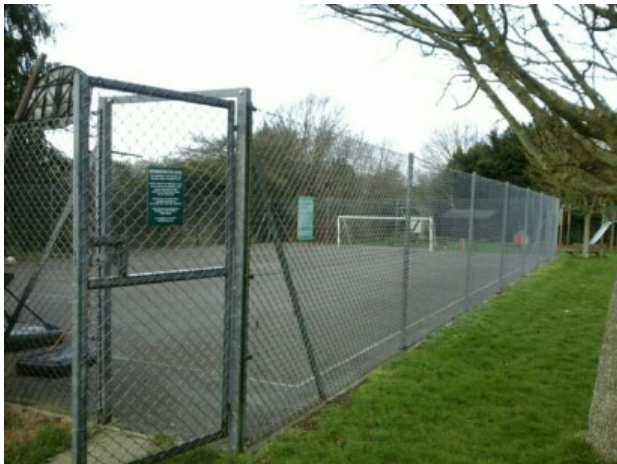
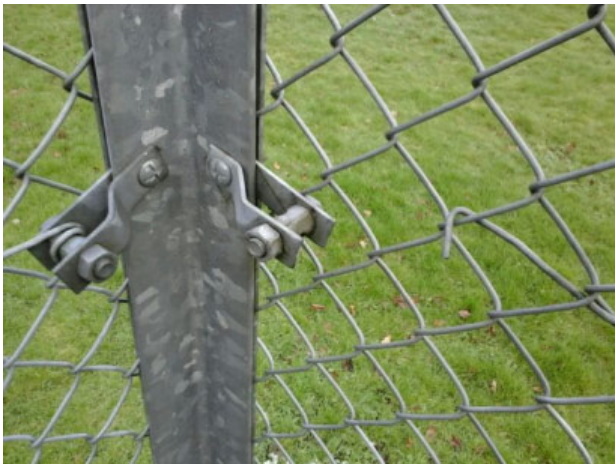
| <div> <b>6 - Low Risk (Finding 2)</b> </div> | | | |
|--|--|--|--|
| <b>Finding:</b> | Fixings are damaged and/or have sharp edges | | <b>Action:</b> Repair or replace as required |

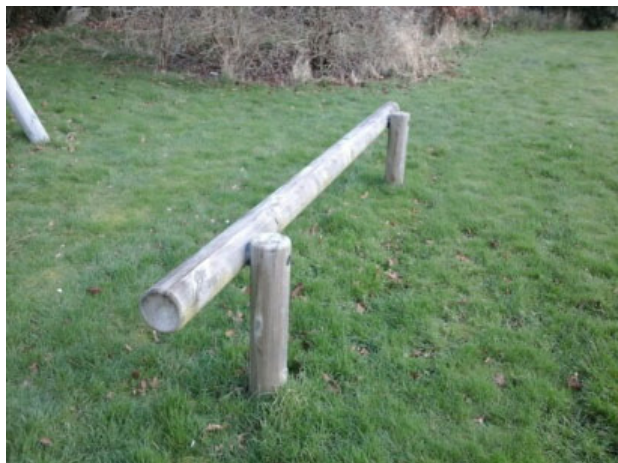
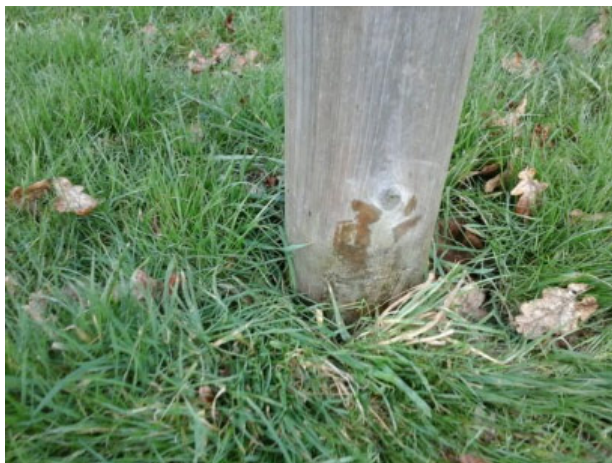
**Finding:** There is some strimmer damage apparent on the posts, this can penetrate the preservative applied to the timber and accelerate the rotting process

**Action:** Monitor for any deterioration (rot) and replace as required

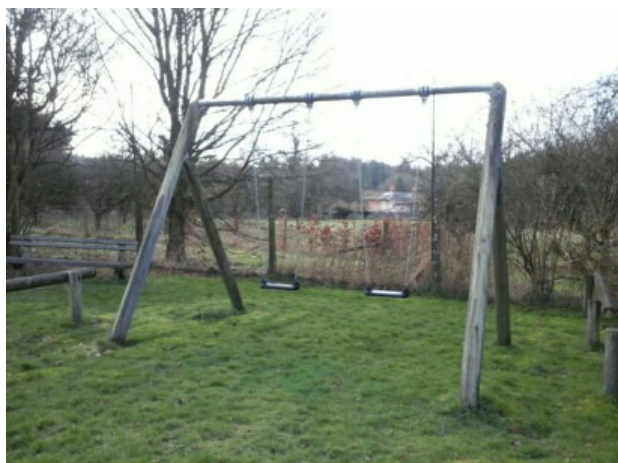
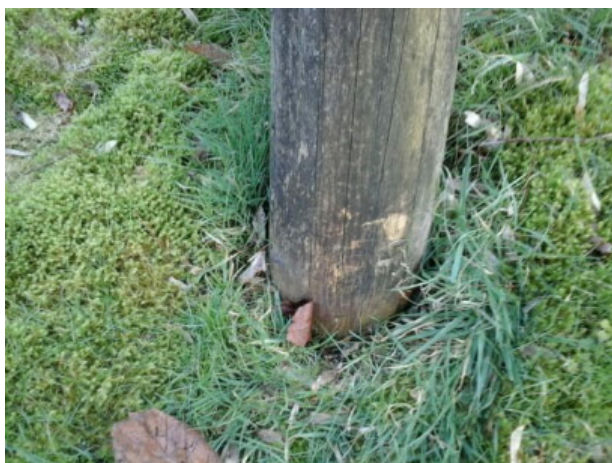
**Finding:** There is some strimmer damage apparent on the posts, this can penetrate the preservative applied to the timber and accelerate the rotting process

**Action:** Monitor for any deterioration (rot) and replace as required

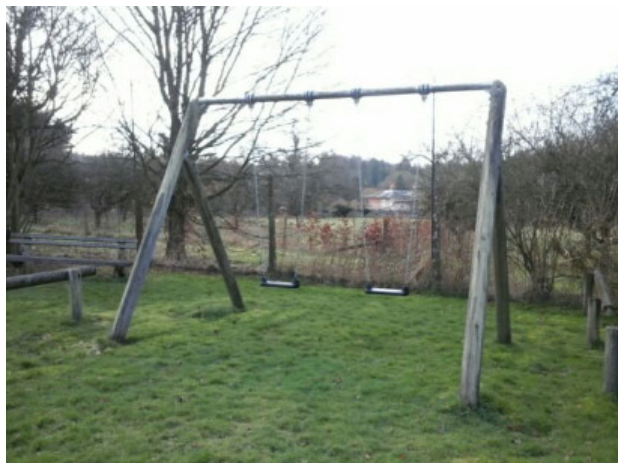
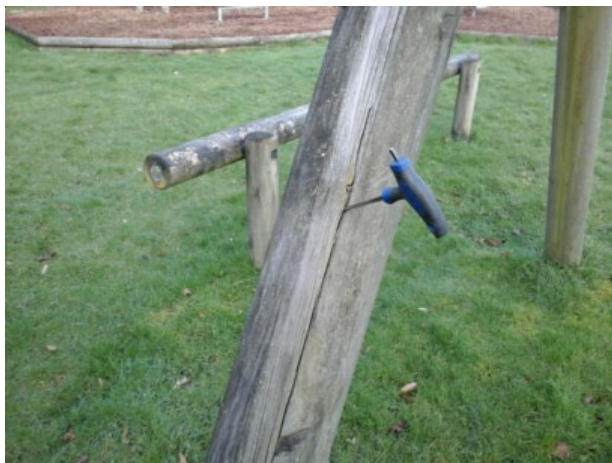
**Finding:** The timber has a number of air cracks apparent, the splits will have penetrated the preservative applied to the timber and allow water ingress to the unprotected areas

**Action:** Monitor for any deterioration (rot) and replace as required

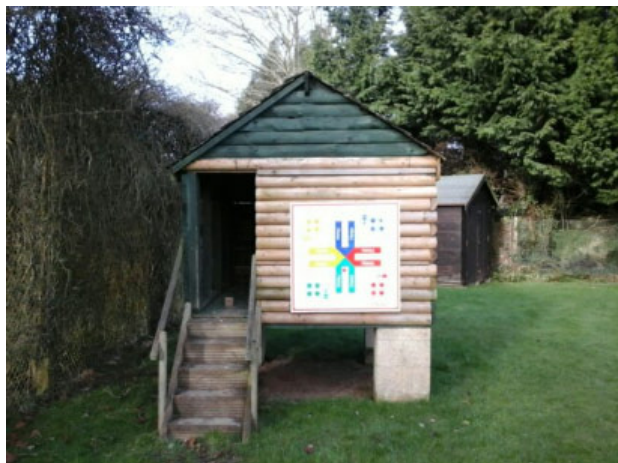
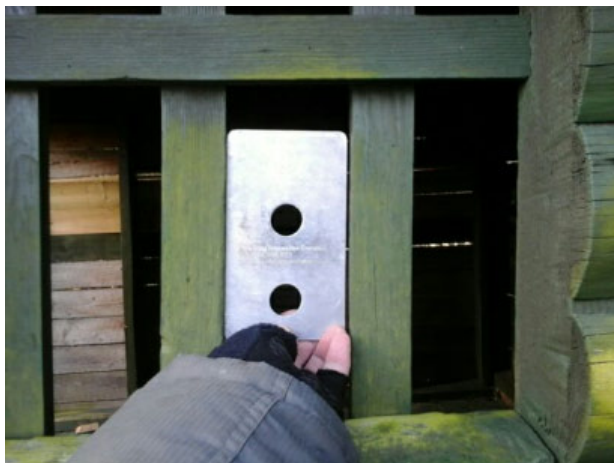
**Finding:** The item fails to meet the requirements of BS EN 1176:2008 Part 1 4.2.7.2 for head and neck entrapment in the windows

**Action:** Monitor use

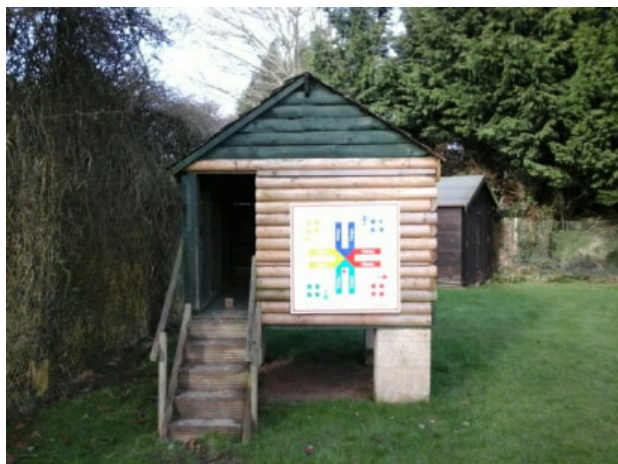
**Finding:** There are projecting bolt thread(s) present

**Action:** Remove excess thread length and deburr or provide cap

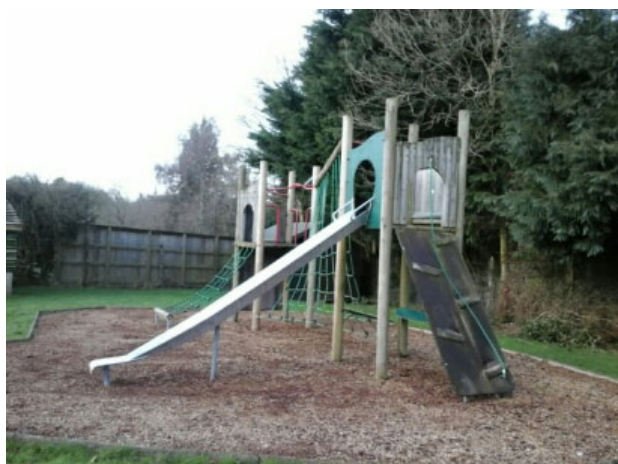
**Finding:** The lower timber forms a hard object within the falling space of the equipment in contravention of the requirements of BS EN 1176 Part 1

**Action:** Monitor use

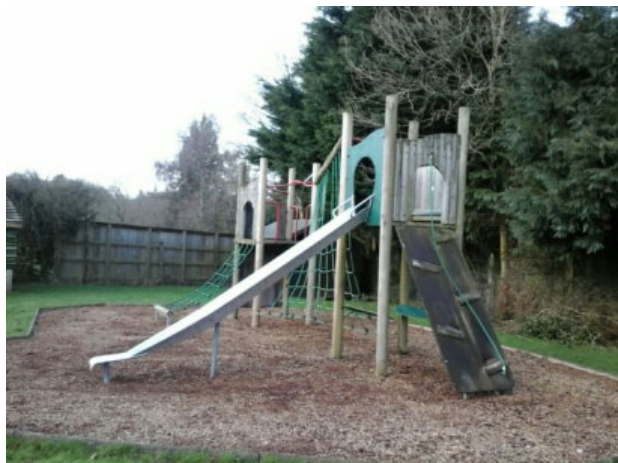
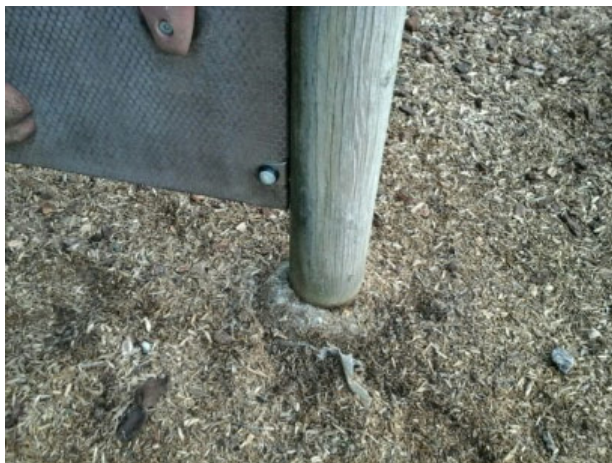
**Finding:** The surface has eroded and the foundations are exposed

**Action:** Reinstate surrounding surfaces to cover the foundations

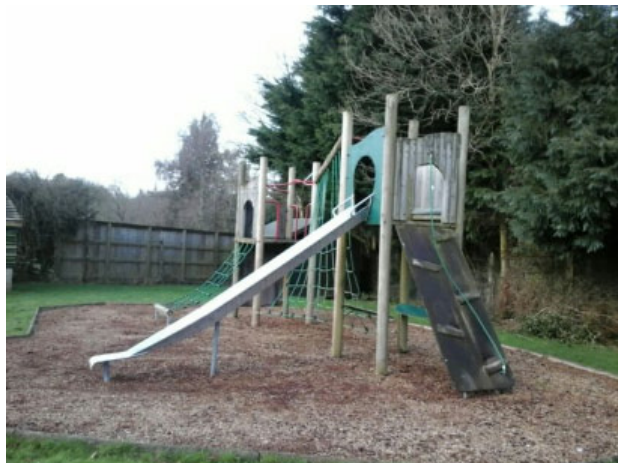
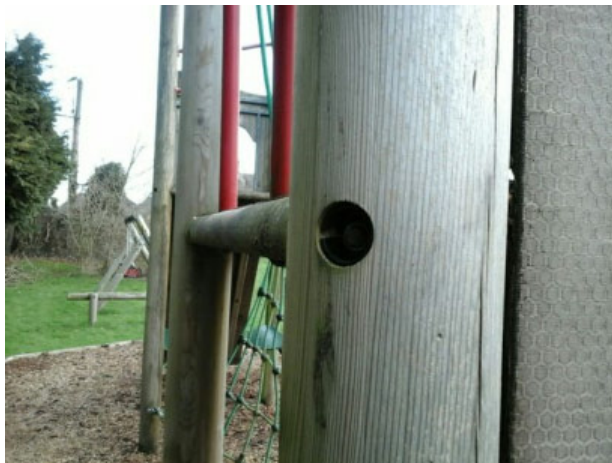
**Finding:** There is/are bolt cap covers missing or damaged on the item

**Action:** Replace missing or damaged bolt cap covers

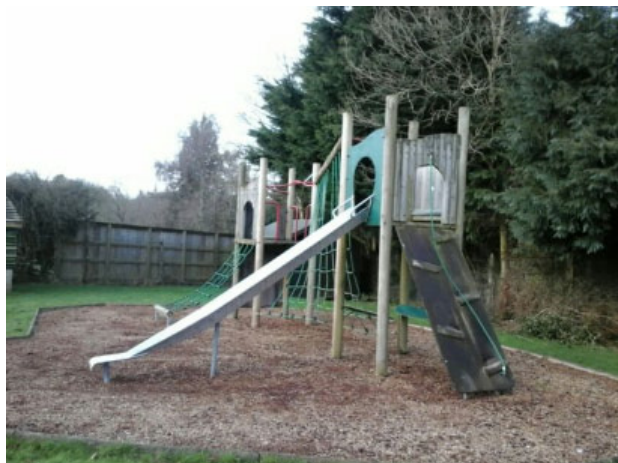
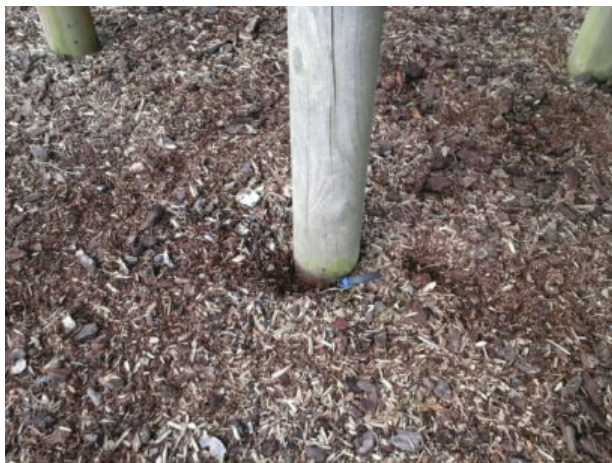
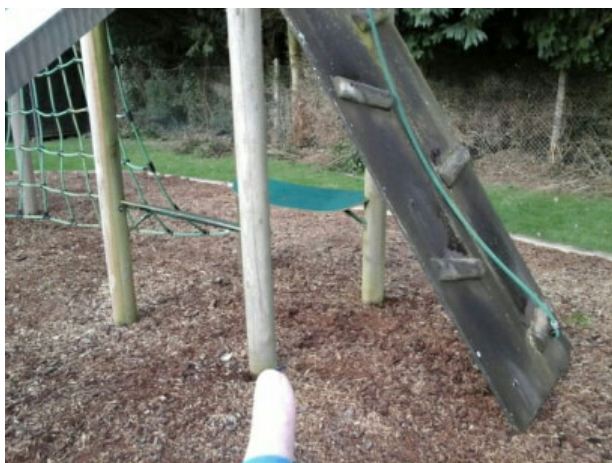
**Finding:** There is some evidence of rot in the timber

**Action:** Monitor for any further deterioration and replace as required

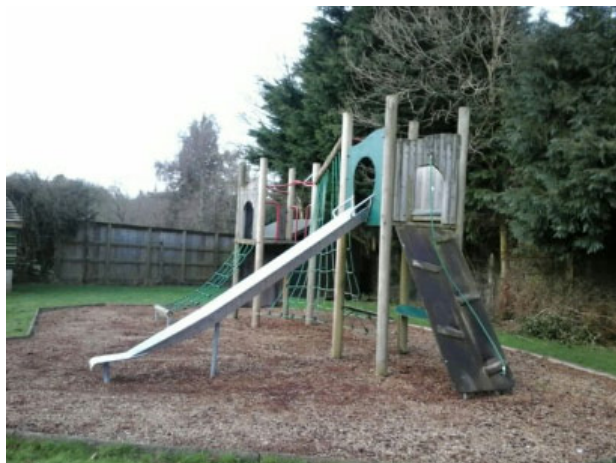
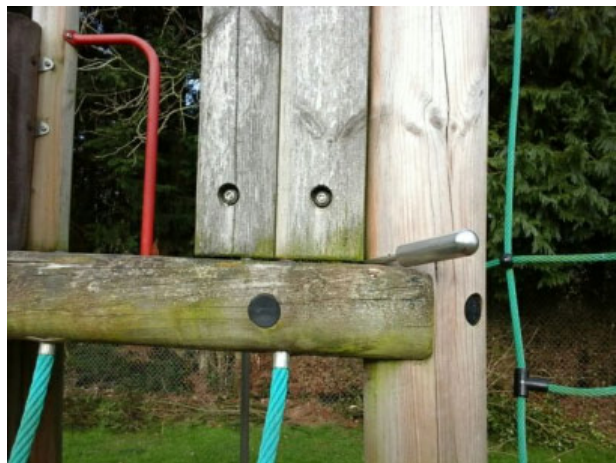
**Finding:** There is/are finger entrapment/s in the barrier corners and the item fails to meet the requirements of BS EN 1176:2008 Part 1 4.2.7.6 Entrapment of fingers

**Action:** Monitor use

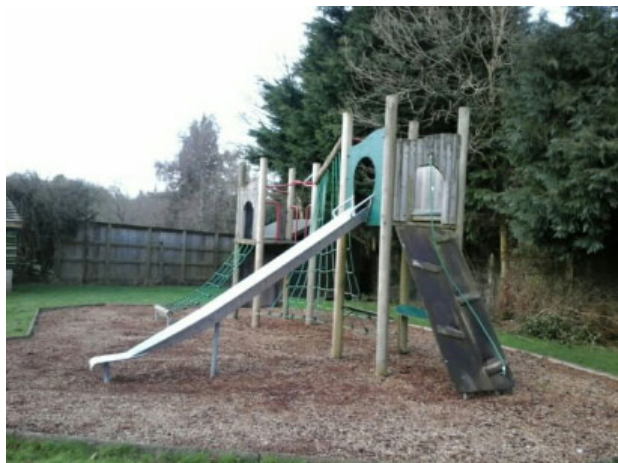
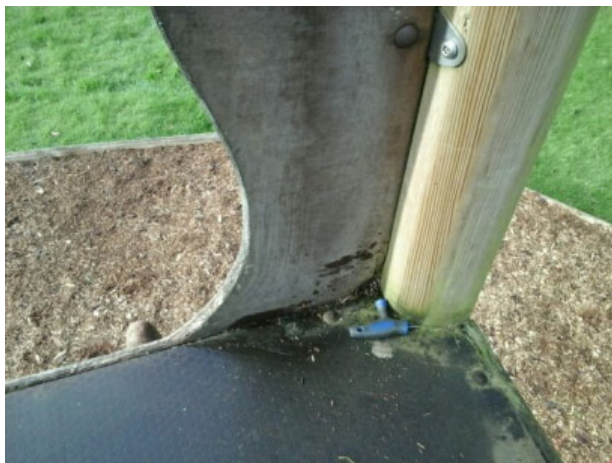
**Finding:** There is some evidence of rot in the timber of the climbing wall

**Action:** Monitor for any further deterioration and replace as required

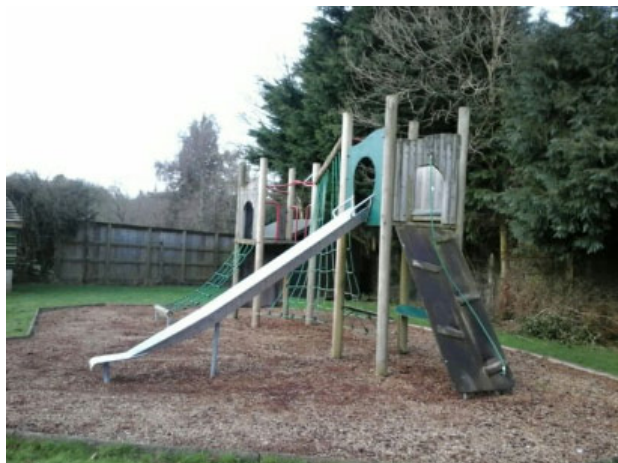
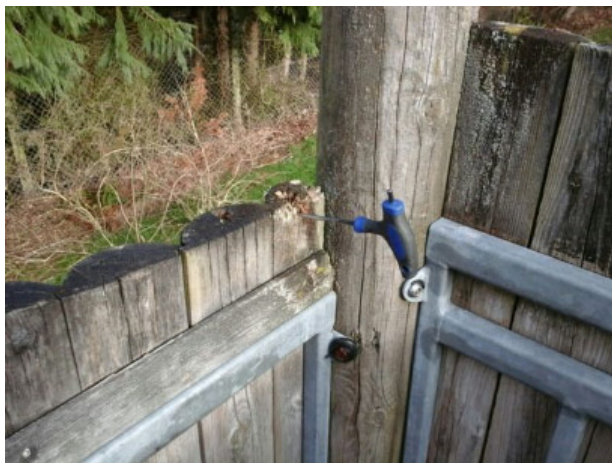
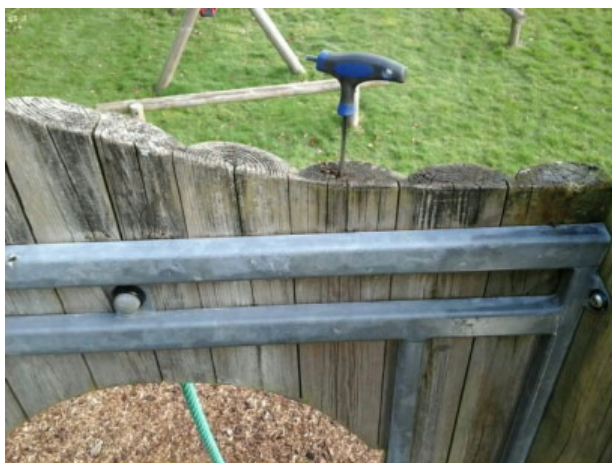
**Finding:** There is some evidence of rot in the timber of the barrier by the pull up rope

**Action:** Monitor for any further deterioration and replace as required

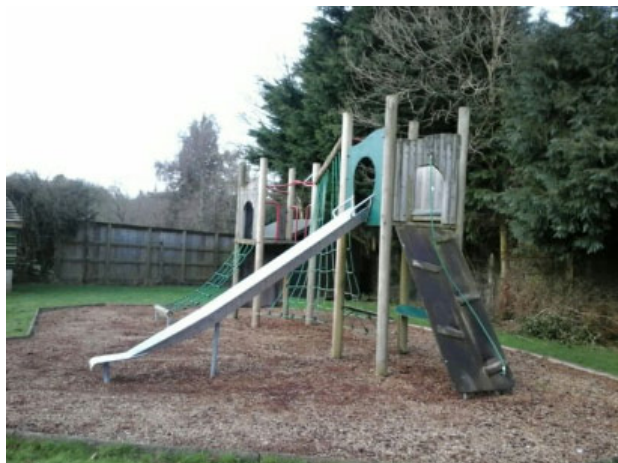
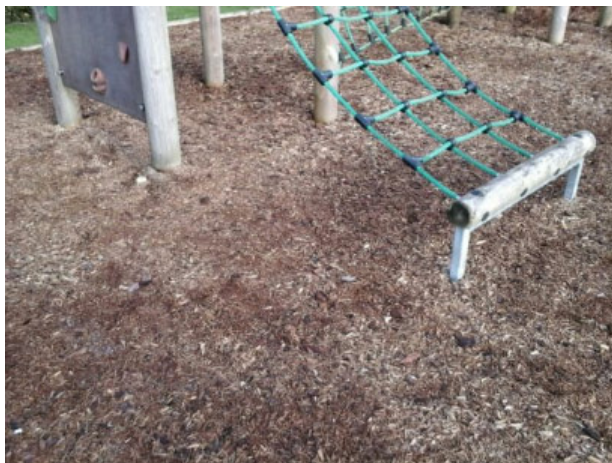
**Finding:** The level of loose fill surfacing has fallen significantly below the minimum 200mm recommended by BS EN 1176 Part 1

**Action:** Top up loose fill surfacing to recommended levels.

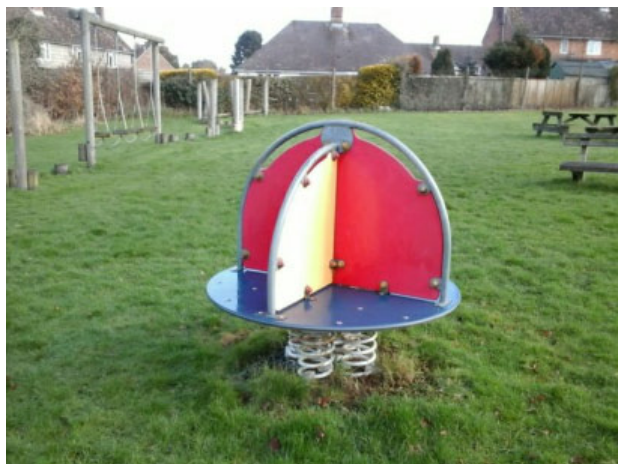
**Finding:** The grass mats are silted up, the soil is compacted and the area will become very slippery when the soil is wet.

**Action:** Lift and relay the mats

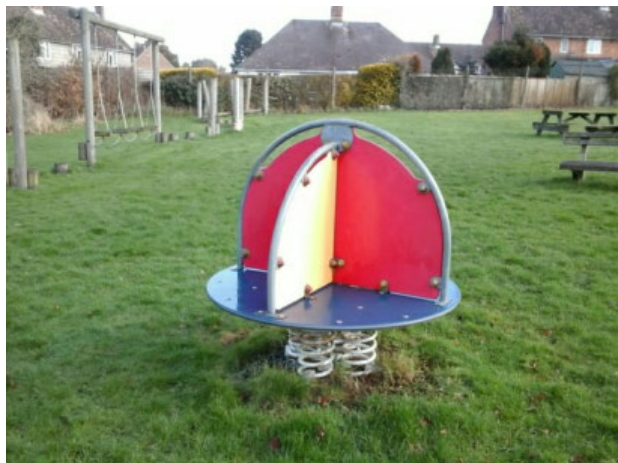
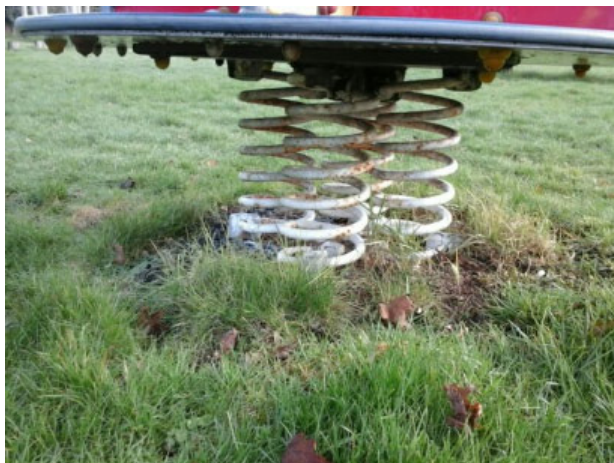
**Finding:** The paintwork on the spring has been damaged or worn exposing the metal underneath which is rusting

**Action:** Treat any rusting components and repaint

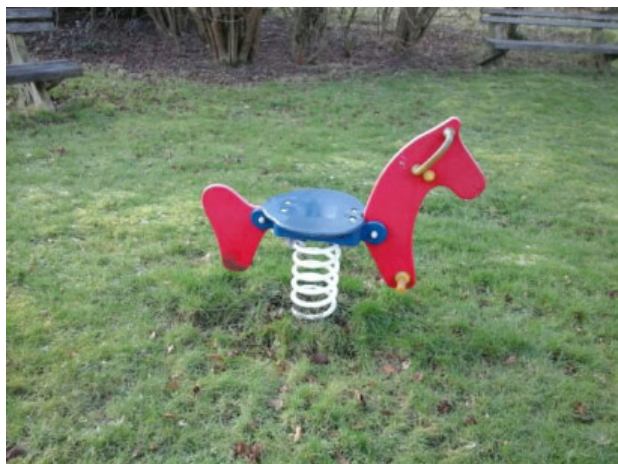
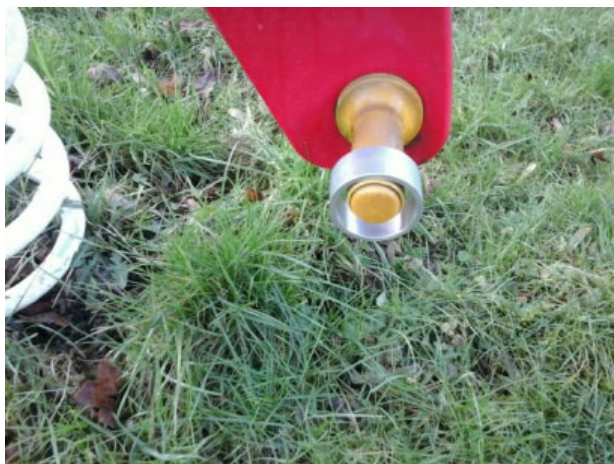
**Finding:** The end of handgrips and/or footrests have a cross section of less than 15cm<sup>2</sup> and fail to meet the requirements of BS EN 1176:2008 Part 6

**Action:** This is a relatively low risk failure and no remedial action is recommended

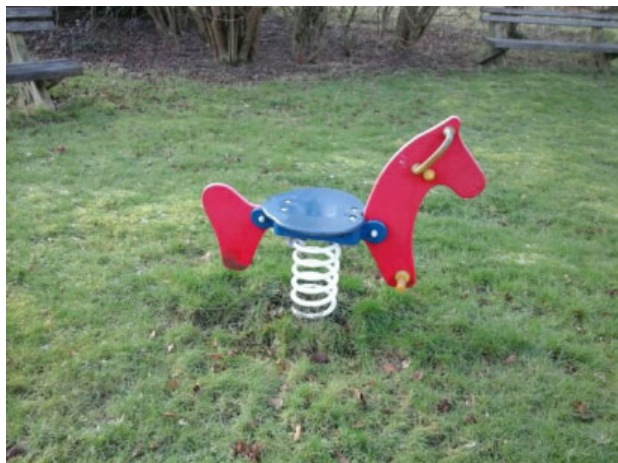
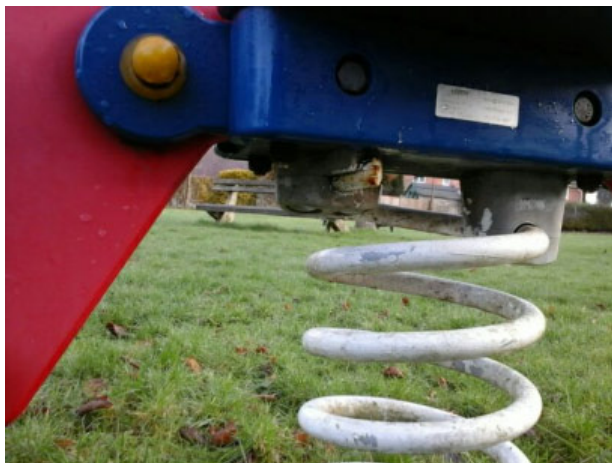
**Finding:** There is/are bolt cap covers missing or damaged on the item

**Action:** Replace missing or damaged bolt cap covers

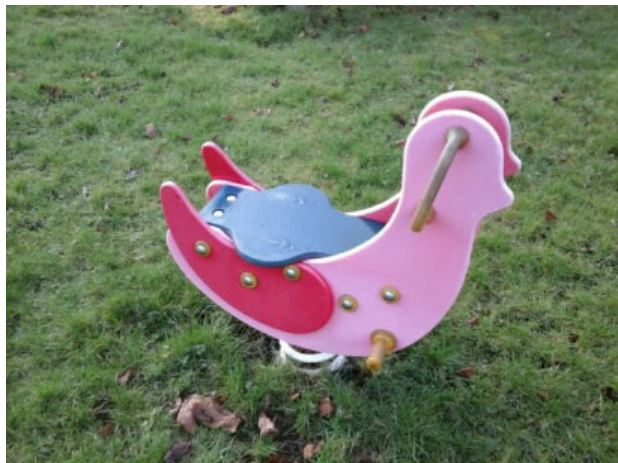
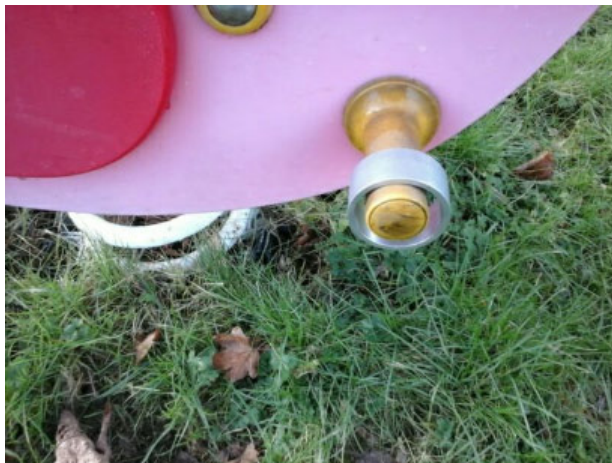
**Finding:** The end of handgrips and/or footrests have a cross section of less than 15cm<sup>2</sup> and fail to meet the requirements of BS EN 1176:2008 Part 6

**Action:** This is a relatively low risk failure and no remedial action is recommended

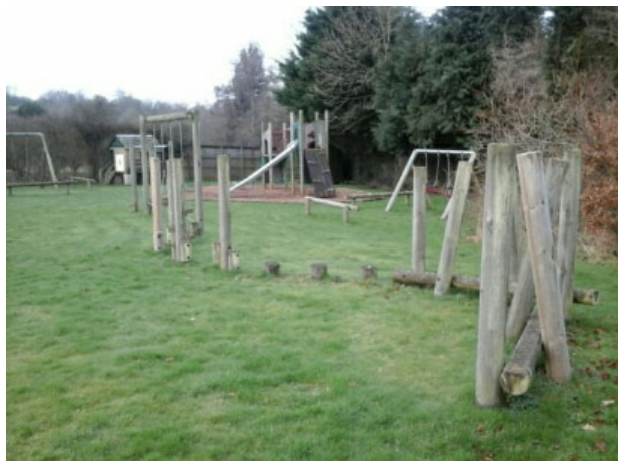
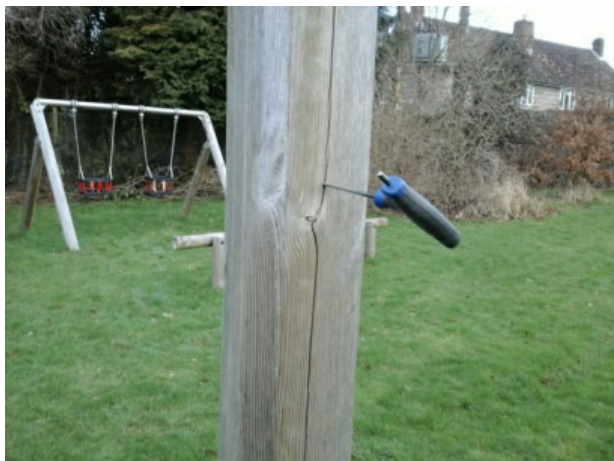
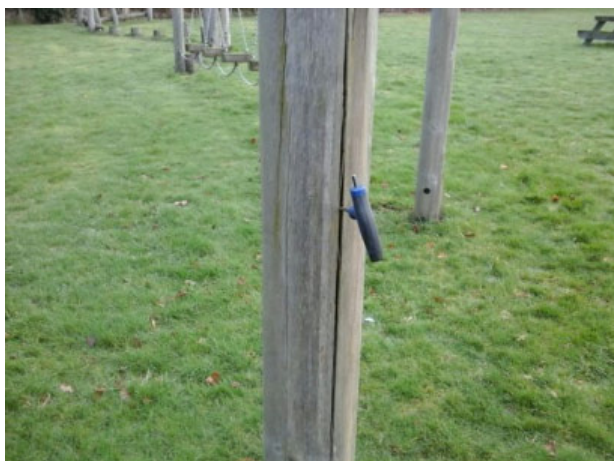
**Finding:** The timber has a number of air cracks apparent, the splits will have penetrated the preservative applied to the timber and allow water ingress to the unprotected areas

**Action:** Monitor for any deterioration (rot) and replace as required

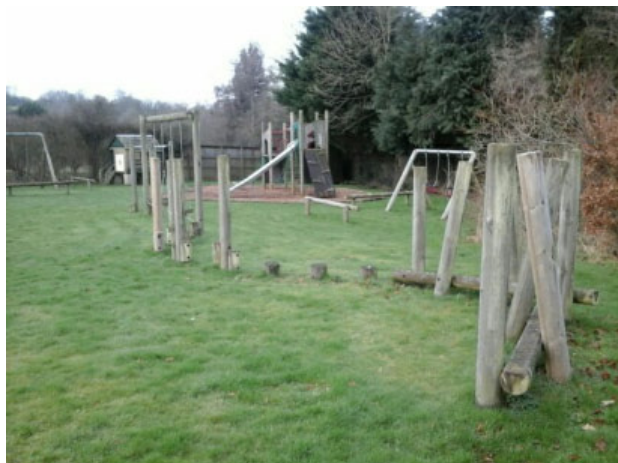
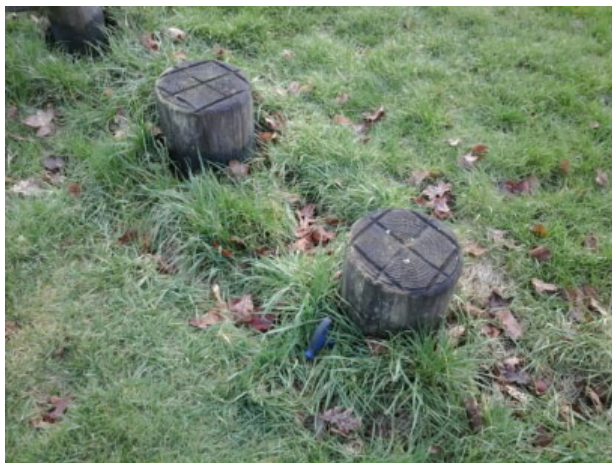
**Finding:** There is some evidence of rot in the timber

**Action:** Monitor for any further deterioration and replace as required

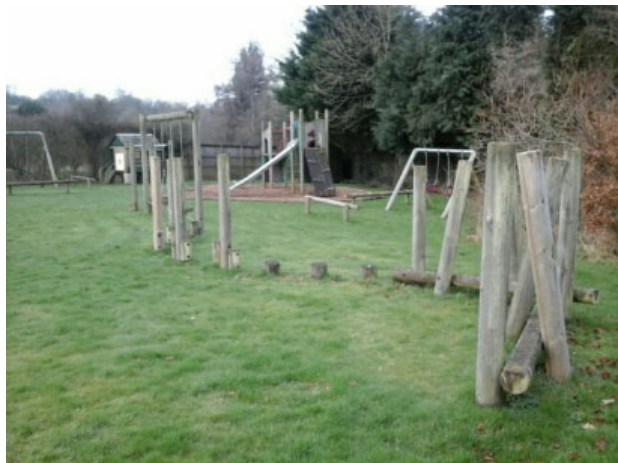
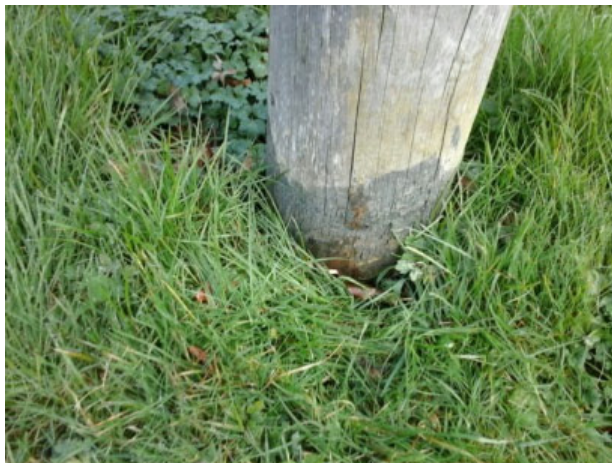
**Finding:** There is some strimmer damage apparent on the posts, this can penetrate the preservative applied to the timber and accelerate the rotting process

**Action:** Monitor for any deterioration (rot) and replace as required

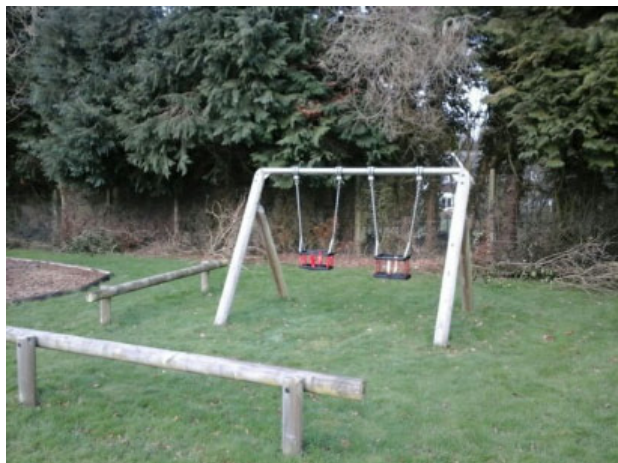
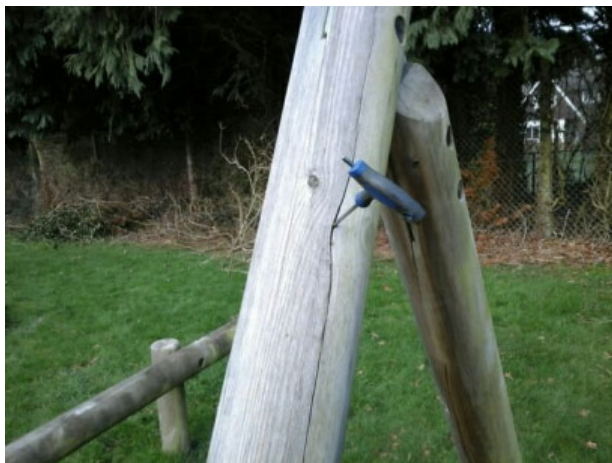
**Finding:** The timber has a number of air cracks apparent, the splits will have penetrated the preservative applied to the timber and allow water ingress to the unprotected areas

**Action:** Monitor for any deterioration (rot) and replace as required
