Annual Inspection

Winchester City Council

The Jubilee RG (Bramdean and Hinton Ampner PC)

Off Woodlane Close, Bramdean, Winchester,
Hampshire, SO24 0JR

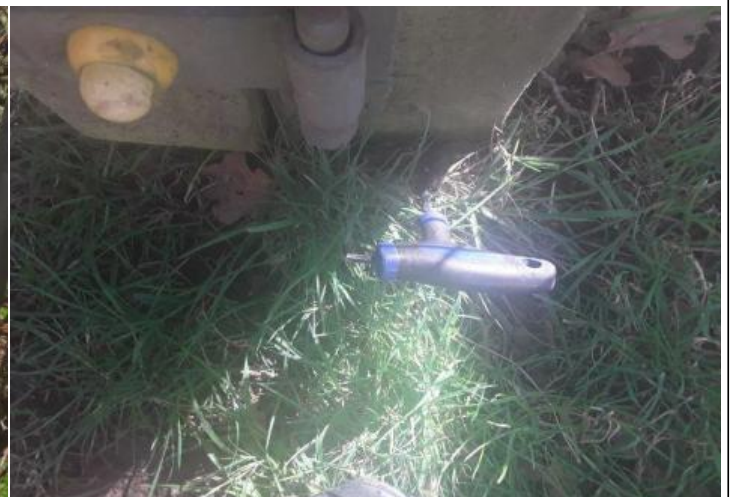
Finding: There is some evidence of rot in the timber

Action: Monitor for any further deterioration and replace as required

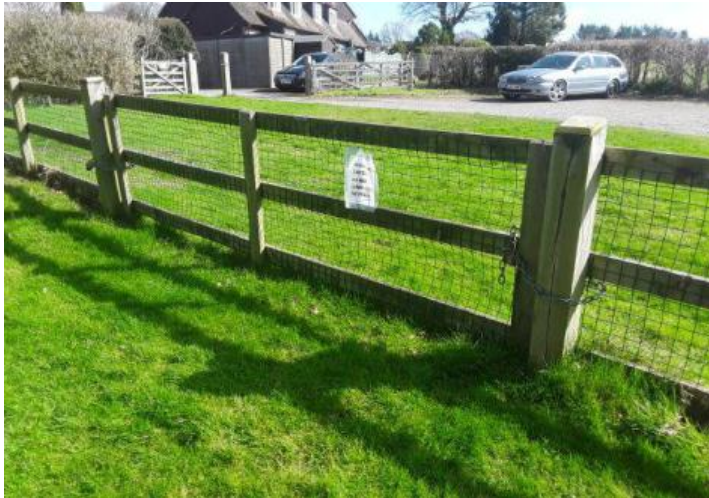
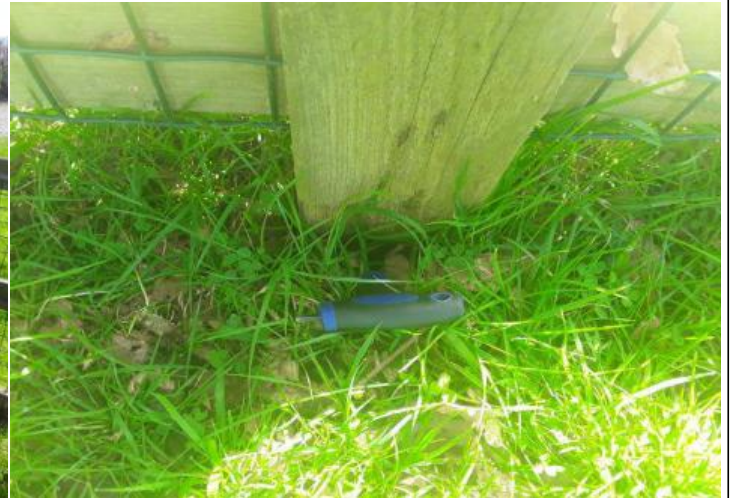
Finding: There are areas or parts of the timber on the structure that have rotted

Action: Replace all affected timbers

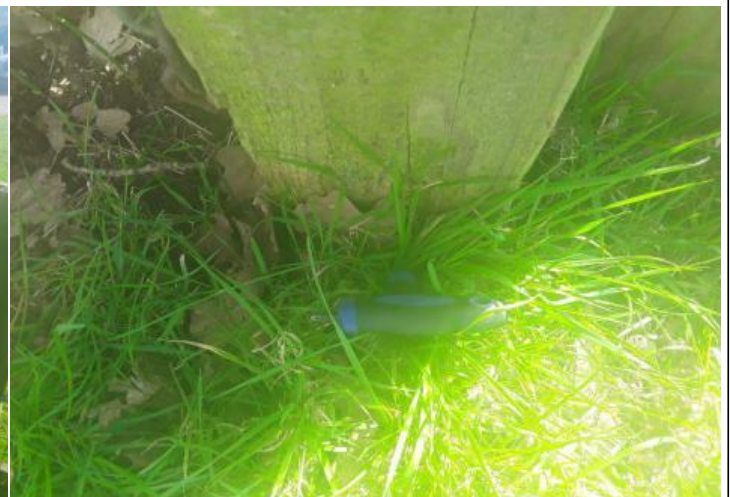
Finding: There are areas or parts of the timber on the structure that have rotted

Action: Replace all affected timbers

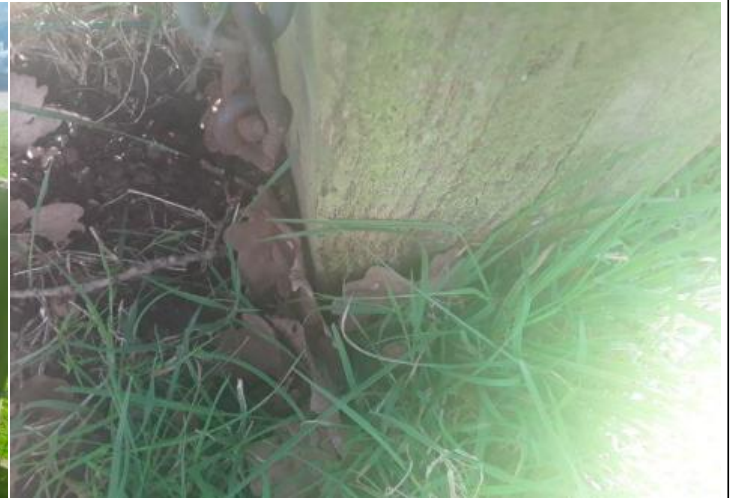
Finding: There is some strimmer / machinery damage apparent on the posts, this can penetrate the preservative applied to the timber and accelerate the rotting process

Action: Monitor for any deterioration (rot) and replace as required

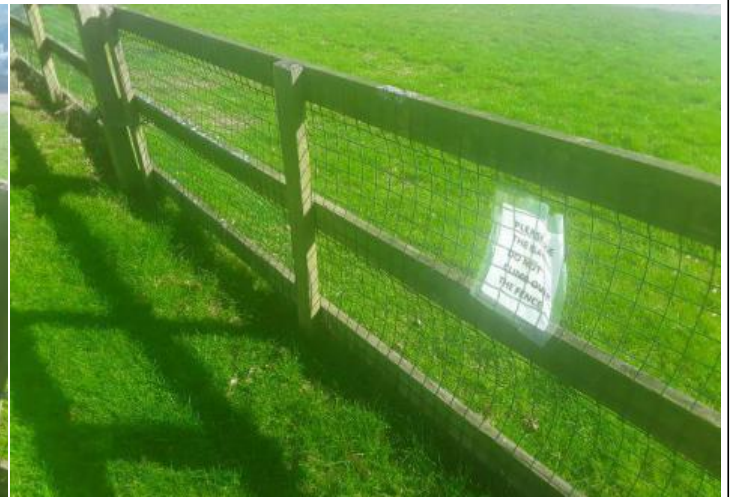
Finding: There are a number of loose posts around the fence

Action: Monitor for any further deterioration and reset as required

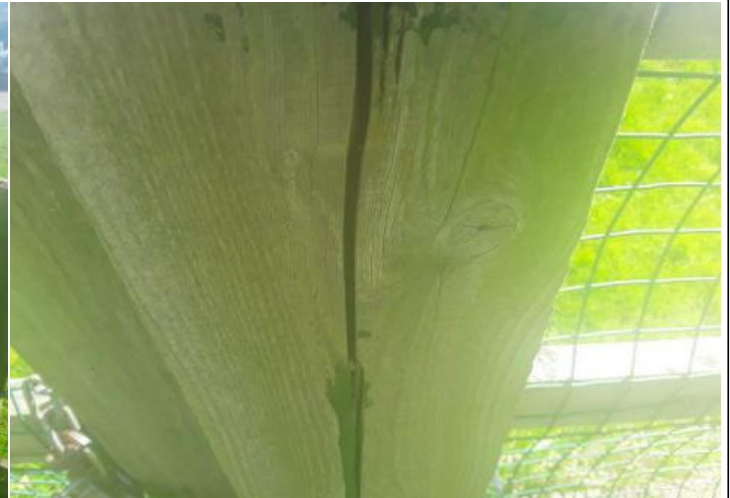
Finding: The timber has a number of splits/shakes or air cracks and this may affect the stability or allow water ingress which will accelerate the rotting process
Action: Monitor to ensure the splits do not cross through fixing points of the structure and/or cause any instability

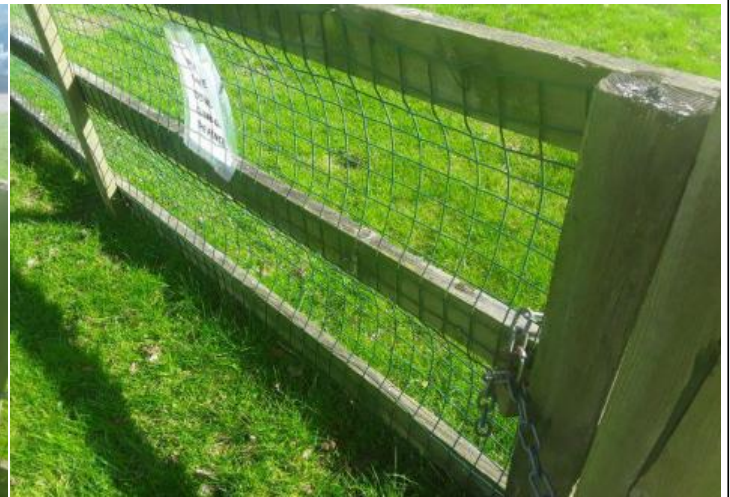
Finding: There is some damage to the fence sections
Action: Monitor for any further deterioration and repair as required

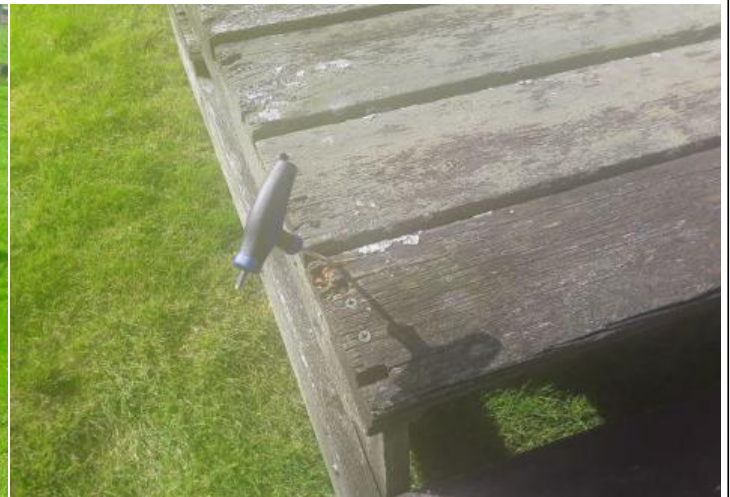
Finding: There are areas or parts of the timber on the structure that have rotted
Action: Replace all affected timbers

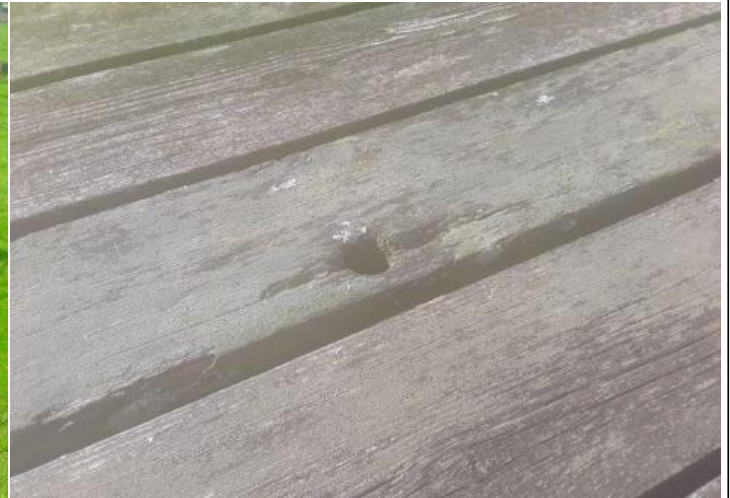
Finding: There is some evidence of fire damage to the item
Action: Monitor for any further deterioration and repair as required

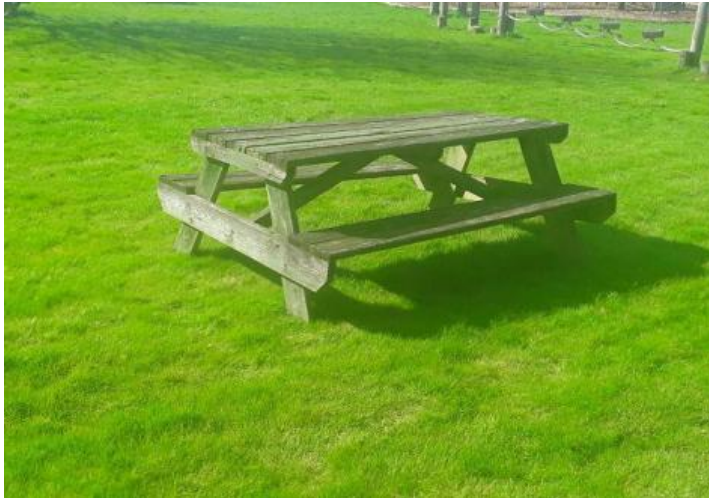
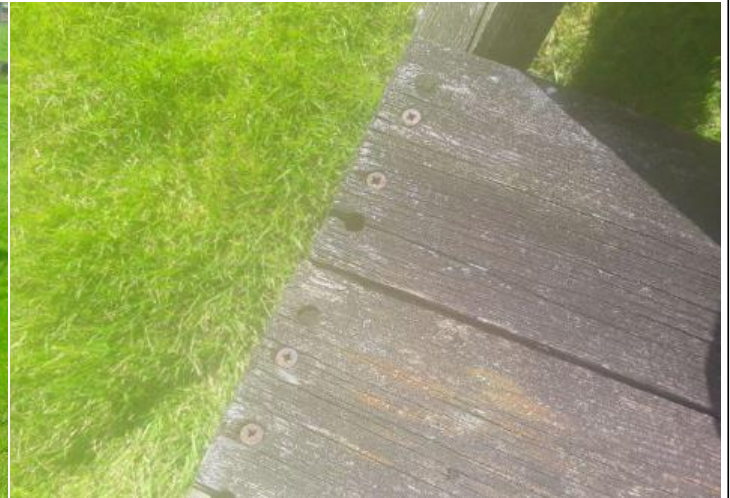
Finding: There is or are fixings missing on the item

Action: Replace all missing fixings

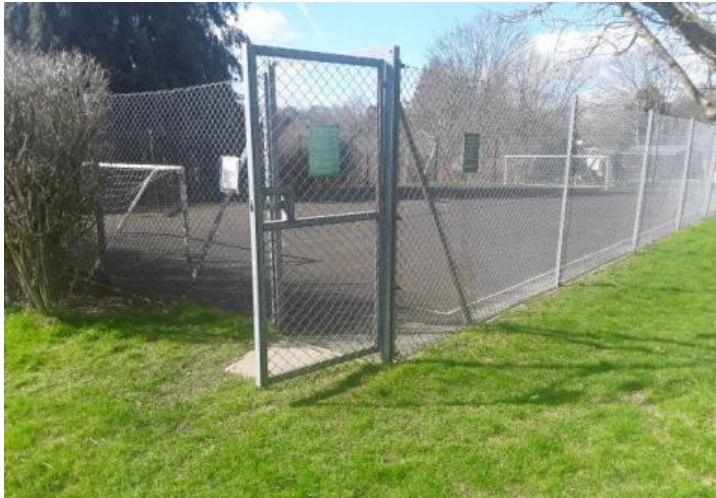
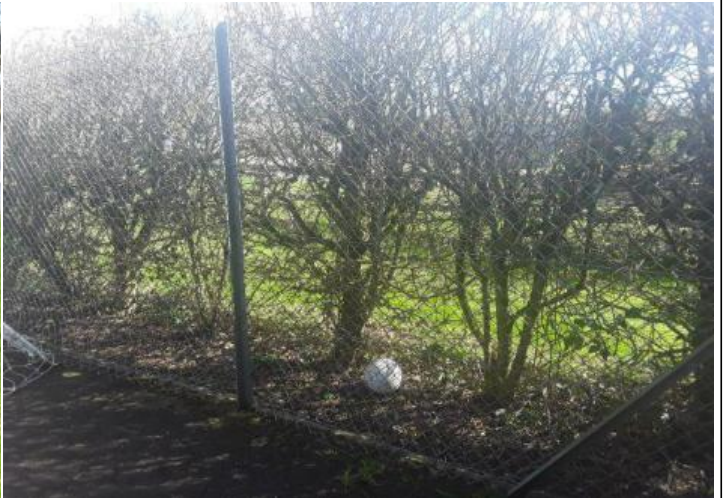
Finding: There are a number of loose posts around the fence

Action: Monitor for any further deterioration and reset as required

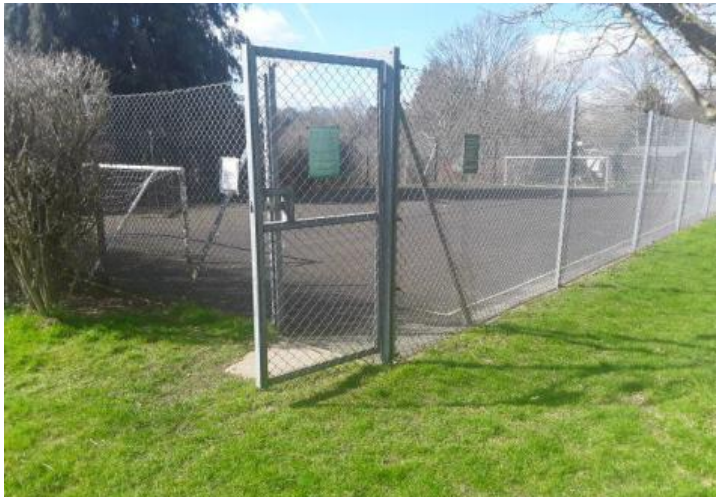
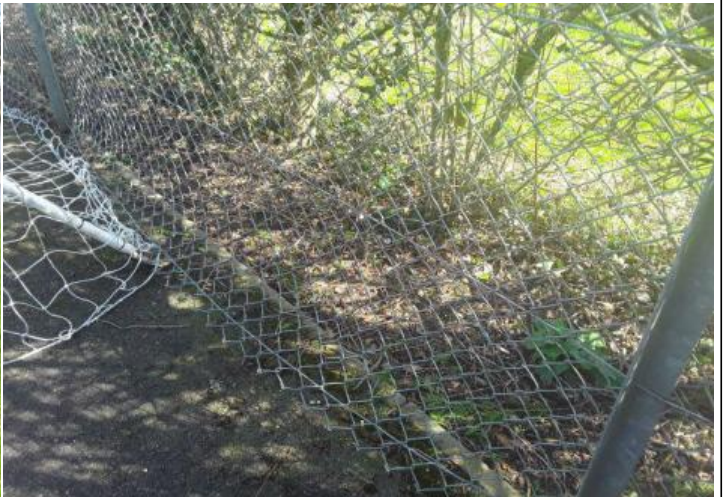
Finding: There is some damage to the fence sections

Action: Monitor for any further deterioration and repair as required

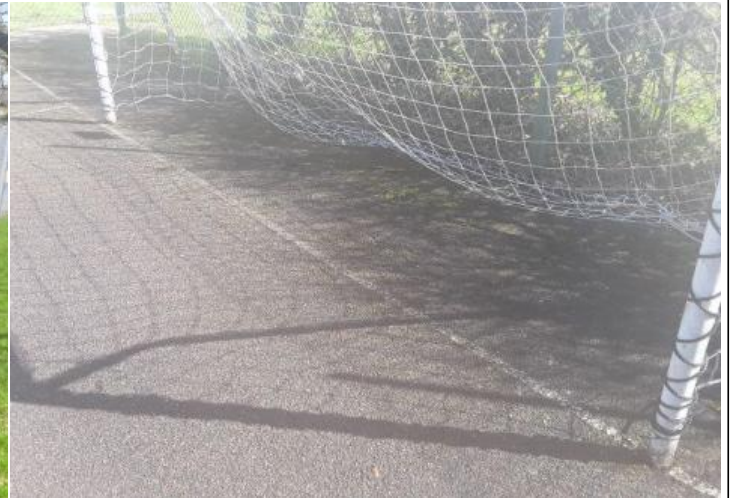
Finding: The goal posts are slightly loose in the ground

Action: Monitor for any further deterioration and reset as required

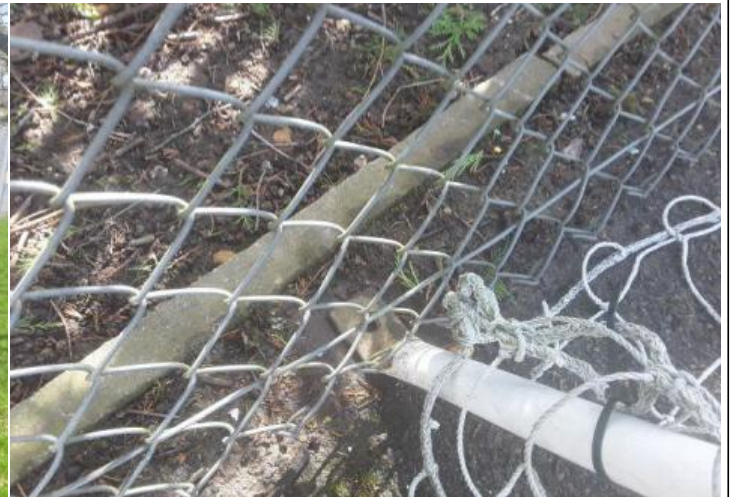
Finding: There are missing ground mount fixings

Action: Replace all missing fixings

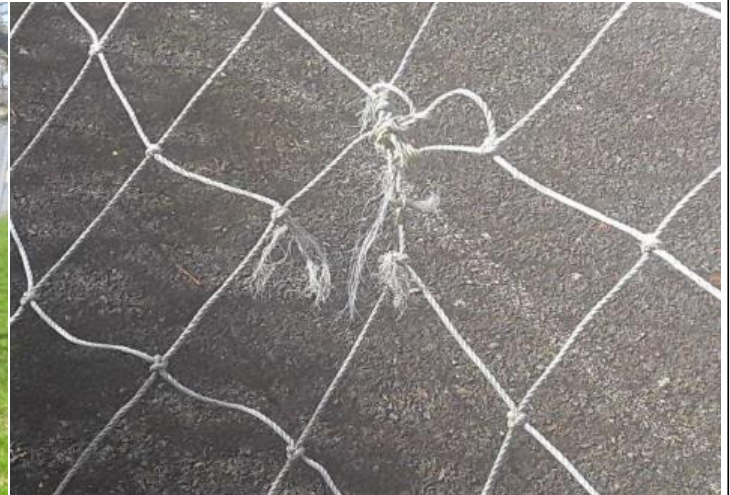
Finding: The goal nets are damaged

Action: Repair / replace as required

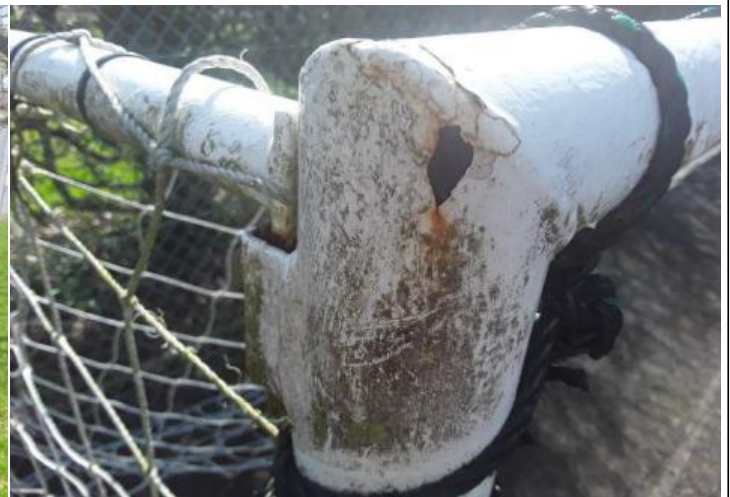
Finding: The paintwork on this item has been damaged or worn exposing the metal underneath which is rusting

Action: Treat any rusting components and repaint

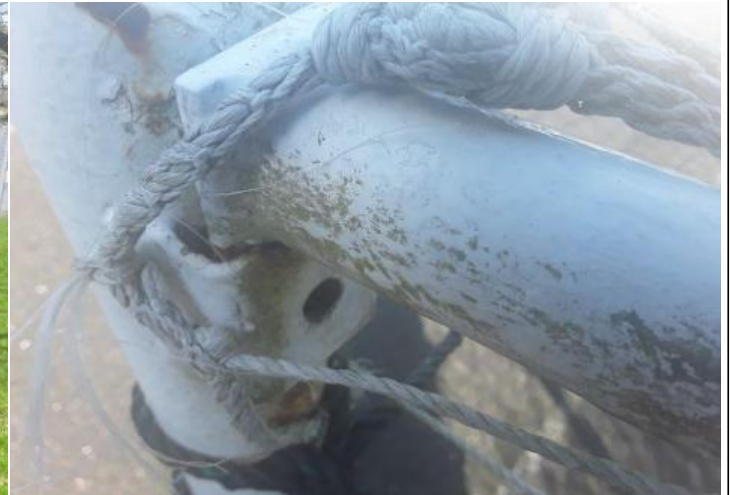
Finding: There are missing goal frame fixings

Action: Replace all missing fixings

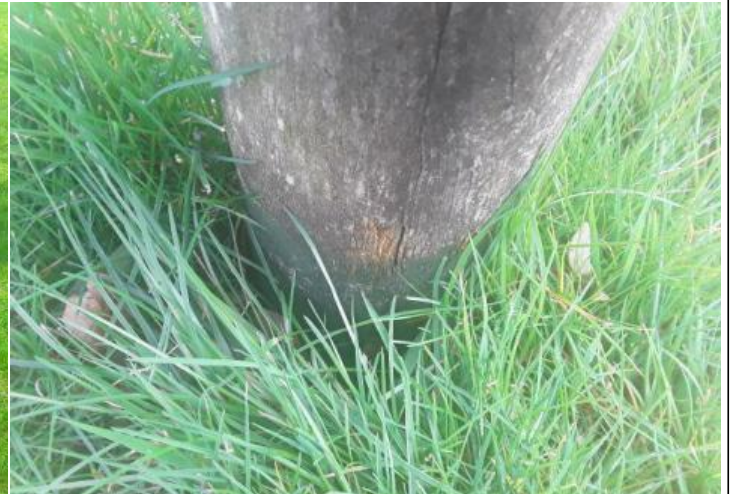
Finding: There is some strimmer / machinery damage apparent on the posts, this can penetrate the preservative applied to the timber and accelerate the rotting process

Action: Monitor for any deterioration (rot) and replace as required

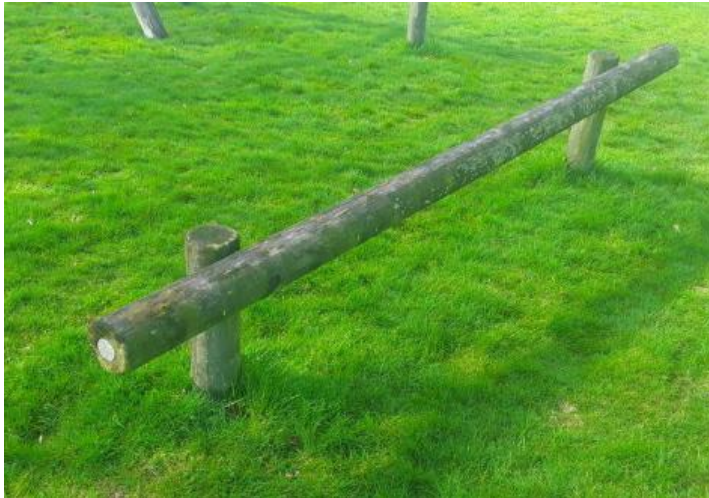
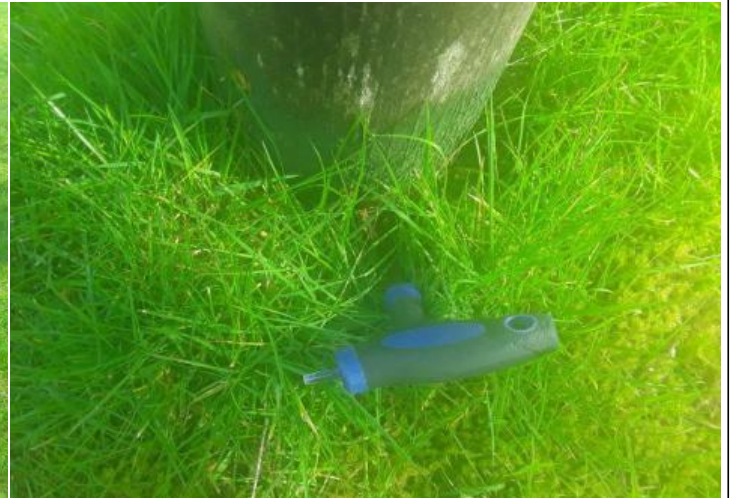
Finding: There is some evidence of rot in the timber

Action: Monitor for any further deterioration and replace as required

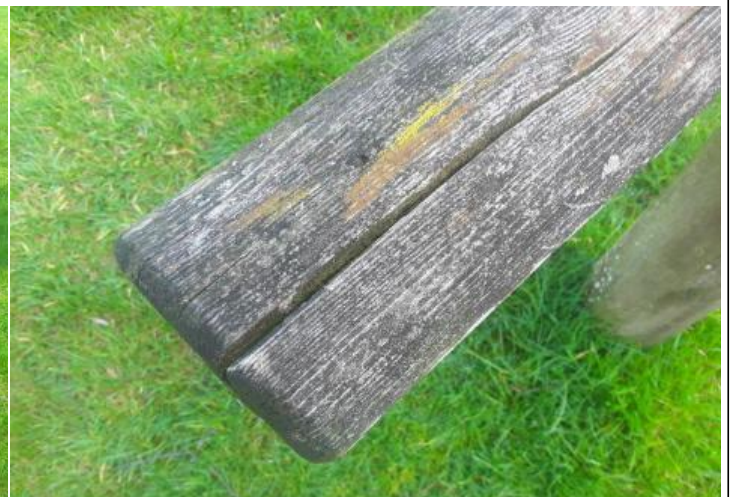
Finding: The timber has a number of splits/shakes or air cracks and this may affect the stability or allow water ingress which will accelerate the rotting process

Action: Monitor to ensure the splits do not cross through fixing points of the structure and/or cause any instability

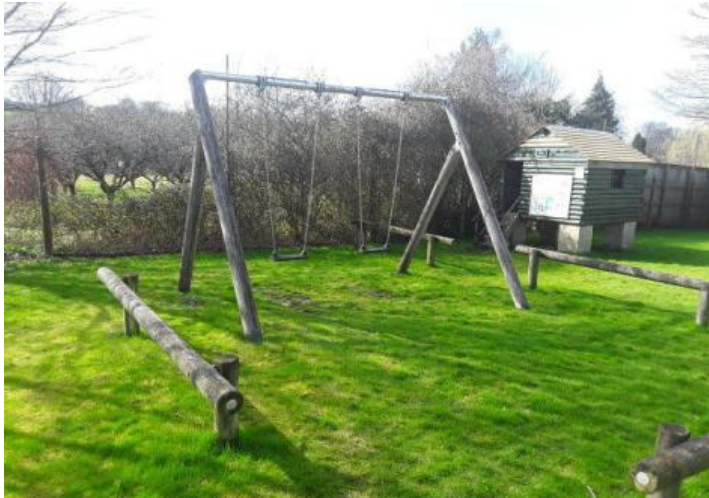
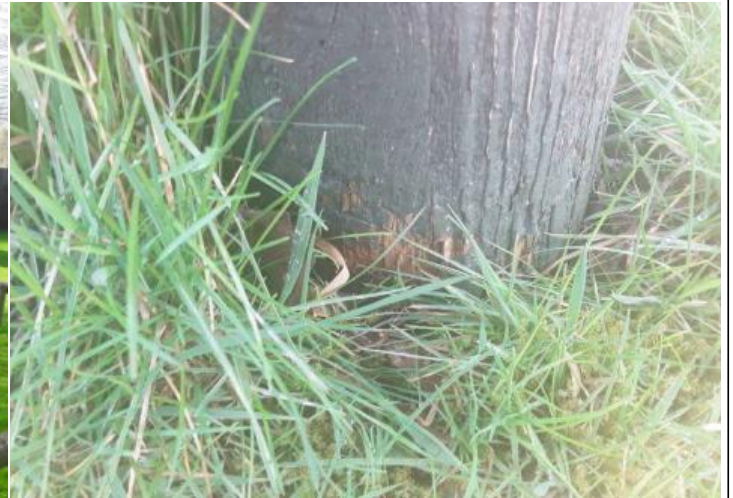
Finding: There is some strimmer / machinery damage apparent on the posts, this can penetrate the preservative applied to the timber and accelerate the rotting process

Action: Monitor for any deterioration (rot) and replace as required

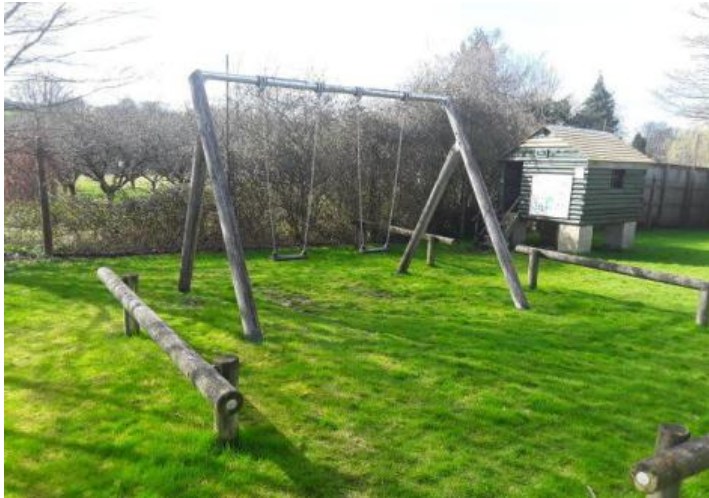
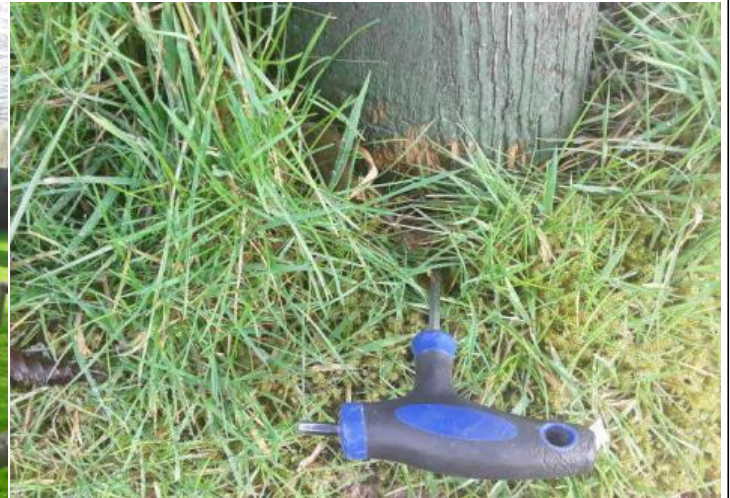
Finding: There is some evidence of rot in the posts

Action: Monitor for any further deterioration and replace as required

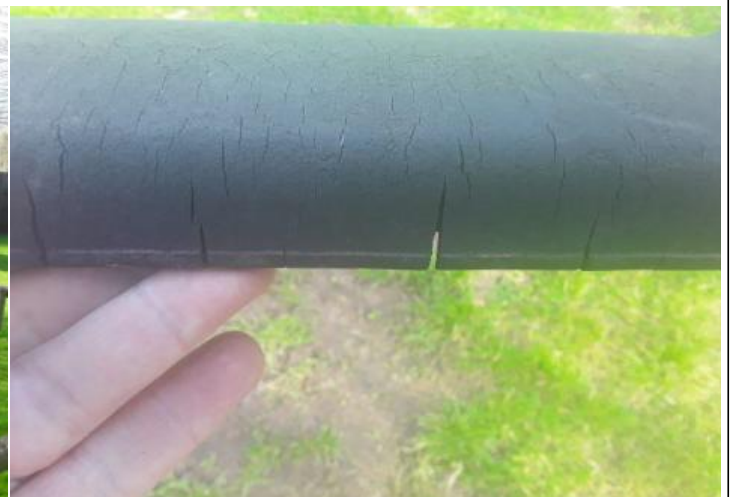
Finding: The seat has minor damage or wear

Action: Monitor for any further deterioration and replace as required

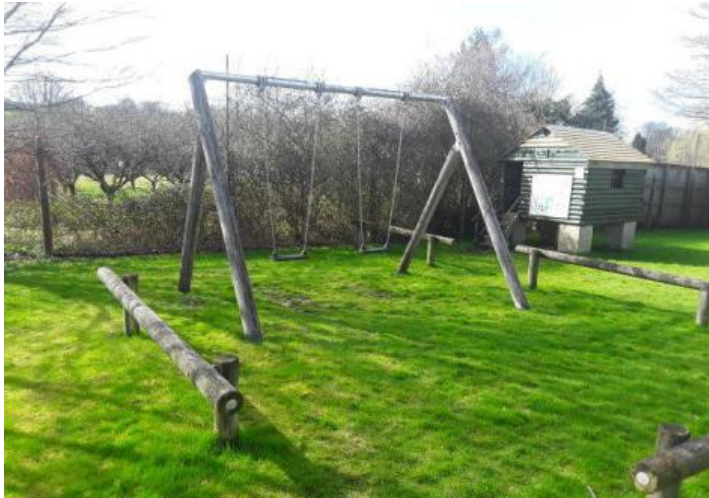
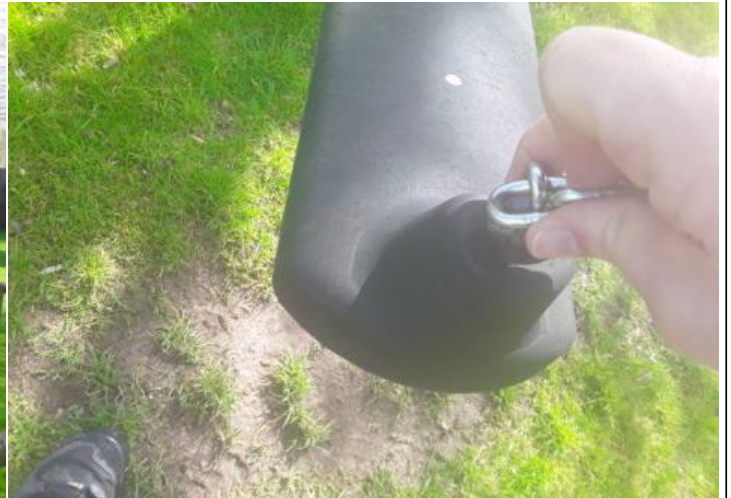
Finding: There is some notable evidence of chain wear

Action: Monitor for any further deterioration and replace when 40% worn

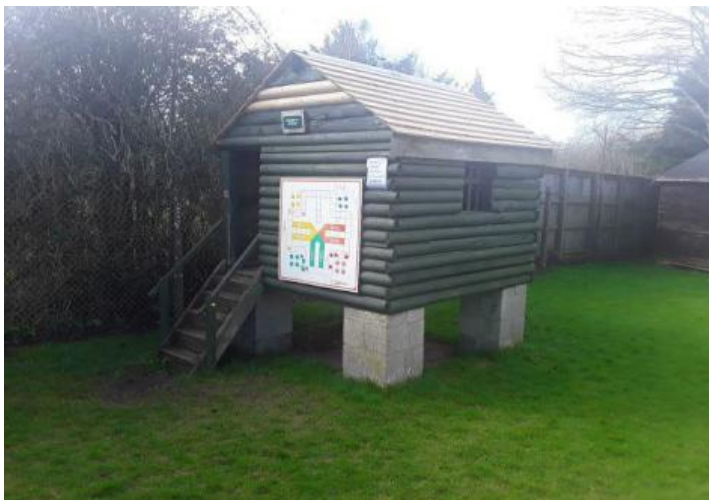
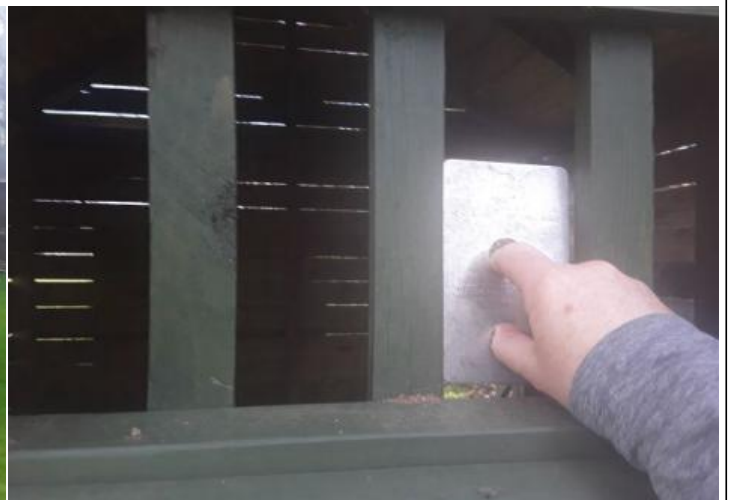
Finding: The item fails to meet the requirements of BS EN 1176 Part 1 4.2.7.2 for head and neck entrapment in the window

Action: Monitor - No remedial work recommended

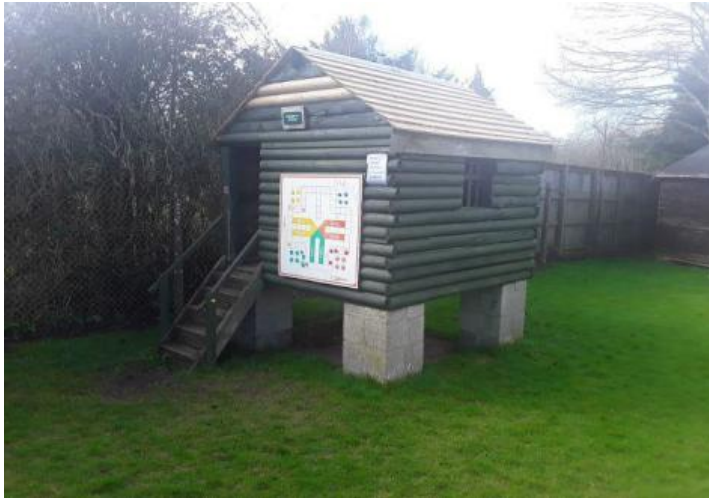
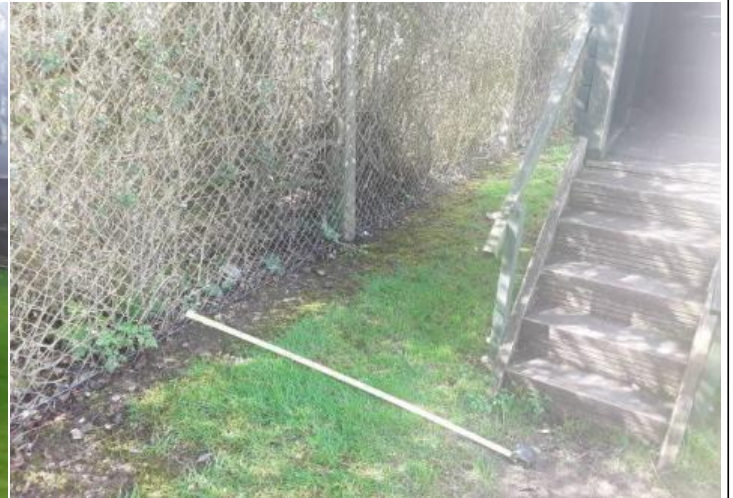
Finding: The fencing forms a hard object within the falling space of the equipment and there is also insufficient surfacing provided in contravention of BS EN 1176 Part 1

Action: Monitor - no remedial work recommended

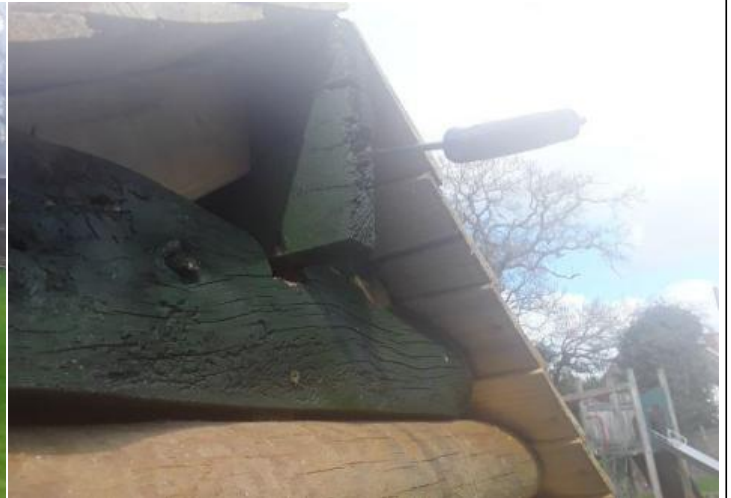
Finding: There is some evidence of rot in the timber

Action: Monitor for any further deterioration and replace as required

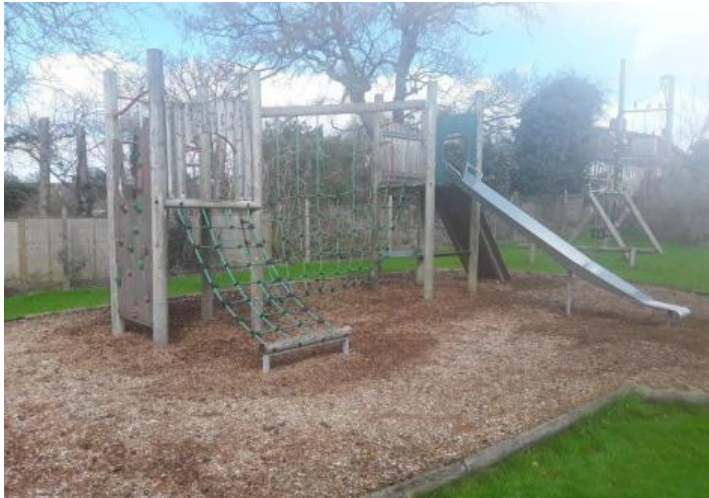
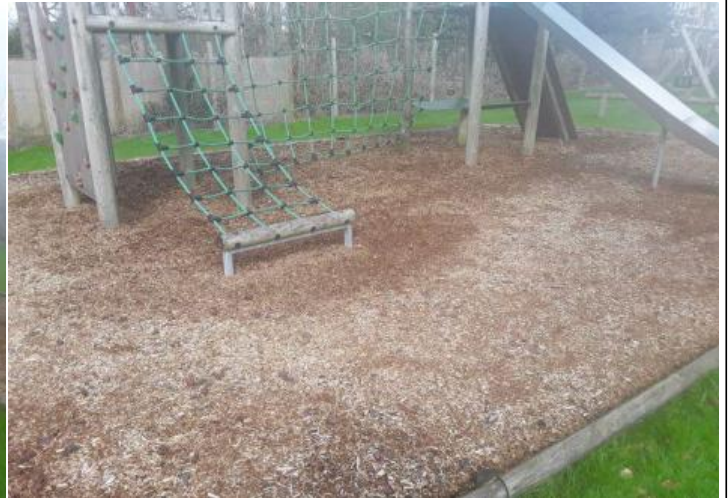
Finding: The depth of the loose fill surfacing is lower than the recommended depth specified in BS EN 1176; the free height of fall of the equipment is less than 2.0m and a minimum of 300mm depth should be provided (including an extra 100mm to allow for compaction and displacement as per BS EN 1176 Part 1 - Table 4)

Action: Top up loose fill surfacing to recommended levels

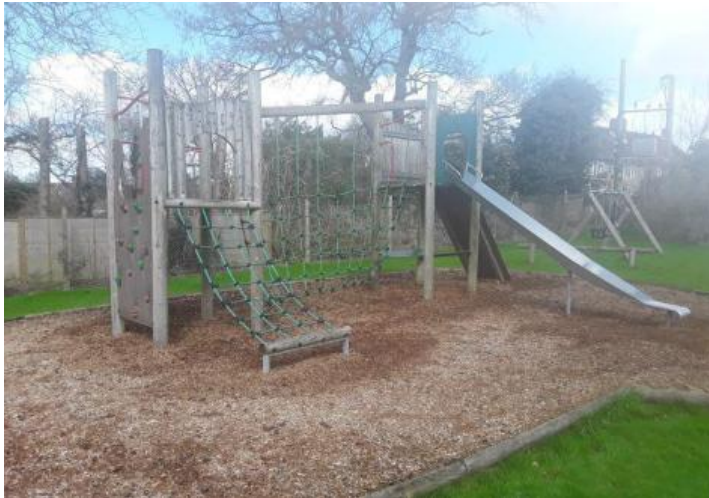
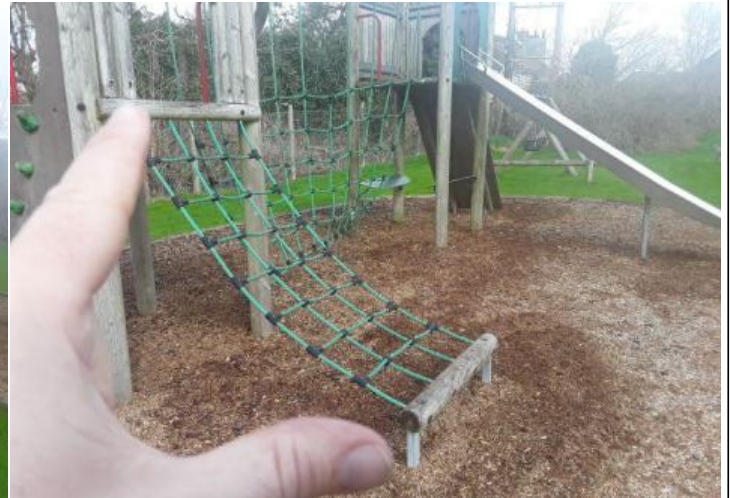
Finding: The net anchor timber forms a hard object within the falling space of the equipment in contravention of the requirements of BS EN 1176 Part 1

Action: Monitor - No remedial work recommended

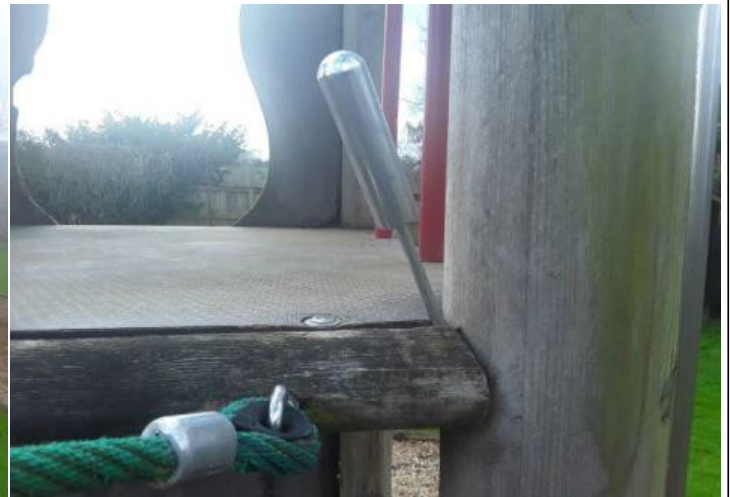
Finding: There is/are finger entrapment/s between platform and post and the item fails to meet the requirements of BS EN 1176 Part 1 4.2.7.6 Entrapment of fingers

Action: Monitor - No remedial work recommended

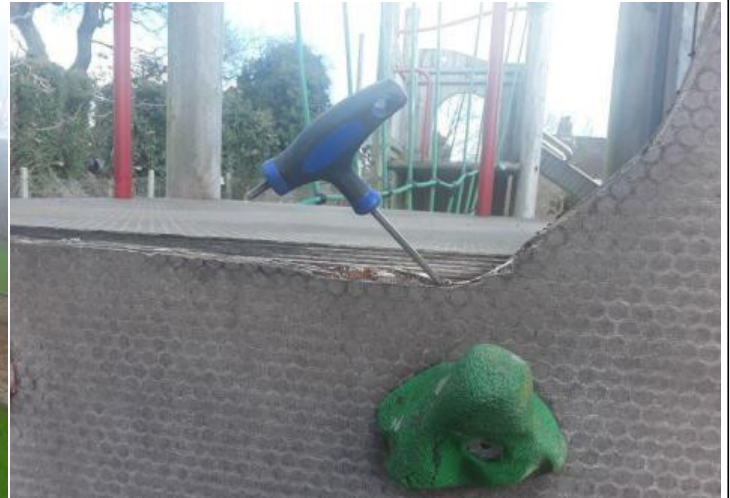
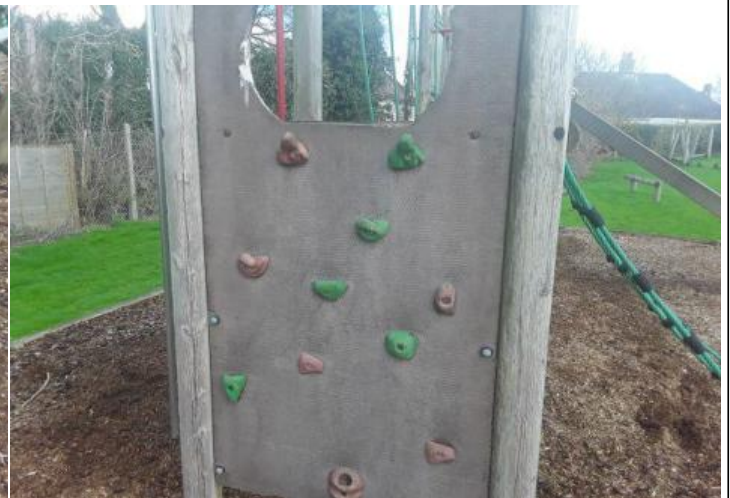
Finding: There is some evidence of rot in the climbing panels

Action: Monitor for any further deterioration and replace as required

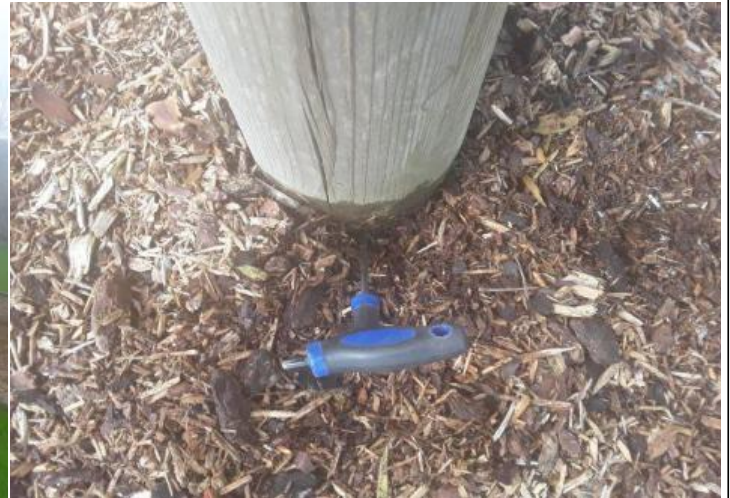
Finding: There is some evidence of rot in the posts

Action: Monitor for any further deterioration and replace as required

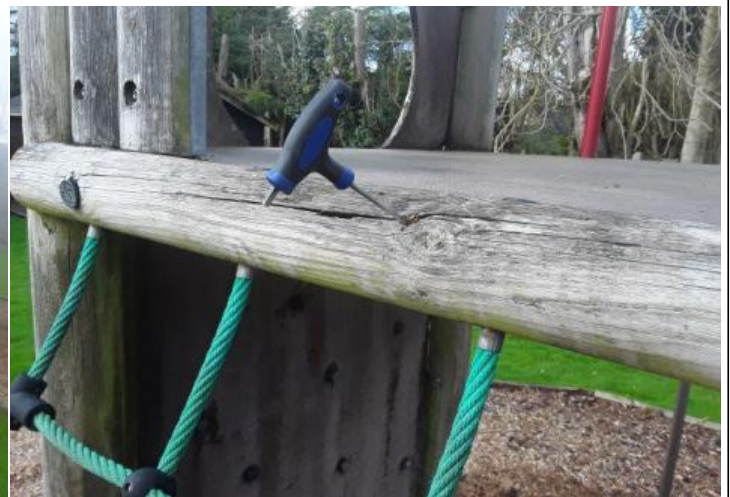
Finding: There is some evidence of rot in the timber above the net climber

Action: Monitor for any further deterioration and replace as required

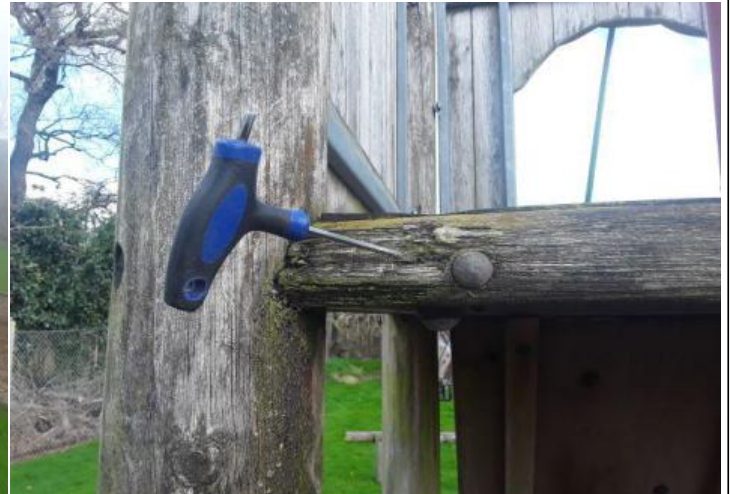
Finding: There is some evidence of rot in the timber

Action: Monitor for any further deterioration and replace as required

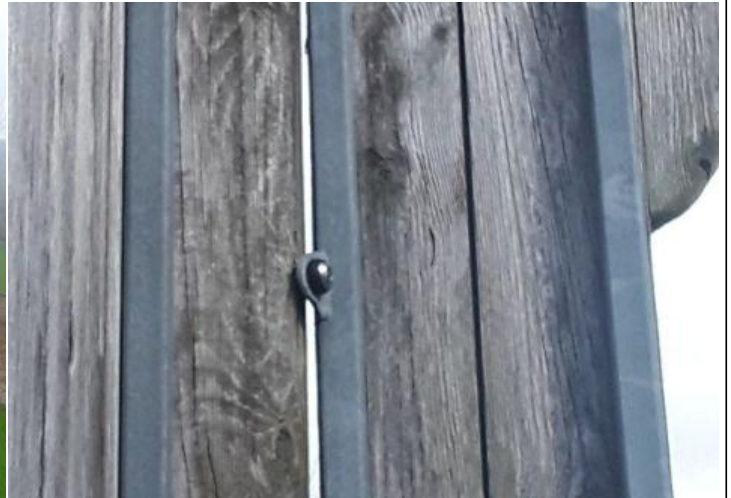
Finding: A number of barrier fixing(s) have worked loose

Action: Secure all loose fixings

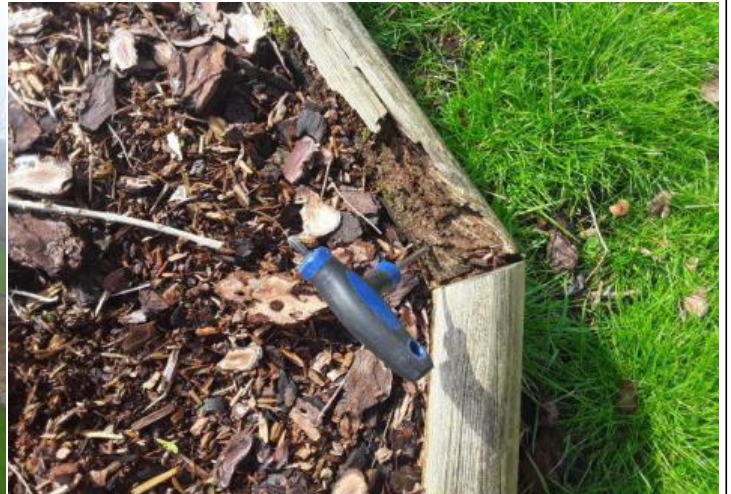
Finding: There are areas or parts of the timber edging surrounding the play equipment that have rotted

Action: Replace all affected timbers

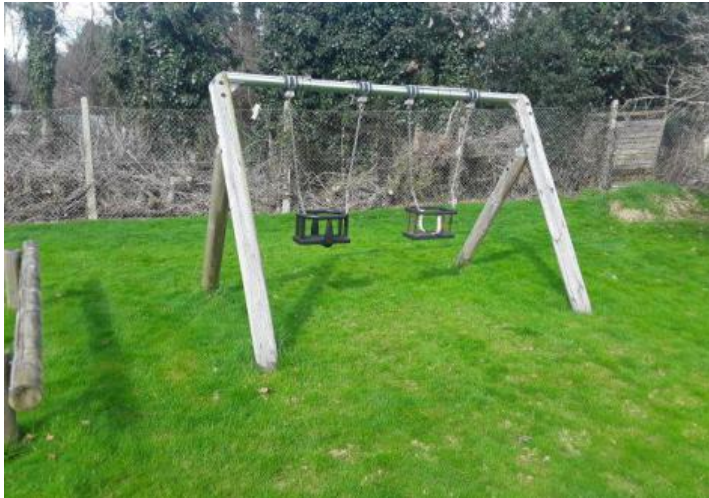
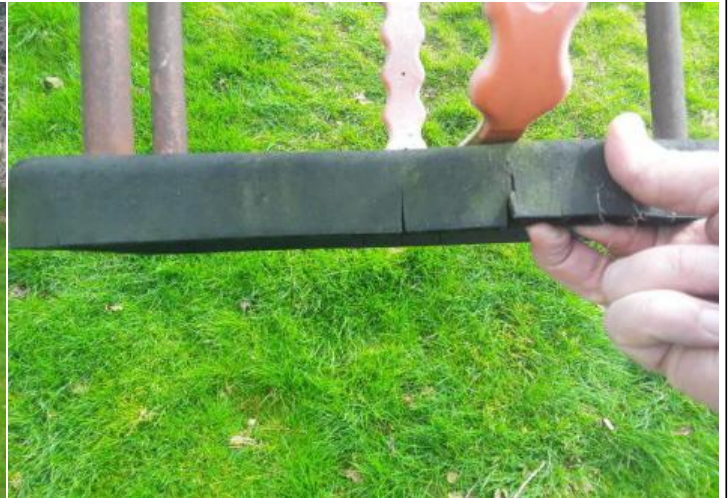
Finding: The seat has minor damage or wear

Action: Monitor for any further deterioration and replace as required

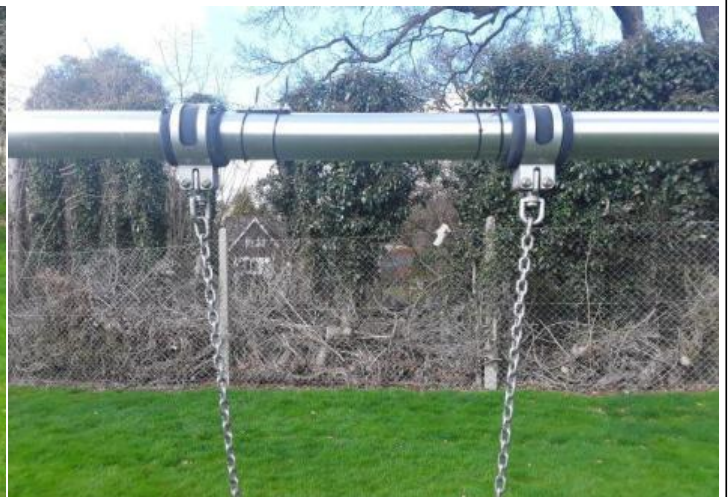
Finding: The Anti Wrap bearings are dry and not moving freely

Action: Lubricate bearings in accordance with the manufacturers recommendations

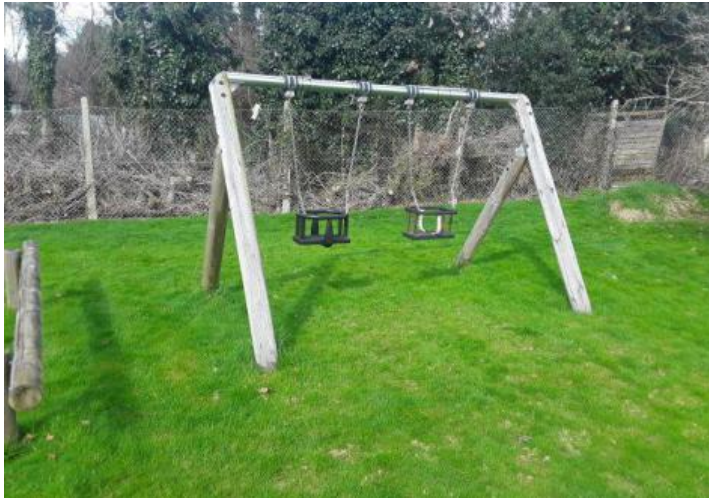
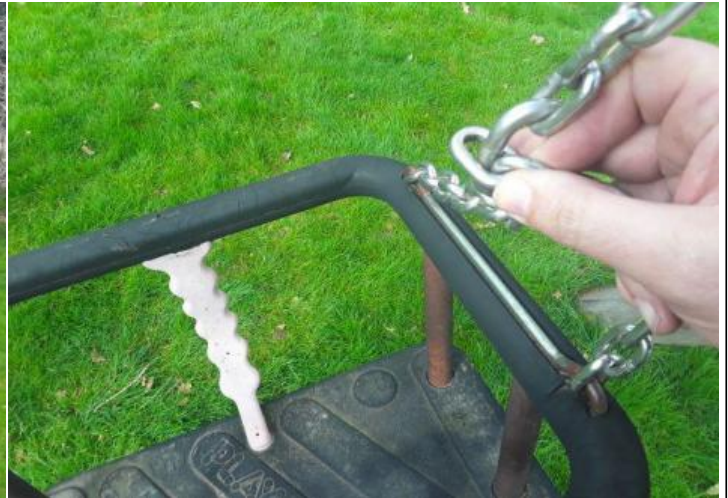
Finding: There is some notable evidence of chain wear

Action: Monitor for any further deterioration and replace when 40% worn

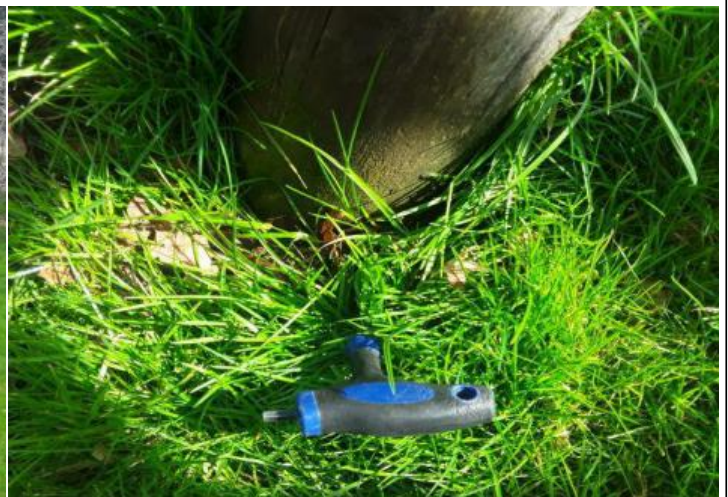
Finding: There is some evidence of rot in the posts

Action: Monitor for any further deterioration and replace as required

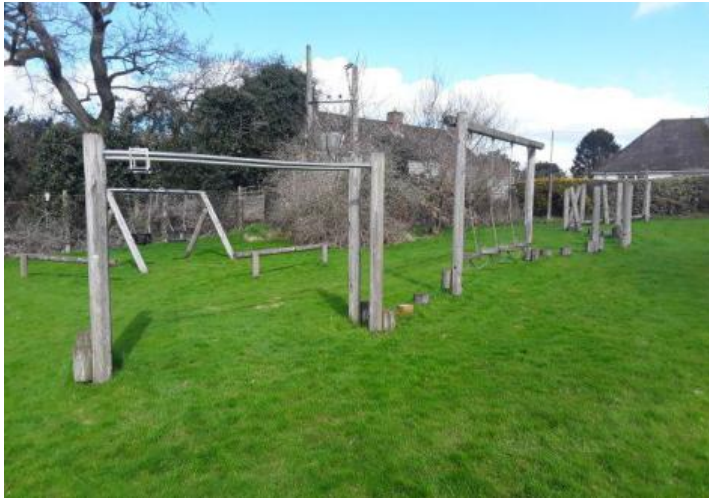
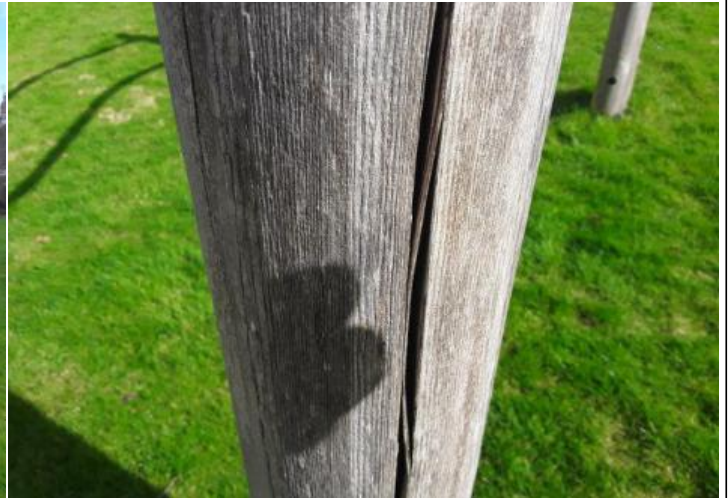
Finding: The timber has a number of splits/shakes or air cracks and this may affect the stability or allow water ingress which will accelerate the rotting process
Action: Monitor to ensure the splits do not cross through fixing points of the structure and/or cause any instability

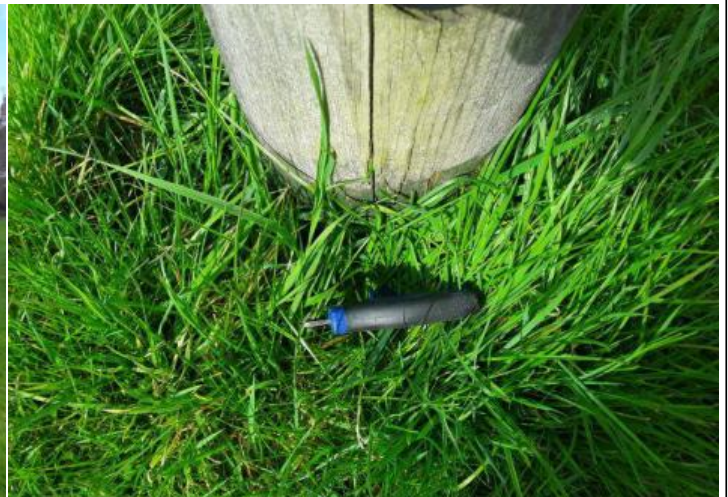
Finding: There is some evidence of rot in the timber throughout the trail
Action: Monitor for any further deterioration and replace as required
