Annual Inspection

Winchester City Council

The Jubilee RG (Bramdean and Hinton Ampner PC)

Off Woodlane Close, Bramdean, Winchester,
Hampshire, SO24 0JR

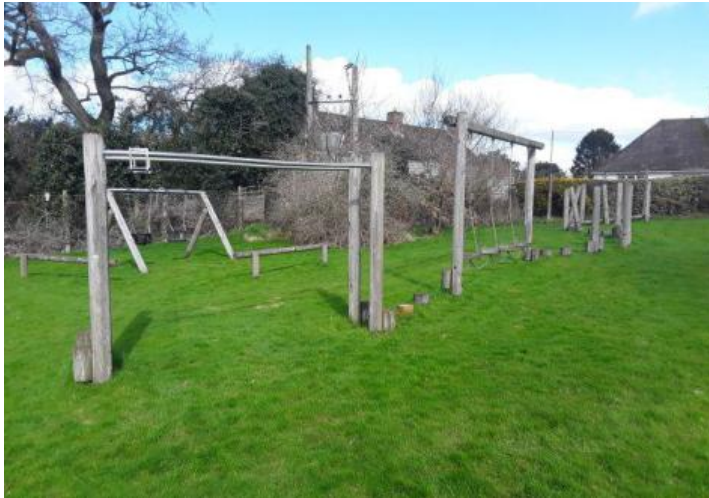
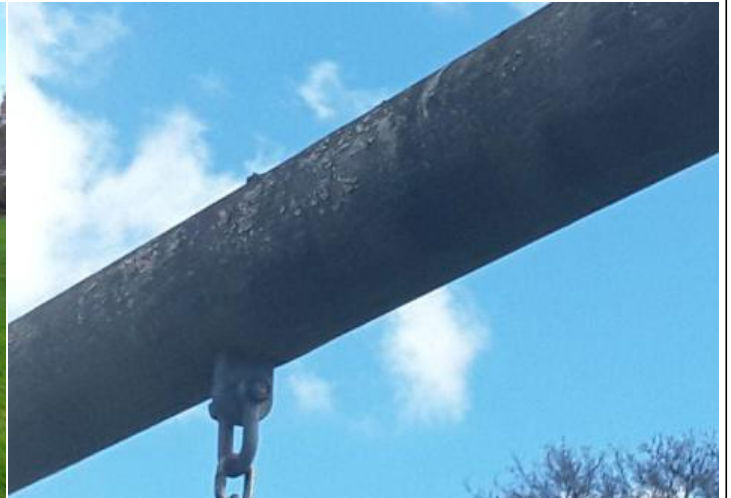
Finding: There is algae or moss on the surface of the equipment that can lead to the onset of rot

Action: Monitor condition of the timbers (rot), clean and treat appropriately

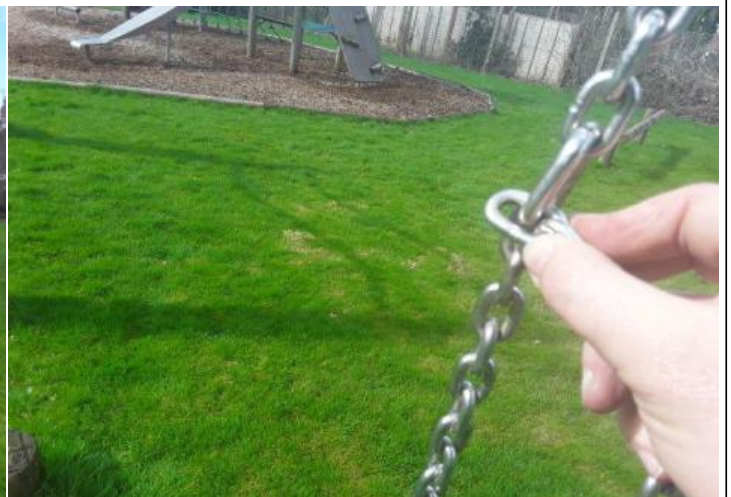
Finding: There is some notable evidence of chain wear

Action: Monitor for any further deterioration and replace when 40% worn

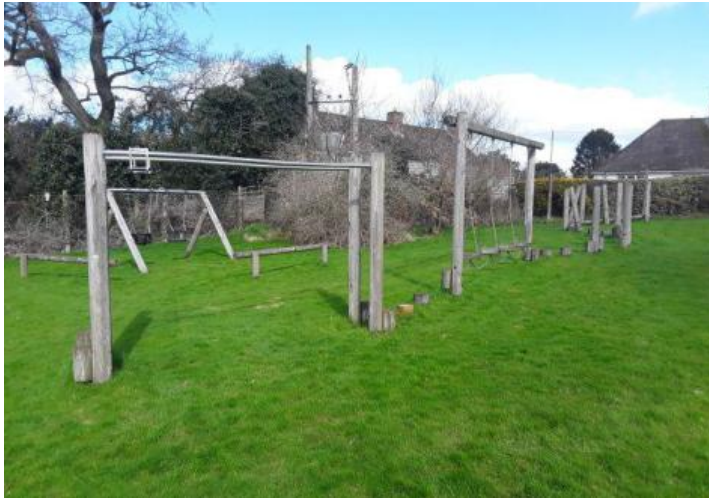
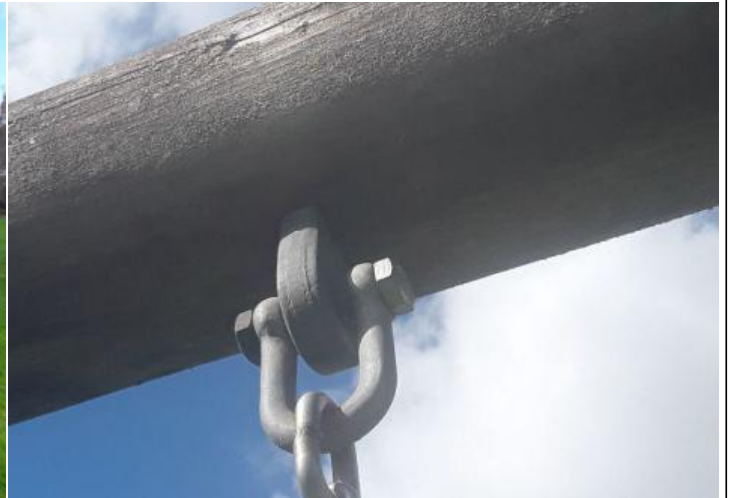
Finding: The bushes are showing signs of wear

Action: Monitor for any further deterioration and replace as required

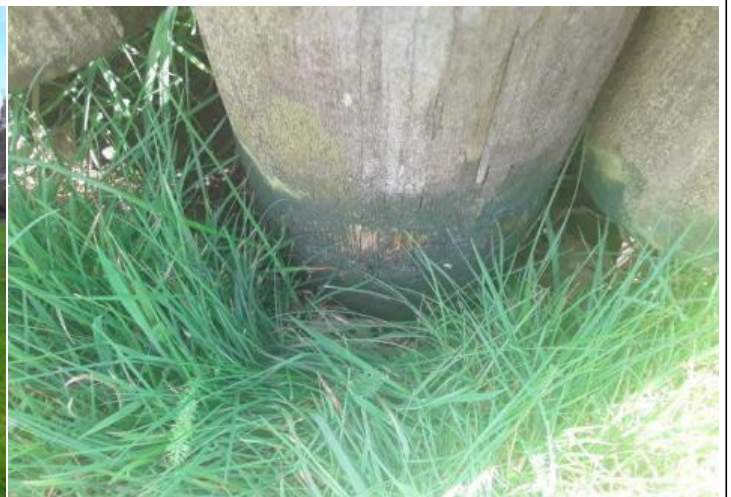
Finding: There is some strimmer / machinery damage apparent on the posts, this can penetrate the preservative applied to the timber and accelerate the rotting process

Action: Monitor for any deterioration (rot) and replace as required

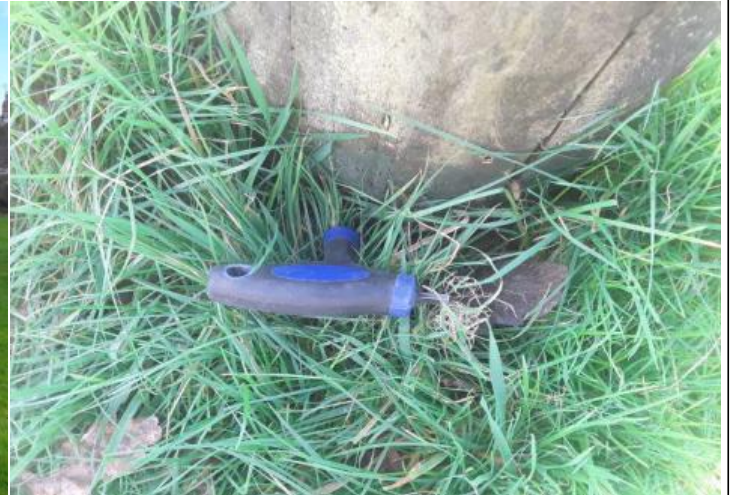
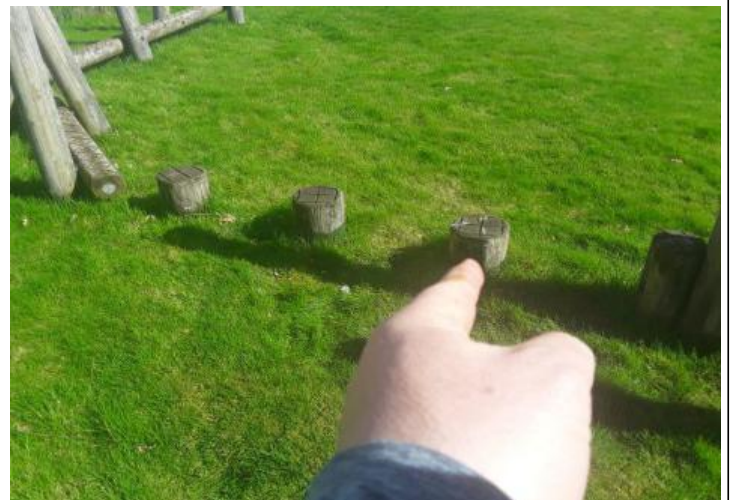
Finding: There are areas or parts of the stepping pods that have rotted

Action: Replace all affected timbers

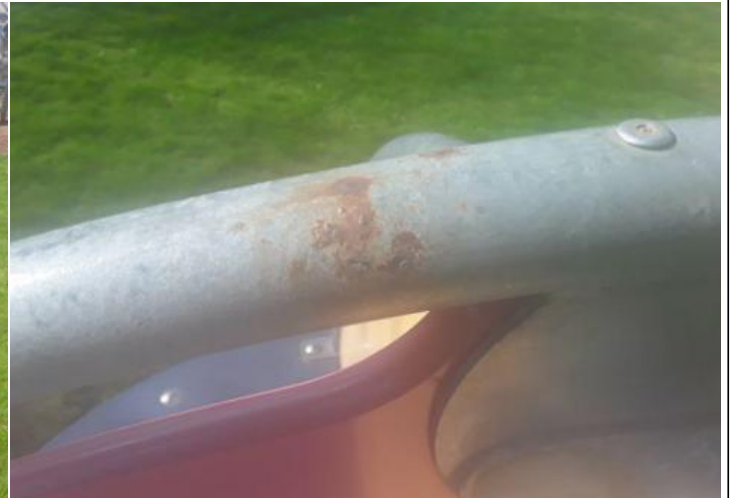
Finding: There is surface corrosion present on the item

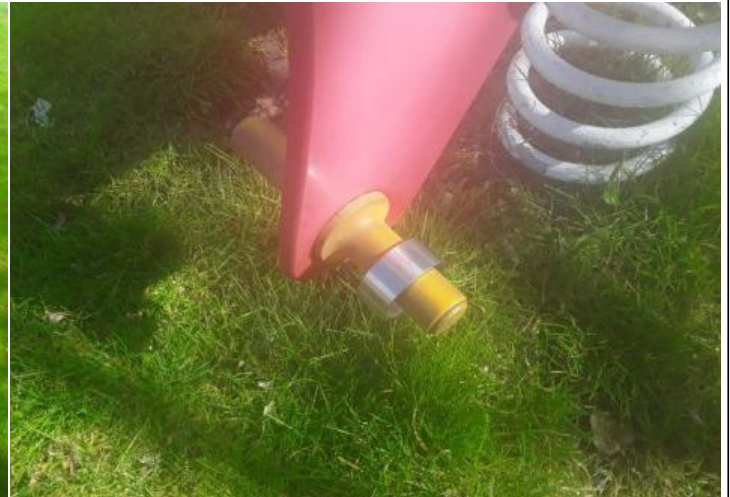
Finding: The end of handgrips and/or footrests have a cross section of less than 15cm² and fail to meet the requirements of BS EN 1176 Part 6

Action: Monitor - No remedial work recommended

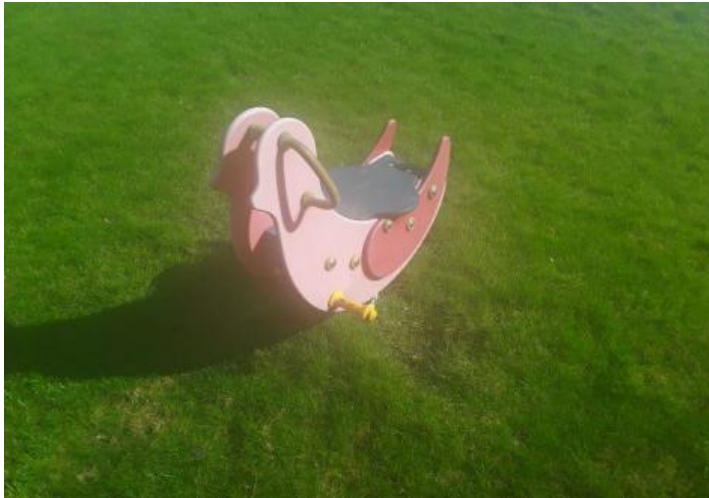
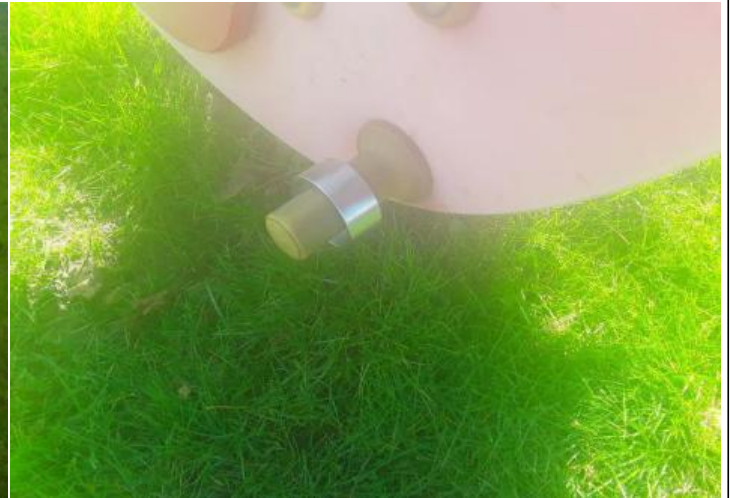
Finding: The end of handgrips and/or footrests have a cross section of less than 15cm² and fail to meet the requirements of BS EN 1176 Part 6
Action: Monitor - No remedial work recommended
