the **play inspection** company

Annual Inspection

Winchester City Council

The Jubilee RG (Bramdean and Hinton Ampner PC)

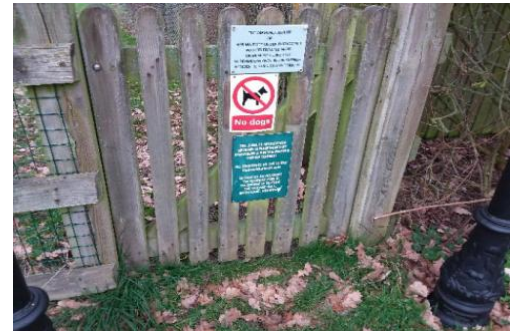
Item: Sign
Manufacturer: Owner/Operator
Surface Type: N/A
Equipment Compliance: N/A
Surface Area Compliance: N/A

It is recommended that information signs with emergency contact details are installed at each entrance/exit point to the playground - Provide in accordance with the recommendations set out in BS EN 1176

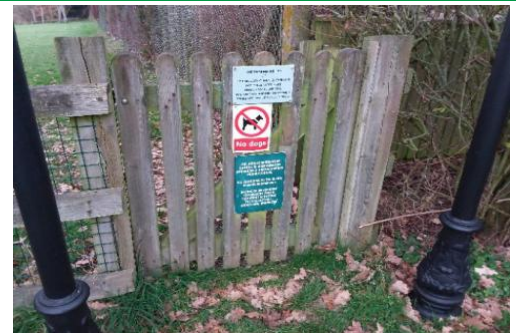
Item: Gate
Manufacturer: Owner/Operator
Surface Type: Grass
Equipment Compliance: N/A
Surface Area Compliance: N/A

The opening between the gate and the post is less than 12mm and could trap users fingers - Adjust gate to ensure a 12mm opening all around

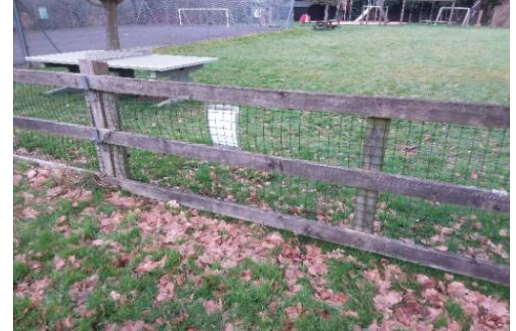
Item: Fence - Timber & Mesh Infill
Manufacturer: Owner/Operator
Surface Type: Grass
Equipment Compliance: N/A
Surface Area Compliance: N/A

There are a number of loose posts around the fence - Monitor for any further deterioration and reset as required

There are areas or parts of the timber on the structure that have rotted - Replace all affected timbers

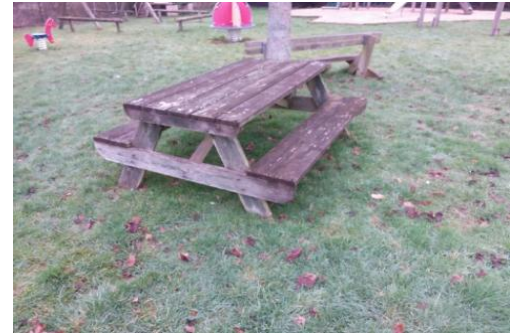
Item: Picnic Table
Manufacturer: Owner/Operator
Surface Type: Grass
Equipment Compliance: N/A
Surface Area Compliance: N/A

There is some evidence of rot in the timber - Monitor for any further deterioration and replace as required

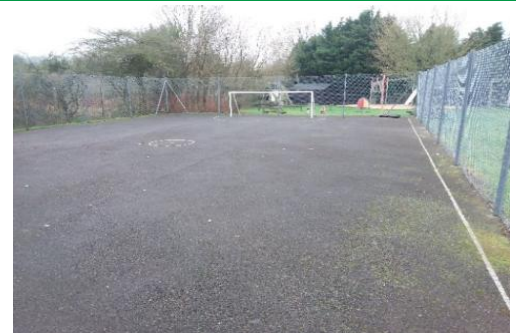
Item: Multi Use Games Area (MUGA)
Manufacturer: Unknown
Surface Type: Bitmac
Equipment Compliance: N/A
Surface Area Compliance: N/A

The goal posts are slightly loose in the ground - Monitor for any further deterioration and repair as required

There is some damage to the fence sections - Monitor for any further deterioration and repair as required

There is or are fixings missing on the goals - Replace all missing fixings

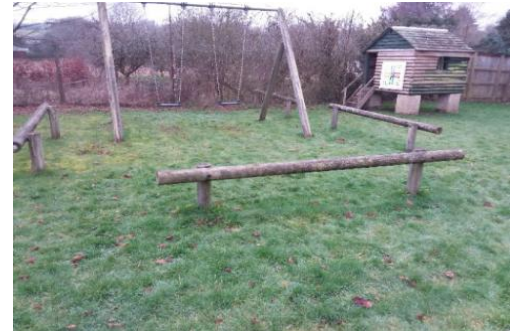
Item: Swing Barrier
Manufacturer: Playdale Playgrounds Ltd
Surface Type: Grass
Equipment Compliance: N/A
Surface Area Compliance: N/A

There is some strimmer / machinery damage apparent on the posts, this can penetrate the preservative applied to the timber and accelerate the rotting process - Monitor for any deterioration (rot) and replace as required

There is some evidence of rot in the timber - Monitor for any further deterioration and replace as required

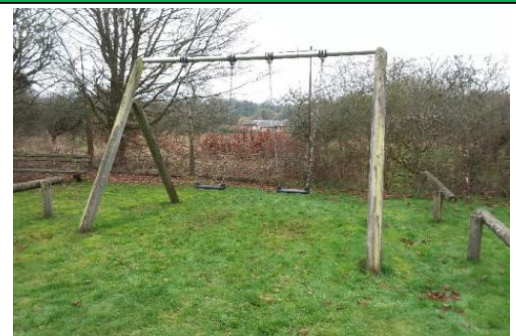
Item: 1 Bay 2 Seat (Flat)
Manufacturer: Playdale Playgrounds Ltd
Surface Type: Grass
Equipment Compliance: Yes
Surface Area Compliance: Yes

There is some strimmer / machinery damage apparent on the posts, this can penetrate the preservative applied to the timber and accelerate the rotting process - Monitor for any deterioration (rot) and replace as required

There is some evidence of rot in the posts - Monitor for any further deterioration and replace as required

There is some notable evidence of chain wear - Monitor for any further deterioration and replace when 40% worn

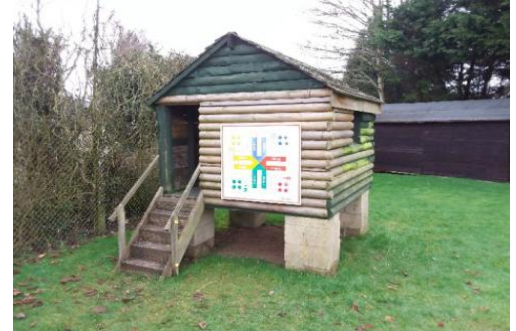
Item: Playhouse
Manufacturer: Unknown
Surface Type: Grass
Equipment Compliance: N/A
Surface Area Compliance: N/A

The item fails to meet the requirements of BS EN 1176 Part 1 4.2.7.2 for head and neck entrapment in the framework - Monitor use

A number of fixing(s) have worked loose - Secure all loose fixings

There is some evidence of rot in the timber - Monitor for any further deterioration and replace as required

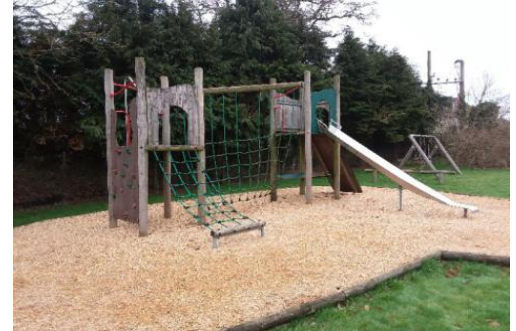
Item: Multi Play (Junior)
Manufacturer: Playdale Playgrounds Ltd
Surface Type: Bark Mulch
Equipment Compliance: No
Surface Area Compliance: Yes

There is/are finger entrapment/s between barrier and post and the item fails to meet the requirements of BS EN 1176 Part 1 4.2.7.6 Entrapment of fingers - Monitor use

There are areas or parts of the climbing panel that have rotted - Replace all affected timbers

There is some evidence of fire damage to the item - Monitor for any further deterioration and repair as required

There is some evidence of rot in the posts - Monitor for any further deterioration and replace as required

There is/are bolt cap covers missing or damaged on the item - Replace missing or damaged bolt cap covers

There is some evidence of rot in the timber - Monitor for any further deterioration and replace as required

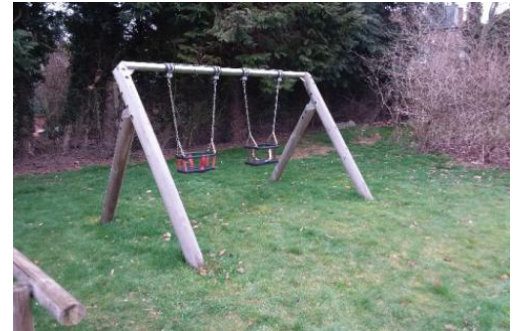
Item: 1 Bay 2 Seat (Cradle)
Manufacturer: Playdale Playgrounds Ltd
Surface Type: Grass
Equipment Compliance: Yes
Surface Area Compliance: Yes

There is some strimmer / machinery damage apparent on the posts, this can penetrate the preservative applied to the timber and accelerate the rotting process - Monitor for any deterioration (rot) and replace as required

There is some evidence of rot in the posts - Monitor for any further deterioration and replace as required

The seat has minor damage or wear - Monitor for any further deterioration and replace as required

The Anti Wrap bearings are dry and not moving freely - Lubricate bearings in accordance with the manufacturers recommendations

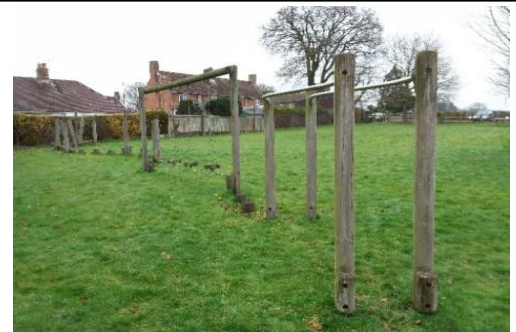
Item: Activity Trail
Manufacturer: Playdale Playgrounds Ltd
Surface Type: Grass
Equipment Compliance: Yes
Surface Area Compliance: No

There is some evidence of rot in the timber - Monitor for any further deterioration and replace as required

There is some strimmer / machinery damage apparent on the posts, this can penetrate the preservative applied to the timber and accelerate the rotting process - Monitor for any deterioration (rot) and replace as required

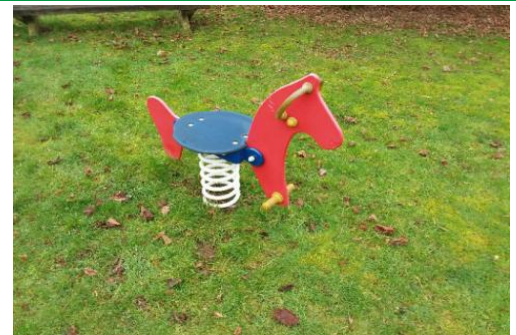
Item: Spring Horse
Manufacturer: Ledon
Surface Type: Grass
Equipment Compliance: No
Surface Area Compliance: Yes

The end of handgrips and/or footrests have a cross section of less than 15cm² and fail to meet the requirements of BS EN 1176 Part 6; this is however, a relatively low risk failure and no remedial action is recommended - Monitor use

There is/are bolt cap covers missing or damaged on the item - Replace missing or damaged bolt cap covers

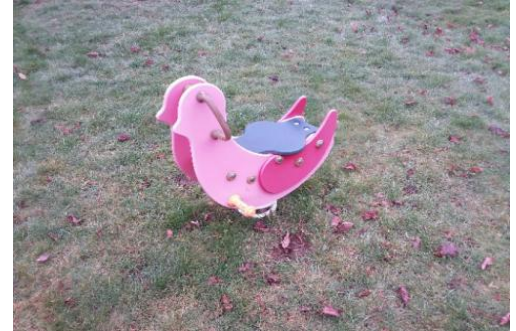
Item: Spring Chicken
Manufacturer: Ledon
Surface Type: Grass
Equipment Compliance: No
Surface Area Compliance: Yes

The end of handgrips and/or footrests have a cross section of less than 15cm² and fail to meet the requirements of BS EN 1176 Part 6; this is however, a relatively low risk failure and no remedial action is recommended - Monitor use

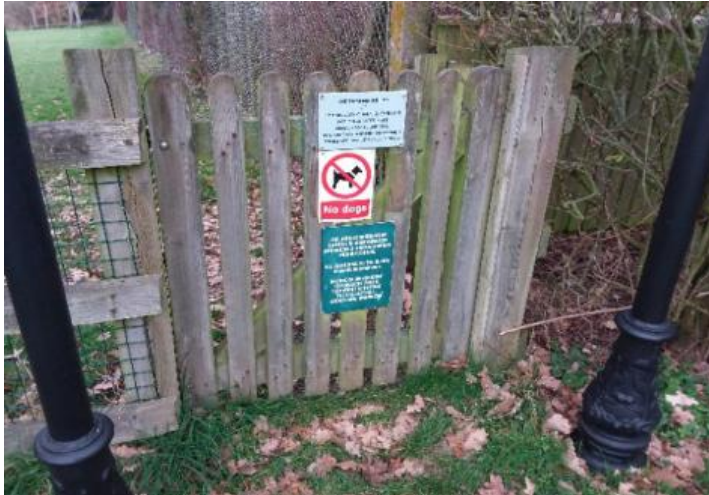
Item: Ancillary Items - Gate
Manufacturer: Owner/Operator

Finding: The opening between the gate and the post is less than 12mm and could trap users fingers
Action: Adjust gate to ensure a 12mm opening all around

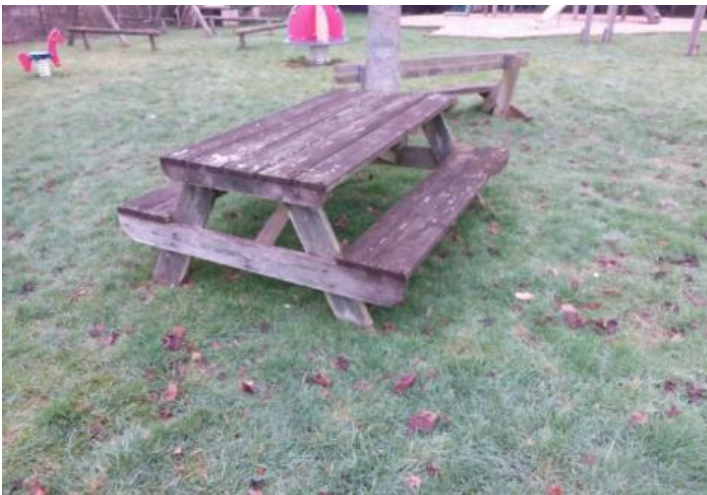
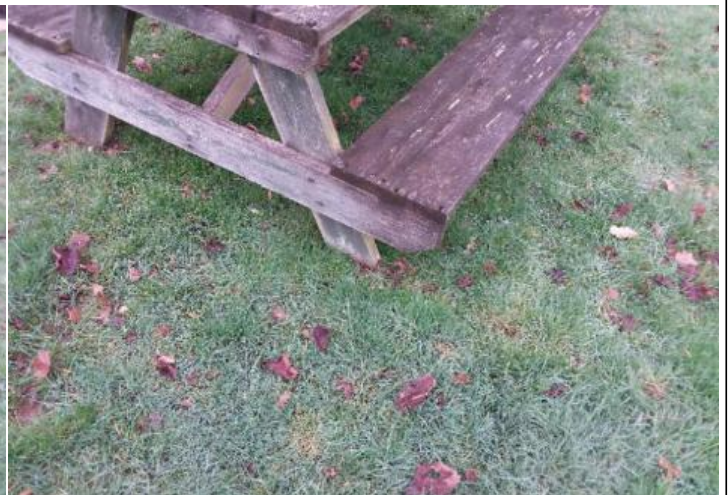
Item: Ancillary Items - Picnic Table
Manufacturer: Owner/Operator

Finding: The table is not secured to the ground and there is some potential for the item to be moved within falling spaces of equipment

Action: Secure the item to the ground

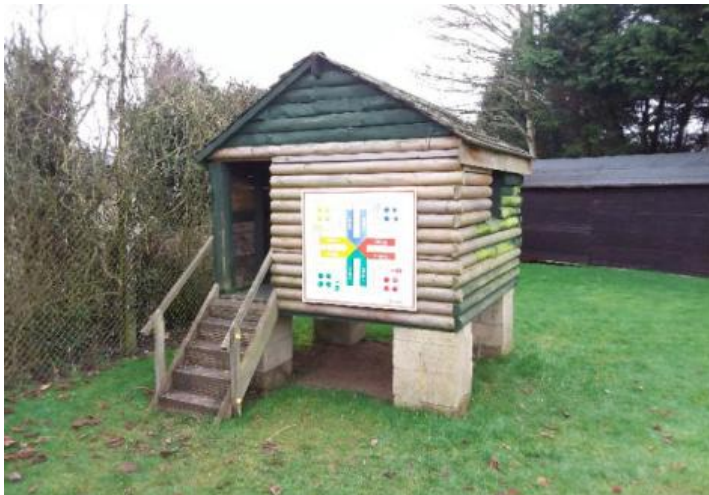
Item: Activity Equipment - Playhouse
Manufacturer: Unknown

Finding: This equipment has not been designed or installed to meet with the requirements of BS EN 1176 for public playground equipment; we have however used our knowledge of these standards to assist in forming the basis of our risk assessment for the equipment and our report.

Action: Monitor use and review the use of the equipment and risk assessment regularly

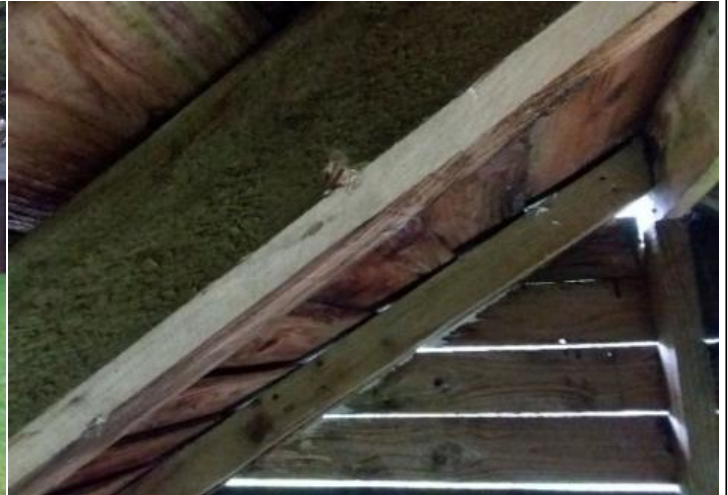
Item: Activity Equipment - Playhouse
Manufacturer: Unknown

Finding: Parts of the timber are rough or splintered

Action: Remove all rough or sharp edges

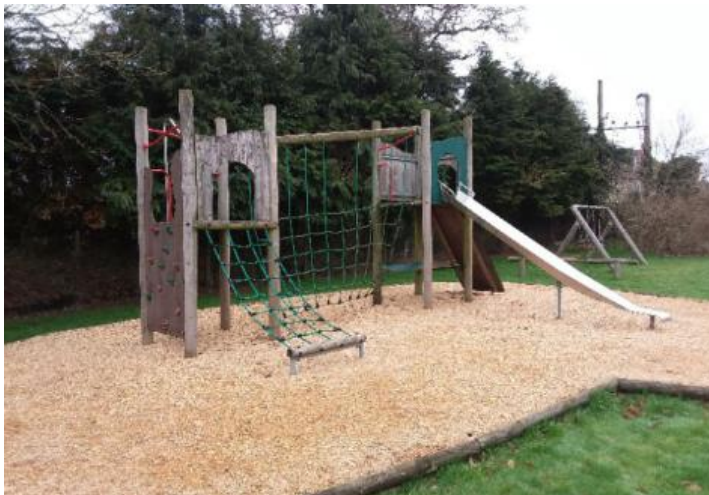
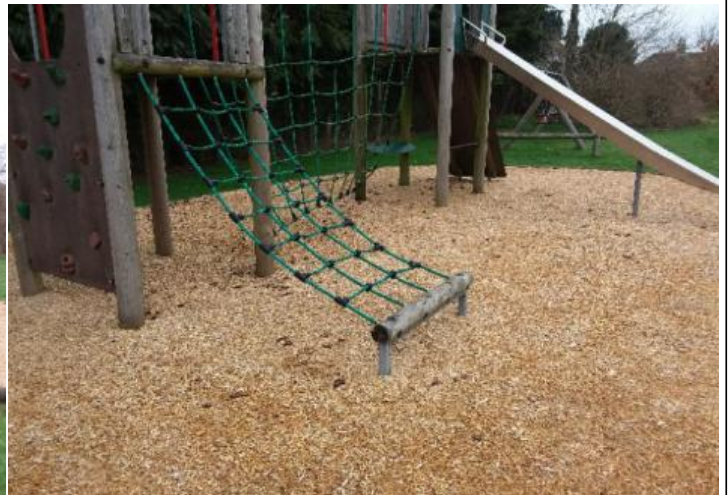
Item: Activity Equipment - Multi Play (Junior)
Manufacturer: Playdale Playgrounds Ltd

Finding: The base of the net forms a hard object within the falling space of the equipment in contravention of the requirements of BS EN 1176 Part 1

Action: Monitor use

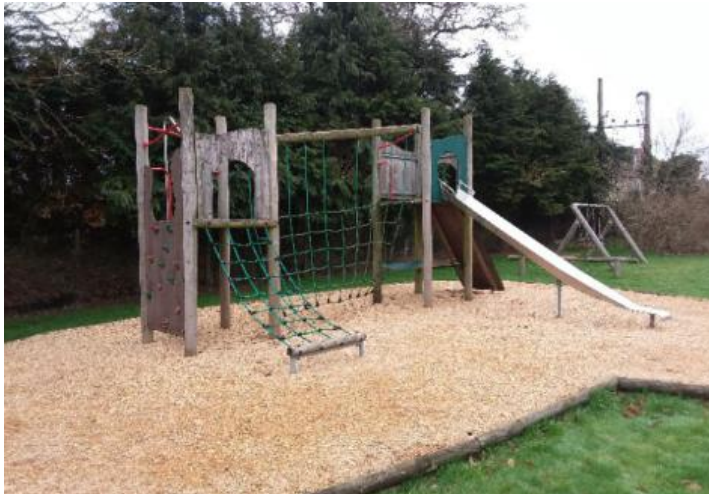
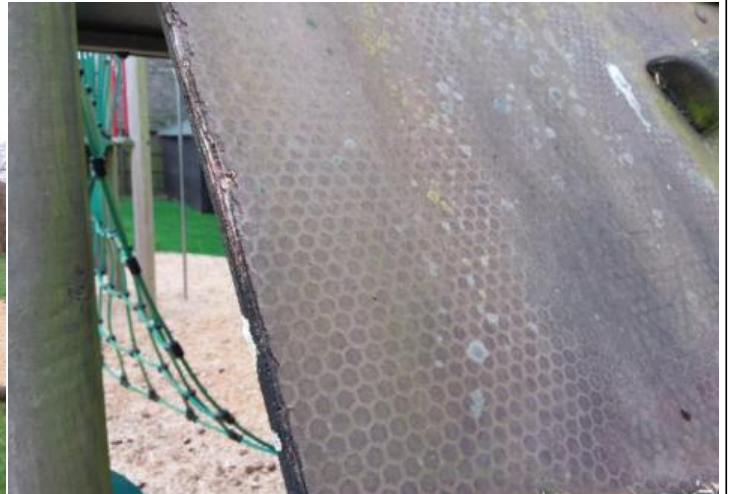
Item: Activity Equipment - Multi Play (Junior)
Manufacturer: Playdale Playgrounds Ltd

Finding: Parts of the timber are rough or splintered

Action: Remove all rough or sharp edges

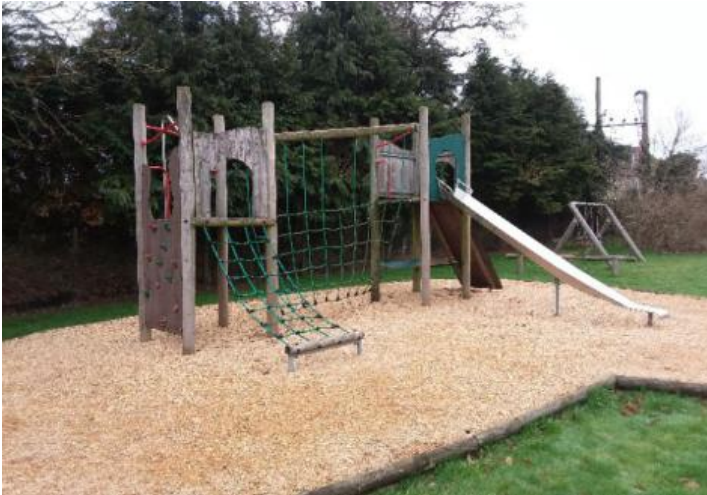
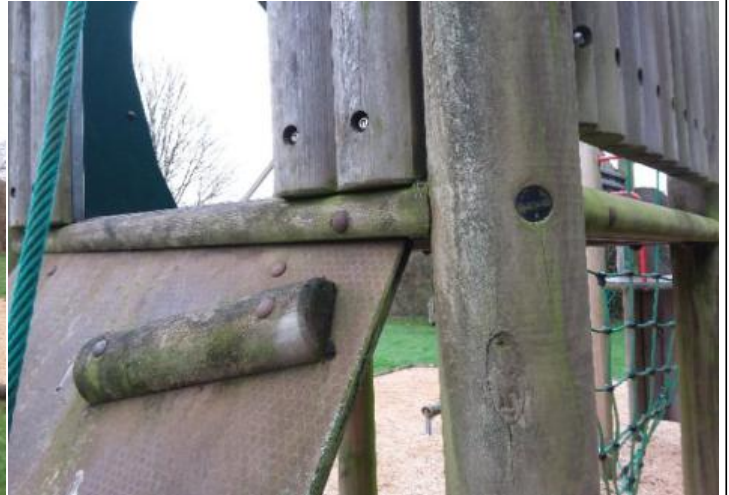
Item: Activity Equipment - Multi Play (Junior)
Manufacturer: Playdale Playgrounds Ltd

Finding: There is algae or moss on the surface of the equipment

Action: Clean and treat appropriately

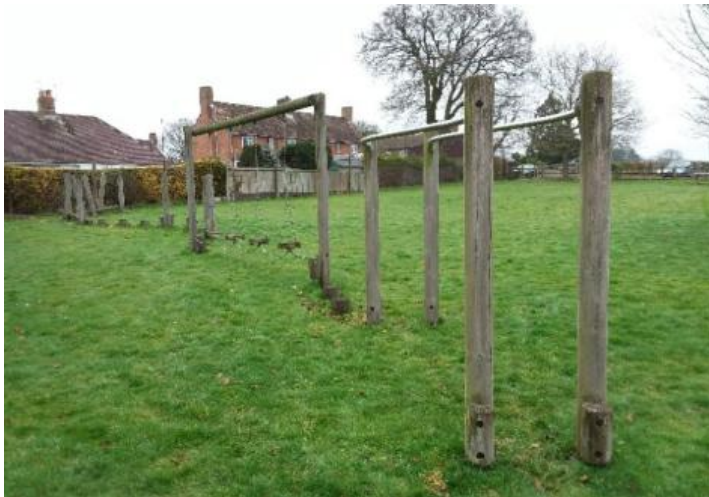
Item: Activity Equipment - Activity Trail
Manufacturer: Playdale Playgrounds Ltd

Finding: There is algae or moss on the surface of the equipment

Action: Clean and treat appropriately
