Annual Inspection

Winchester City Council

The Jubilee RG (Bramdean and Hinton Ampner PC)

Off Woodlane Close, Bramdean, Winchester,
Hampshire, SO24 0JR

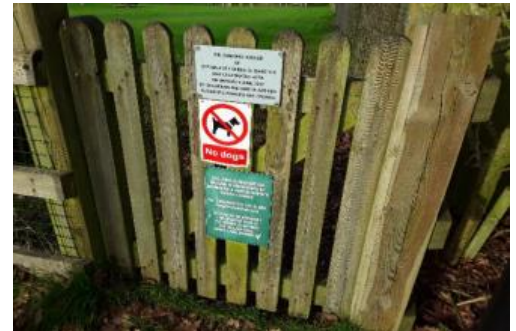
Item: Sign
Manufacturer: Owner/Operator
Surface Type: N/A
Equipment Compliance: N/A
Surface Area Compliance: N/A

This item is satisfactory - no work required -

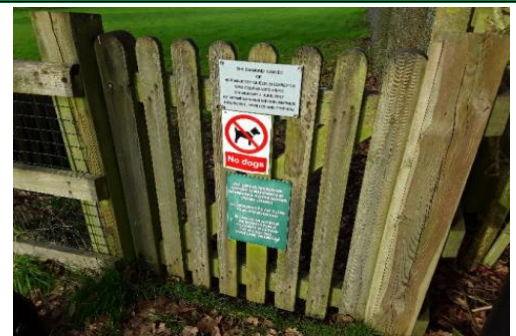
Item: Gate
Manufacturer: Owner/Operator
Surface Type: Grass
Equipment Compliance: N/A
Surface Area Compliance: N/A

There are openings that are less than 12mm that could trap or crush fingers - Where possible a 12mm gap should be maintained on both sides or between the gate leaves

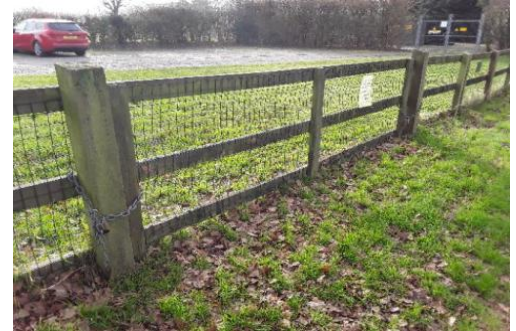
Item: Gate - Maintenance
Manufacturer: Owner/Operator
Surface Type: Grass
Equipment Compliance: N/A
Surface Area Compliance: N/A

There is some evidence of rot in the posts - Monitor for any further deterioration and replace as required

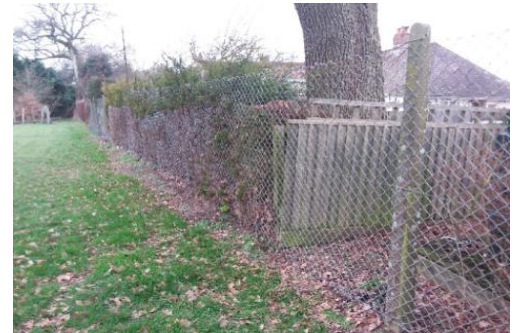
Item: Fence - Chainlink
Manufacturer: Owner/Operator
Surface Type: Grass
Equipment Compliance: N/A
Surface Area Compliance: N/A

There are areas or parts of the timber on the structure that have rotted - Replace all affected timbers

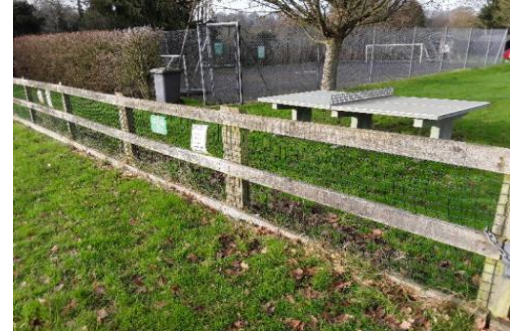
Item: Fence - Timber & Mesh Infill
Manufacturer: Owner/Operator
Surface Type: Grass
Equipment Compliance: N/A
Surface Area Compliance: N/A

There are a number of loose posts around the fence - Monitor for any further deterioration and reset as required

There are areas or parts of the timber on the structure that have rotted - Replace all affected timbers

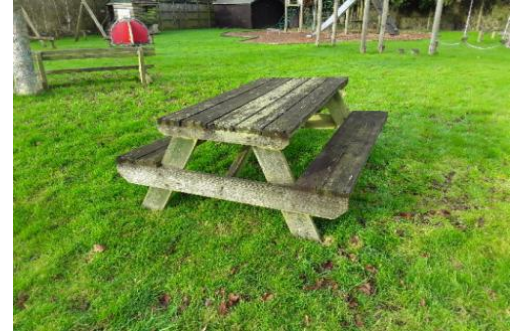
Item: Picnic Table
Manufacturer: Owner/Operator
Surface Type: Grass
Equipment Compliance: N/A
Surface Area Compliance: N/A

There is some evidence of rot in the timber - Monitor for any further deterioration and replace as required

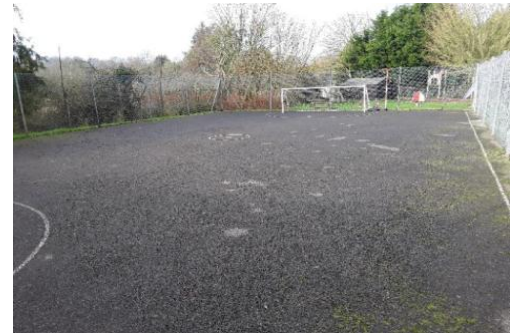
Item: Ball Games Area
Manufacturer: Unknown
Surface Type: Bitmac
Equipment Compliance: N/A
Surface Area Compliance: N/A

The goal posts are slightly loose in the ground - Monitor for any further deterioration and repair as required

There is or are fixings missing on the goals - Replace all missing fixings

There is some damage to the fence sections - Monitor for any further deterioration and repair as required

A number of goal fixing(s) have worked loose - Secure all loose fixings

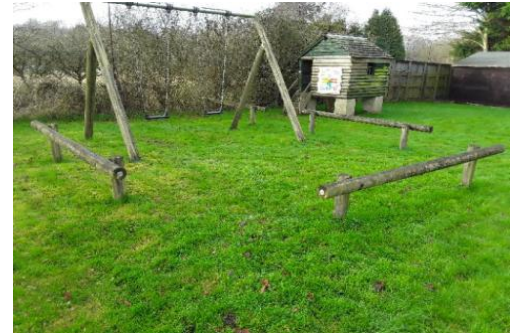
Item: Swing Barrier
Manufacturer: Playdale Playgrounds Ltd
Surface Type: Grass
Equipment Compliance: N/A
Surface Area Compliance: N/A

There is some evidence of rot in the timber - Monitor for any further deterioration and replace as required

There is some strimmer / machinery damage apparent on the posts, this can penetrate the preservative applied to the timber and accelerate the rotting process - Monitor for any deterioration (rot) and replace as required

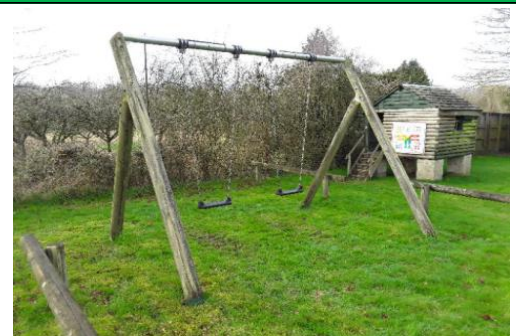
Item: 1 Bay 2 Seat (Flat)
Manufacturer: Playdale Playgrounds Ltd
Surface Type: Grass
Equipment Compliance: Yes
Surface Area Compliance: Yes

There is some evidence of rot in the posts - Monitor for any further deterioration and replace as required

There is some strimmer / machinery damage apparent on the posts, this can penetrate the preservative applied to the timber and accelerate the rotting process - Monitor for any deterioration (rot) and replace as required

The seat has minor damage or wear - Monitor for any further deterioration and replace as required

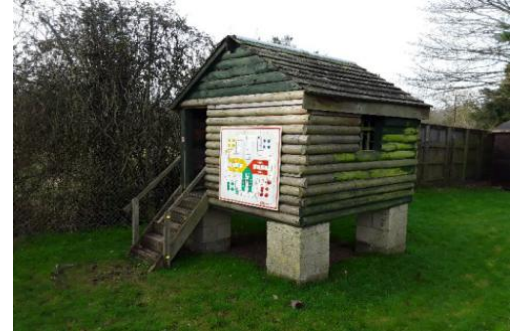
Item: Playhouse
Manufacturer: Unknown
Surface Type: Grass
Equipment Compliance: N/A
Surface Area Compliance: N/A

This equipment has not been designed or installed to meet with the requirements of BS EN 1176 for public playground equipment; we have however used our knowledge of these standards to assist in forming the basis of our risk assessment for the equipment and our report. - Monitor use and review the use of the equipment and risk assessment regularly

The fencing forms a hard object within the falling space of the equipment and there is also insufficient surfacing provided - Monitor - no remedial work recommended

The item fails to meet the requirements of BS EN 1176 Part 1 4.2.7.2 for head and neck entrapment in the framework - Monitor - No remedial work recommended

There is some evidence of rot in the timber - Monitor for any further deterioration and replace as required

A number of fixing(s) have worked loose - Secure all loose fixings

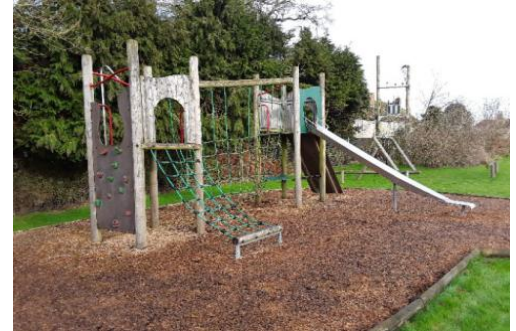
Item: Multi Play (Junior)
Manufacturer: Playdale Playgrounds Ltd
Surface Type: Bark Mulch
Equipment Compliance: No
Surface Area Compliance: Yes

The base of the net forms a hard object within the falling space of the equipment in contravention of the requirements of BS EN 1176 Part 1 - Monitor - No remedial work recommended

There is/are finger entrapment/s between barrier and post and the item fails to meet the requirements of BS EN 1176 Part 1 4.2.7.6 Entrapment of fingers - Monitor - No remedial work recommended

There is algae or moss on the surface of the equipment that can lead to the onset of rot - Clean and treat appropriately

There are areas or parts of the climbing panel that have rotted - Replace all affected timbers

There is some evidence of rot in the posts - Monitor for any further deterioration and replace as required

There is some evidence of rot in the timber - Monitor for any further deterioration and replace as required

There is/are bolt cap covers missing or damaged on the item - Replace missing or damaged bolt cap covers

There is some evidence of rot in the barriers - Monitor for any further deterioration and replace as required

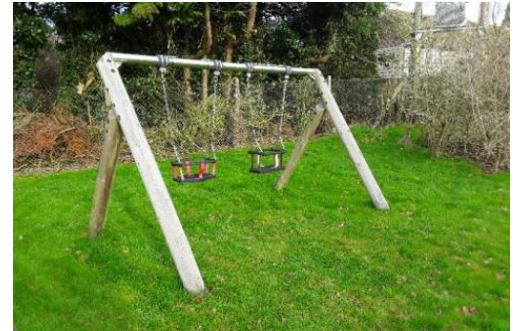
Item: 1 Bay 2 Seat (Cradle)
Manufacturer: Playdale Playgrounds Ltd
Surface Type: Grass
Equipment Compliance: Yes
Surface Area Compliance: Yes

There is some evidence of rot in the posts - Monitor for any further deterioration and replace as required

There is some strimmer / machinery damage apparent on the posts, this can penetrate the preservative applied to the timber and accelerate the rotting process - Monitor for any deterioration (rot) and replace as required

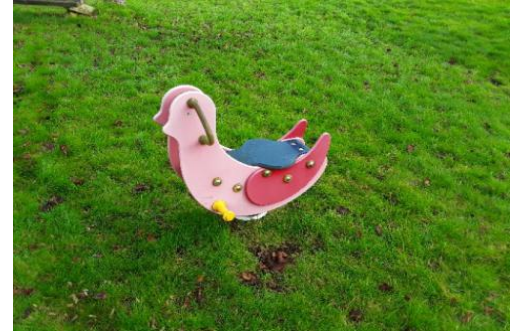
Item: Spring Chicken
Manufacturer: Ledon
Surface Type: Grass
Equipment Compliance: No
Surface Area Compliance: Yes

The end of handgrips and/or footrests have a cross section of less than 15cm² and fail to meet the requirements of BS EN 1176 Part 6 - Monitor - No remedial work recommended

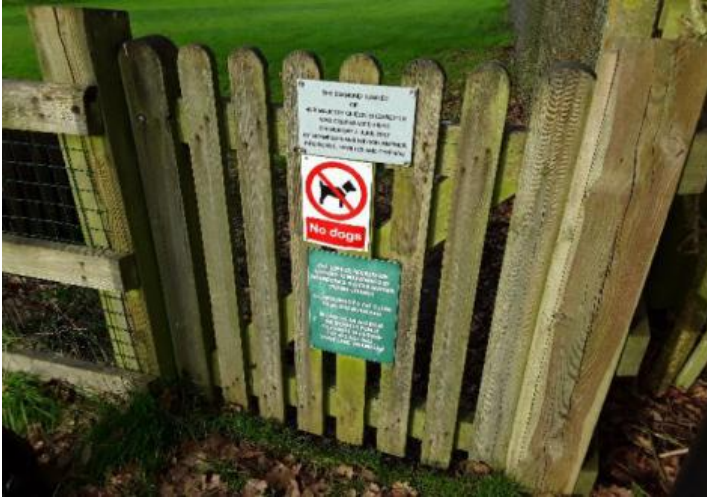
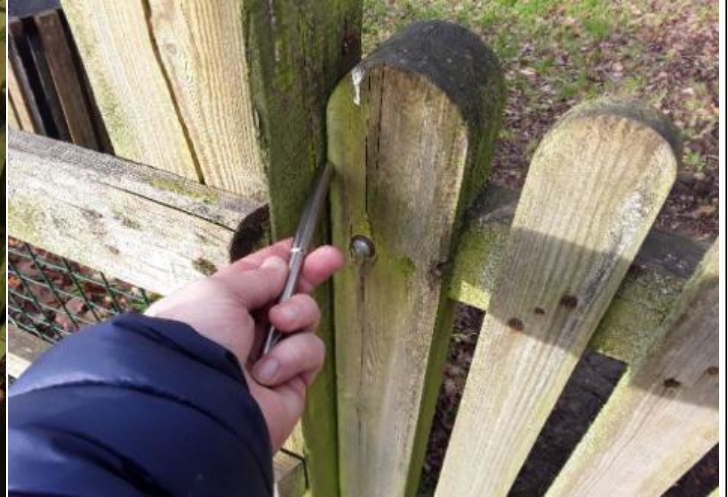
Item: Ancillary Items - Gate
Manufacturer: Owner/Operator

Finding: There are openings that are less than 12mm that could trap or crush fingers

Action: Where possible a 12mm gap should be maintained on both sides or between the gate leaves

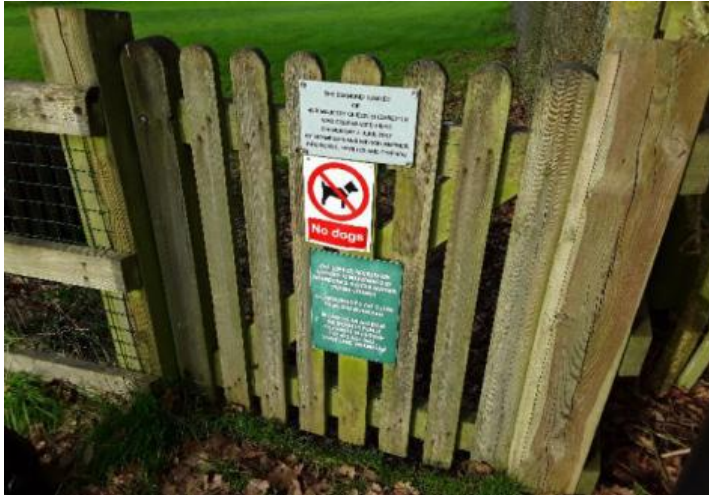
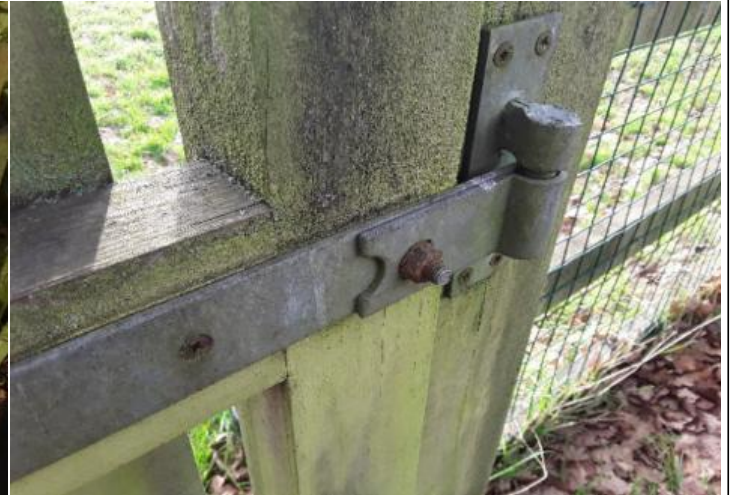
Item: Ancillary Items - Gate
Manufacturer: Owner/Operator

Finding: There are projecting bolt thread(s) present

Action: Remove excess thread length and deburr or provide cap

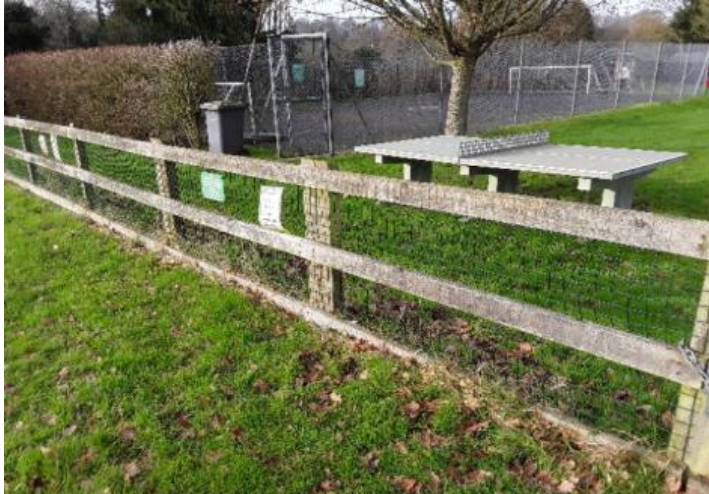
Item: Ancillary Items - Fence - Timber & Mesh Infill
Manufacturer: Owner/Operator

Finding: There are areas or parts of the timber on the structure that have rotted

Action: Replace all affected timbers

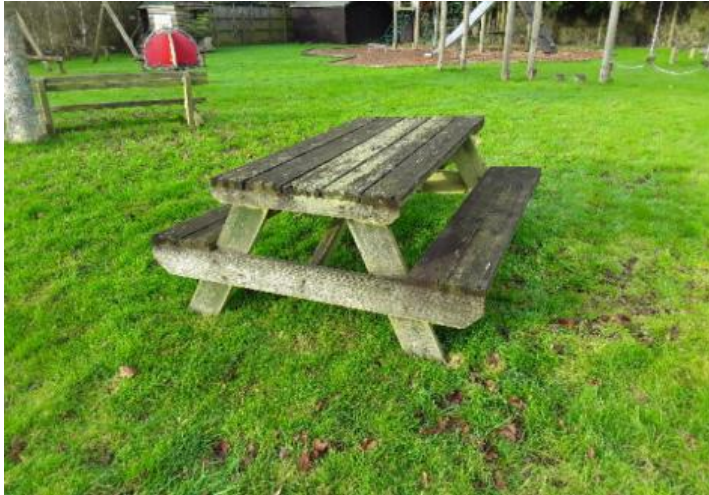
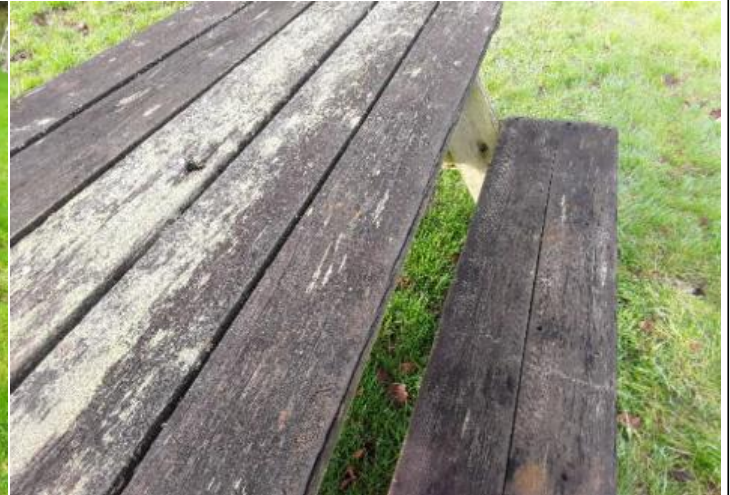
Item: Ancillary Items - Picnic Table
Manufacturer: Owner/Operator

Finding: There is algae or moss on the surface of the equipment

Action: Clean and treat appropriately

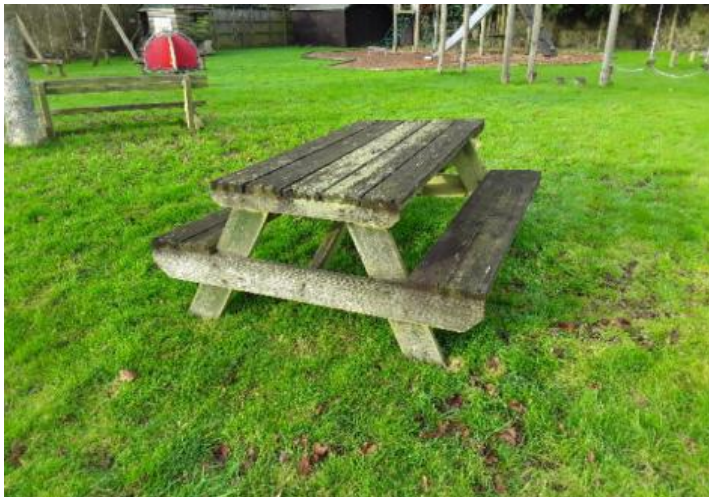
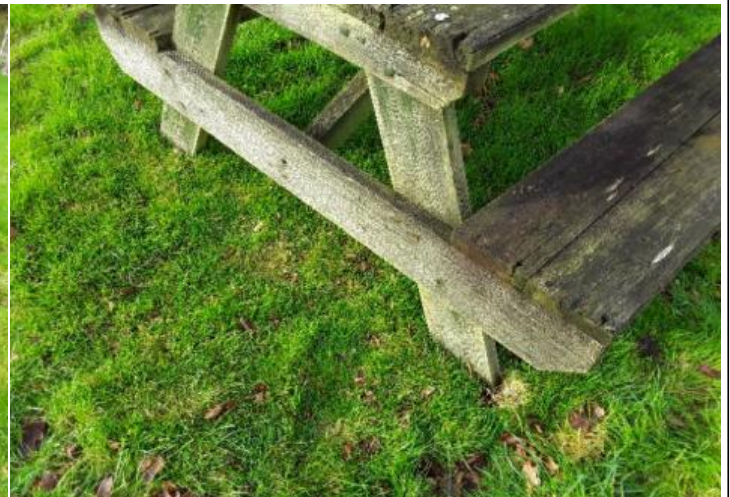
Item: Ancillary Items - Picnic Table
Manufacturer: Owner/Operator

Finding: The table is not secured to the ground and there is some potential for the item to be moved within falling spaces of equipment

Action: Secure the item to the ground

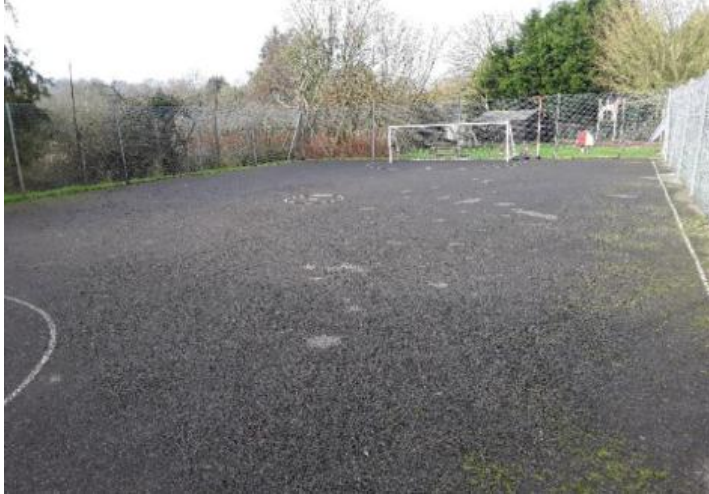
Item: Multi Use Games Area - Ball Games Area
Manufacturer: Unknown

Finding: The goal posts are slightly loose in the ground

Action: Monitor for any further deterioration and repair as required

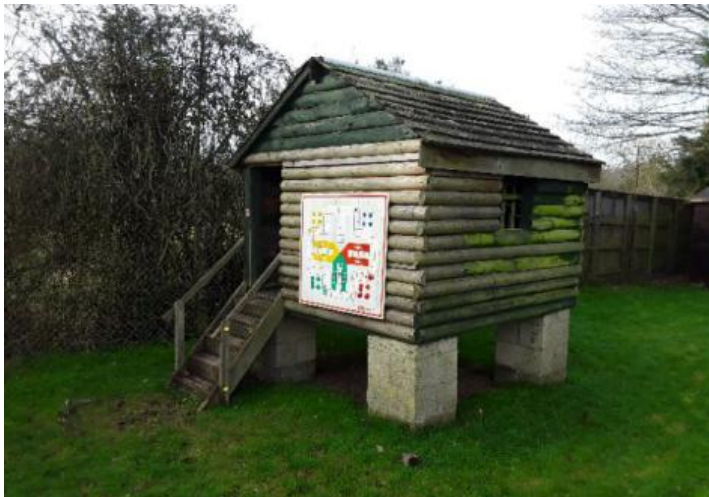
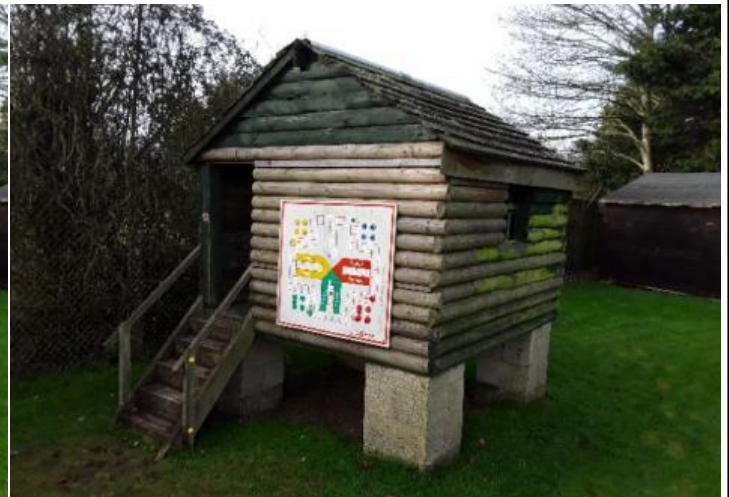
Item: Activity Equipment - Playhouse
Manufacturer: Unknown

Finding: This equipment has not been designed or installed to meet with the requirements of BS EN 1176 for public playground equipment; we have however used our knowledge of these standards to assist in forming the basis of our risk assessment for the equipment and our report.

Action: Monitor use and review the use of the equipment and risk assessment regularly

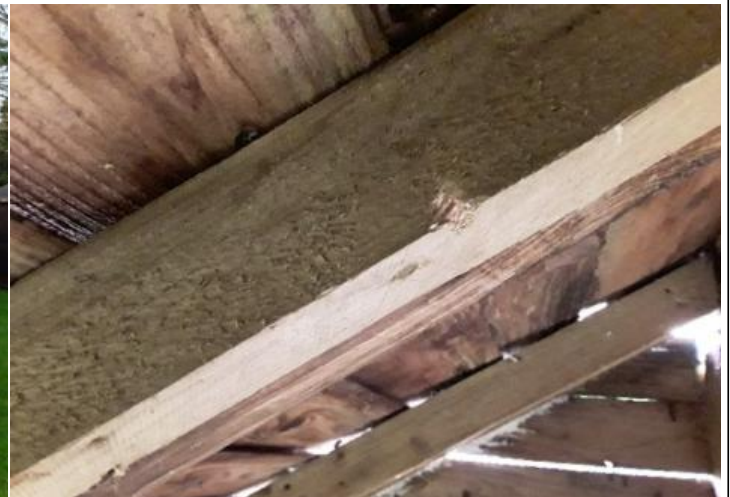
Item: Activity Equipment - Playhouse
Manufacturer: Unknown

Finding: Parts of the timber are rough or splintered

Action: Remove all rough or sharp edges

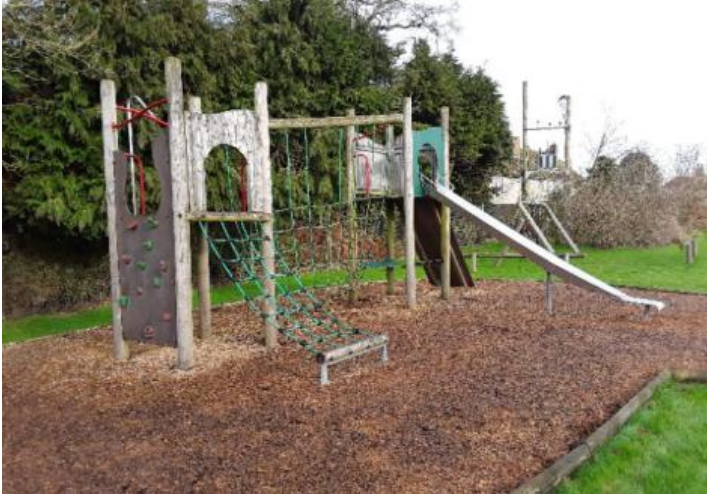
Item: Activity Equipment - Multi Play (Junior)
Manufacturer: Playdale Playgrounds Ltd

Finding: There is/are finger entrapment/s between barrier and post and the item fails to meet the requirements of BS EN 1176 Part 1 4.2.7.6 Entrapment of fingers

Action: Monitor - No remedial work recommended

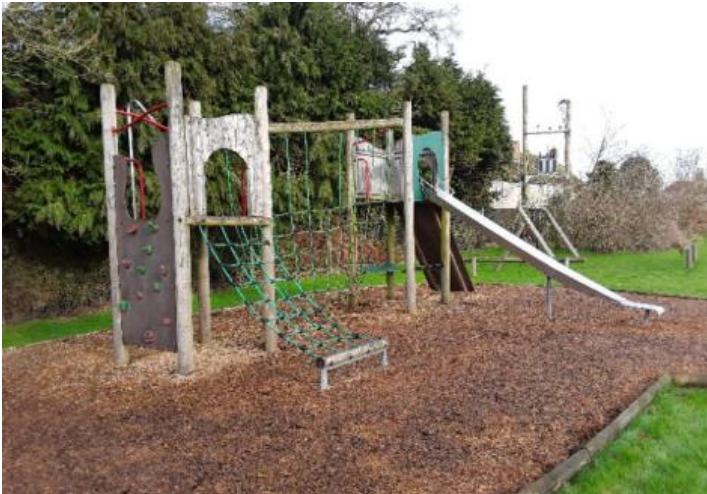
Item: Activity Equipment - Multi Play (Junior)
Manufacturer: Playdale Playgrounds Ltd

Finding: There is algae or moss on the surface of the equipment that can lead to the onset of rot

Action: Clean and treat appropriately

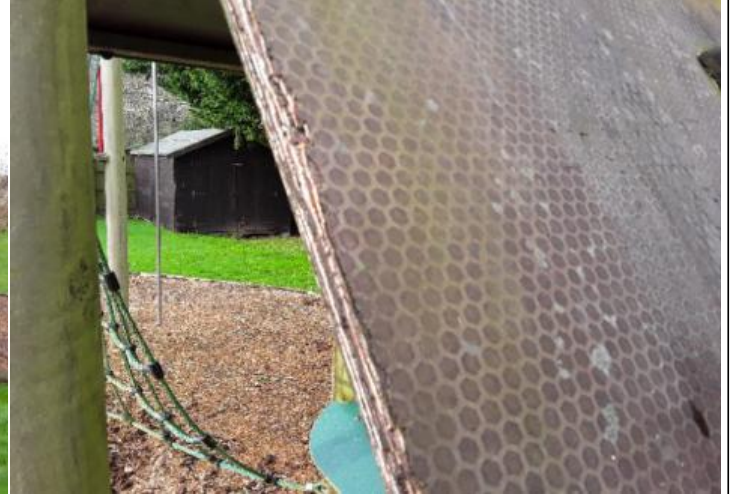
Item: Activity Equipment - Multi Play (Junior)
Manufacturer: Playdale Playgrounds Ltd

Finding: Parts of the timber are rough or splintered

Action: Remove all rough or sharp edges

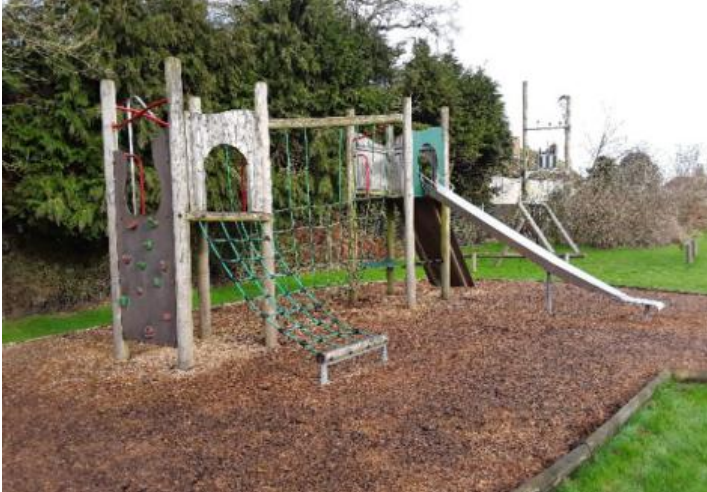
Item: Activity Equipment - Multi Play (Junior)
Manufacturer: Playdale Playgrounds Ltd

Finding: There are areas or parts of the climbing panel that have rotted

Action: Replace all affected timbers

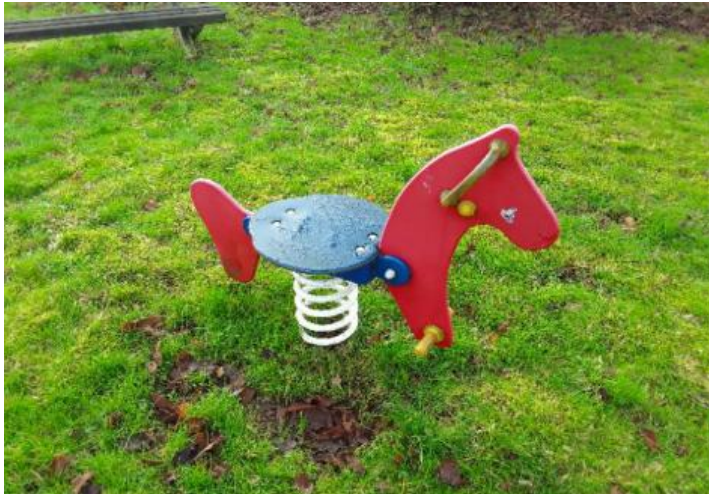
Item: Rocking Equipment - Spring Horse
Manufacturer: Ledon

Finding: There is/are bolt cap covers missing or damaged on the item
Action: Replace missing or damaged bolt cap covers
