## Annual Inspection

Winchester City Council

The Jubilee RG (Bramdean and Hinton Ampner PC)  
Off Woodlane Close, Bramdean, Winchester, Hampshire

Annual Inspection - 12 May 2016 at 09:40 Inspector: Matt Clay (RPII Annual Inspector)

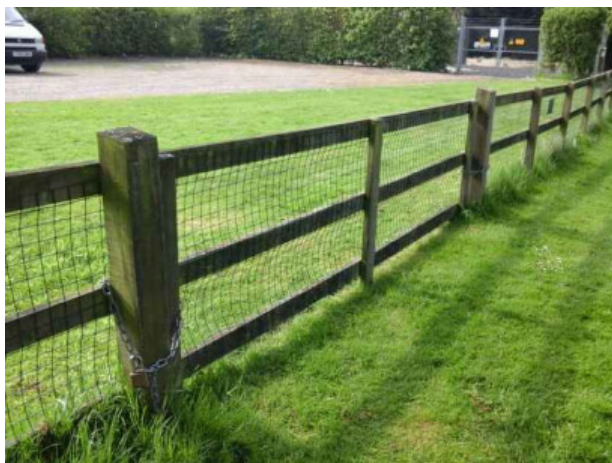
**Item:** Ancillary Items - Gate - Maintenance  
**Manufacturer:** Owner/Operator  
**Surface Type:** Grass  
**Equipment Compliance:** N/A  
**Surface Area Compliance:** N/A  
**Ref/Part Number:**  
**Total Findings:** 1

This item is satisfactory - no work required

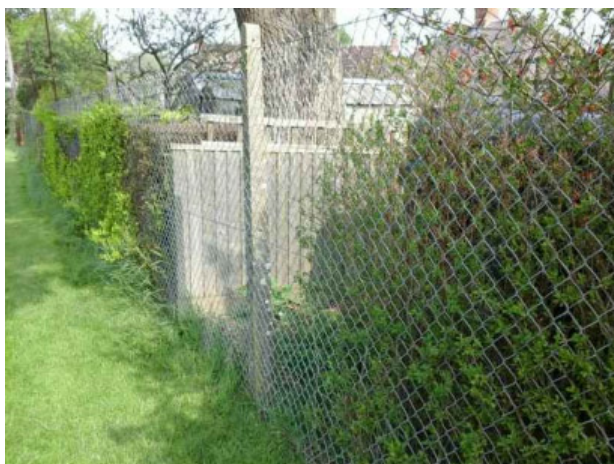
**Item:** Ancillary Items - Fence - Chainlink  
**Manufacturer:** Owner/Operator  
**Surface Type:** Grass  
**Equipment Compliance:** N/A  
**Surface Area Compliance:** N/A  
**Ref/Part Number:**  
**Total Findings:** 1

This item is satisfactory - no work required

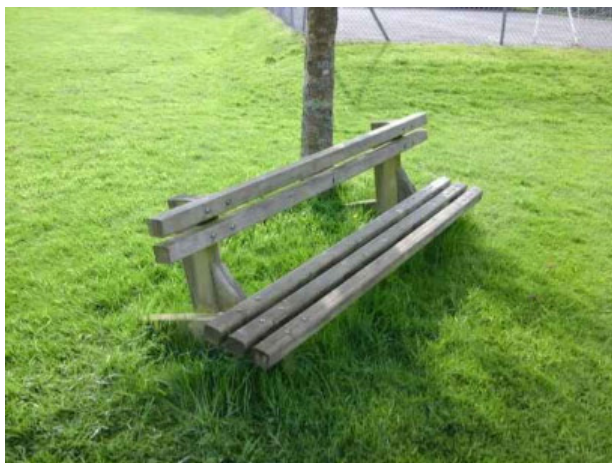
**Item:** Ancillary Items - Bench  
**Manufacturer:** Owner/Operator  
**Surface Type:** Grass  
**Equipment Compliance:** N/A  
**Surface Area Compliance:** N/A  
**Ref/Part Number:**  
**Total Findings:** 1

This item is satisfactory - no work required

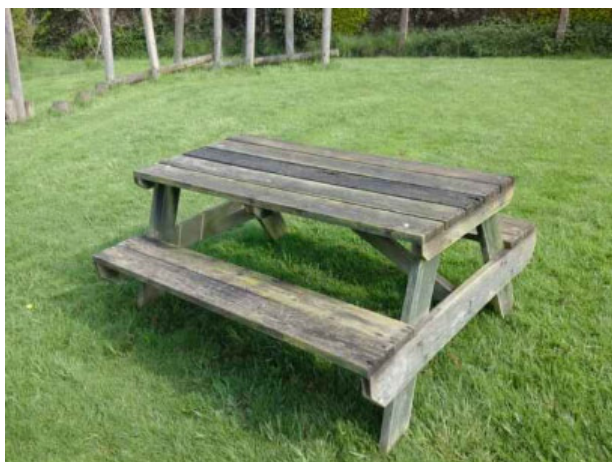
**Item:** Ancillary Items - Picnic Table  
**Manufacturer:** Owner/Operator  
**Surface Type:** Grass  
**Equipment Compliance:** N/A  
**Surface Area Compliance:** N/A  
**Ref/Part Number:**  
**Total Findings:** 1

The bench is not securely fixed to the surface and there is some possibility of the item tipping or rolling over - Secure the bench to the ground

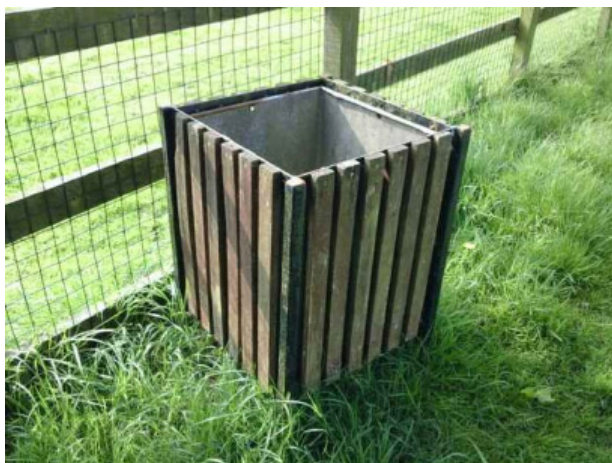
**Item:** Ancillary Items - Litter Bin  
**Manufacturer:** Owner/Operator  
**Surface Type:** Grass  
**Equipment Compliance:** N/A  
**Surface Area Compliance:** N/A  
**Ref/Part Number:**  
**Total Findings:** 1

This item is satisfactory - no work required

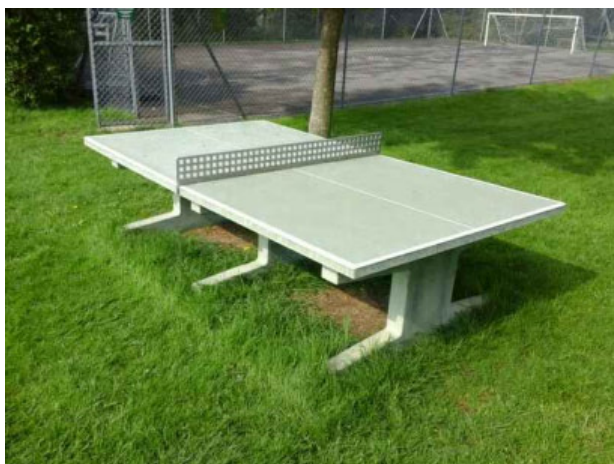
**Item:** Other - Table Tennis  
**Manufacturer:** Unknown  
**Surface Type:** Grass  
**Equipment Compliance:** N/A  
**Surface Area Compliance:** N/A  
**Ref/Part Number:**  
**Total Findings:** 1

This item is satisfactory - no work required

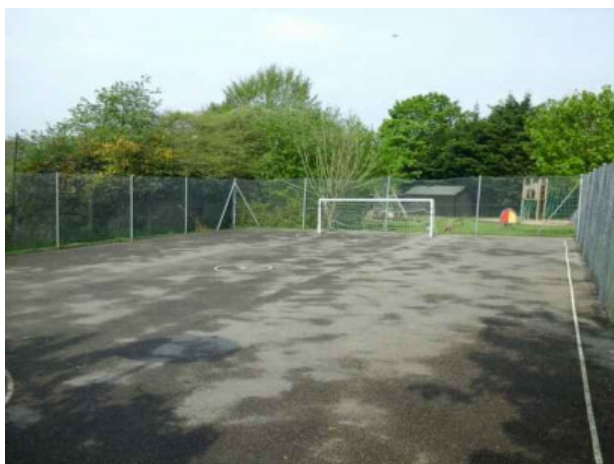
**Item:** Multi Use Games Area - Multi Use Games Area (MUGA)  
**Manufacturer:** Unknown  
**Surface Type:** Bitmac  
**Equipment Compliance:** Yes  
**Surface Area Compliance:** N/A  
**Ref/Part Number:**  
**Total Findings:** 1

This item is satisfactory - no work required

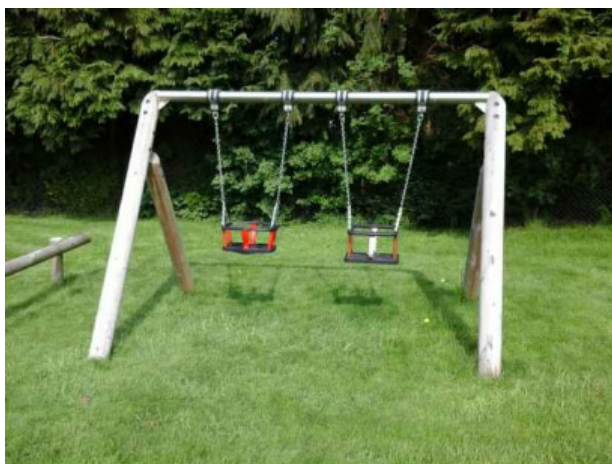
**Item:** Swings - 1 Bay 2 Seat (Cradle)  
**Manufacturer:** Playdale Playgrounds Ltd  
**Surface Type:** Grass  
**Equipment Compliance:** Yes  
**Surface Area Compliance:** Yes  
**Ref/Part Number:**  
**Total Findings:** 1

This item is satisfactory - no work required
