## Annual Inspection

Winchester City Council

The Jubilee RG (Bramdean and Hinton Ampner PC)

Annual Inspection - 08 February 2018 at 09:25 Inspector: Richard Sewell (RPII Annual Inspector)

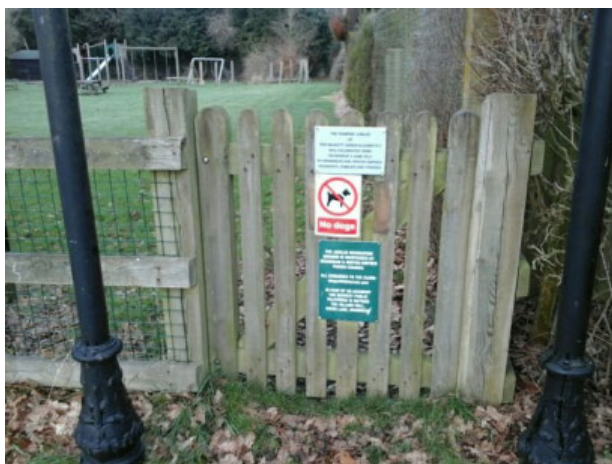
**Item:** Ancillary Items - Gate  
**Manufacturer:** Owner/Operator  
**Surface Type:** Grass  
**Equipment Compliance:** N/A  
**Surface Area Compliance:** N/A  
**Ref/Part Number:**  
**Total Findings:** 1

The opening between the gate and the post is less than 12mm and could trap users fingers - Adjust gate to ensure a 12mm opening all around

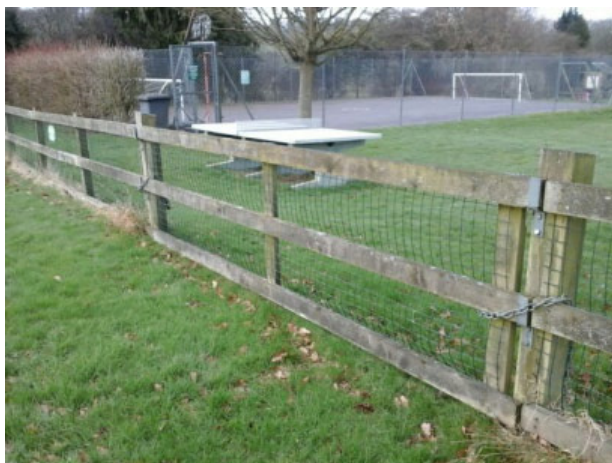
**Item:** Ancillary Items - Gate - Maintenance  
**Manufacturer:** Owner/Operator  
**Surface Type:** Grass  
**Equipment Compliance:** N/A  
**Surface Area Compliance:** N/A  
**Ref/Part Number:**  
**Total Findings:** 1

This item is satisfactory - no work required

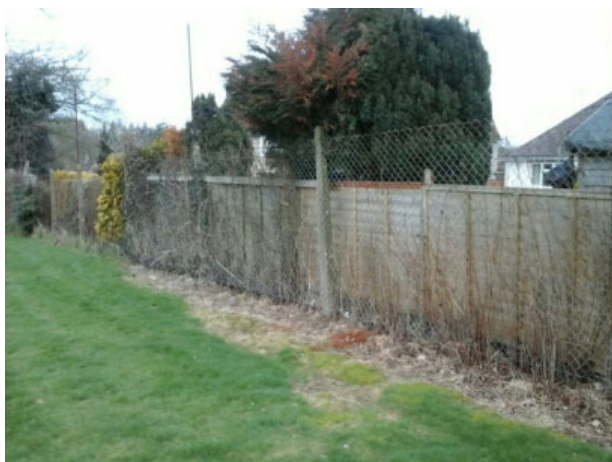
**Item:** Ancillary Items - Fence - Chainlink  
**Manufacturer:** Owner/Operator  
**Surface Type:** Grass  
**Equipment Compliance:** N/A  
**Surface Area Compliance:** N/A  
**Ref/Part Number:**  
**Total Findings:** 1

This item is satisfactory - no work required

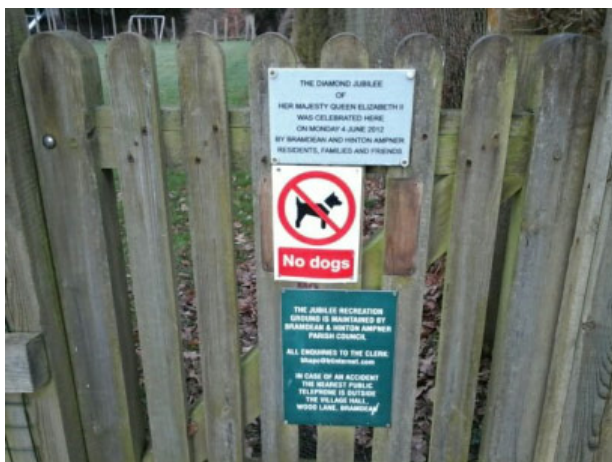
**Item:** Ancillary Items - Sign  
**Manufacturer:** Owner/Operator  
**Surface Type:** N/A  
**Equipment Compliance:** N/A  
**Surface Area Compliance:** N/A  
**Ref/Part Number:**  
**Total Findings:** 1

It is recommended that information signs with emergency contact details are installed at each entrance/exit point to the playground - Provide in accordance with the recommendations set out in BS EN 1176

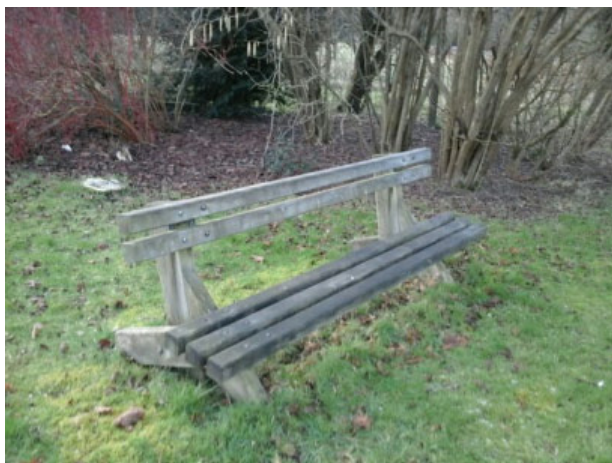
**Item:** Ancillary Items - Bench  
**Manufacturer:** Owner/Operator  
**Surface Type:** Grass  
**Equipment Compliance:** N/A  
**Surface Area Compliance:** N/A  
**Ref/Part Number:**  
**Total Findings:** 1

This item is satisfactory - no work required

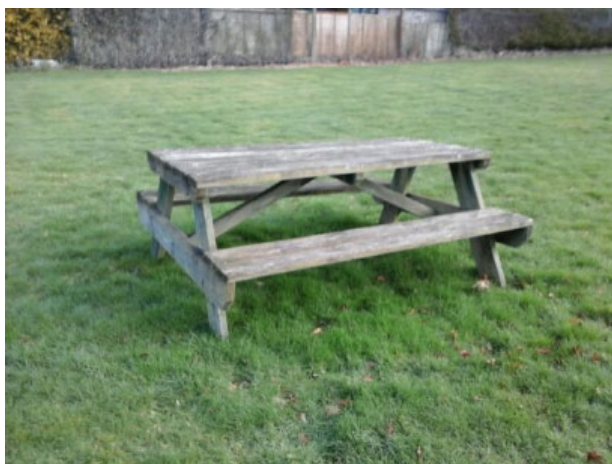
**Item:** Ancillary Items - Picnic Table  
**Manufacturer:** Owner/Operator  
**Surface Type:** Grass  
**Equipment Compliance:** N/A  
**Surface Area Compliance:** N/A  
**Ref/Part Number:**  
**Total Findings:** 2

The bench is not securely fixed to the surface and there is some possibility of the item tipping or rolling over - Secure the bench to the ground

There is some evidence of rot in the timber in the legs - Monitor for any further deterioration and replace as required

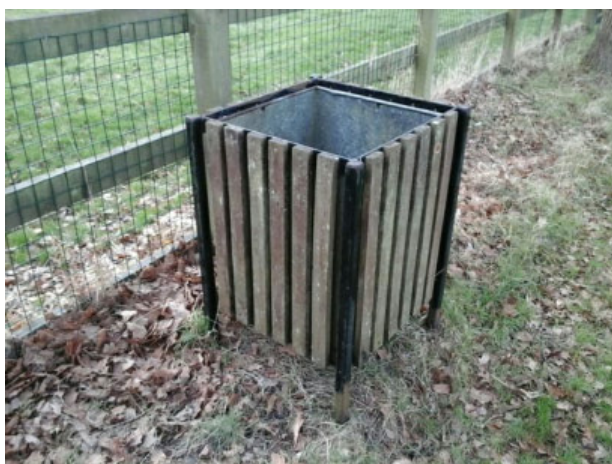
**Item:** Ancillary Items - Litter Bin  
**Manufacturer:** Owner/Operator  
**Surface Type:** Grass  
**Equipment Compliance:** N/A  
**Surface Area Compliance:** N/A  
**Ref/Part Number:**  
**Total Findings:** 1

This item is satisfactory - no work required

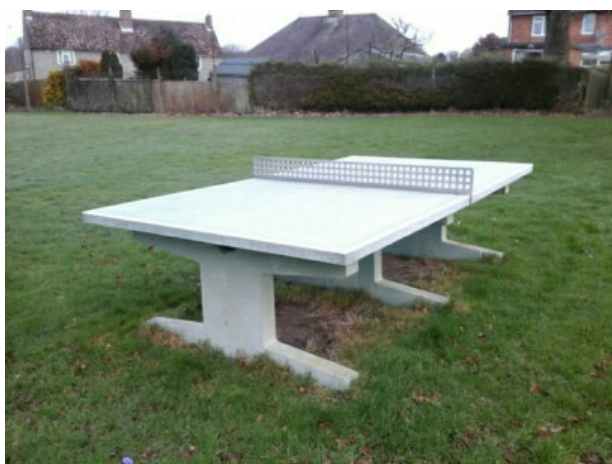
**Item:** Other - Table Tennis  
**Manufacturer:** Unknown  
**Surface Type:** Grass  
**Equipment Compliance:** N/A  
**Surface Area Compliance:** N/A  
**Ref/Part Number:**  
**Total Findings:** 1

This item is satisfactory - no work required

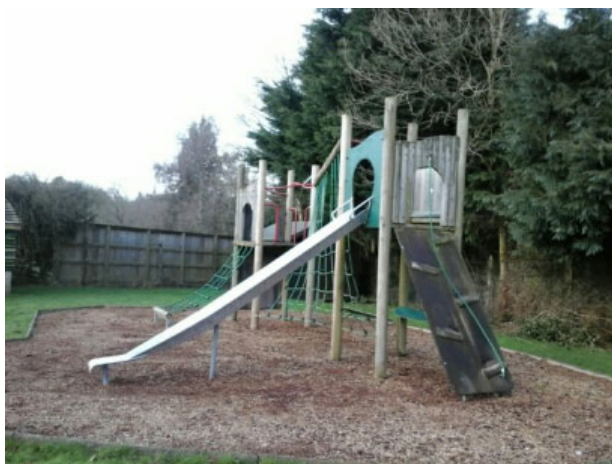
**Item:** Activity Equipment - Multi Play (Junior)  
**Manufacturer:** Playdale Playgrounds Ltd  
**Surface Type:** Bark Mulch  
**Equipment Compliance:** No  
**Surface Area Compliance:** Yes  
**Ref/Part Number:**  
**Total Findings:** 12

The lower timber forms a hard object within the falling space of the equipment in contravention of the requirements of BS EN 1176 Part 1 - Monitor use

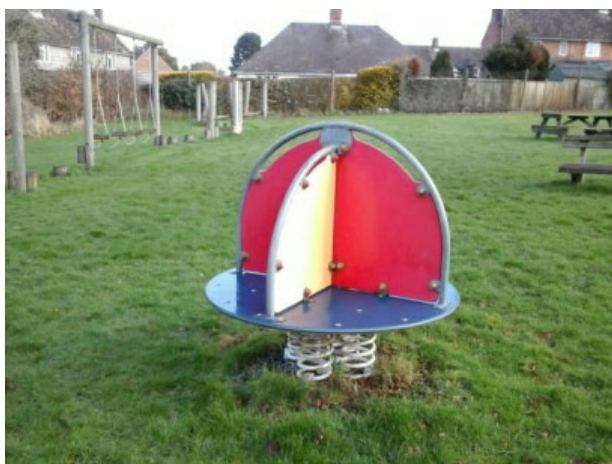
**Item:** Rocking Equipment - Spring Ark  
**Manufacturer:** Unknown  
**Surface Type:** Grass Matrix Tiles  
**Equipment Compliance:** Yes  
**Surface Area Compliance:** Yes  
**Ref/Part Number:**  
**Total Findings:** 2

The grass mats are silted up, the soil is compacted and the area will become very slippery when the soil is wet. - Lift and relay the mats

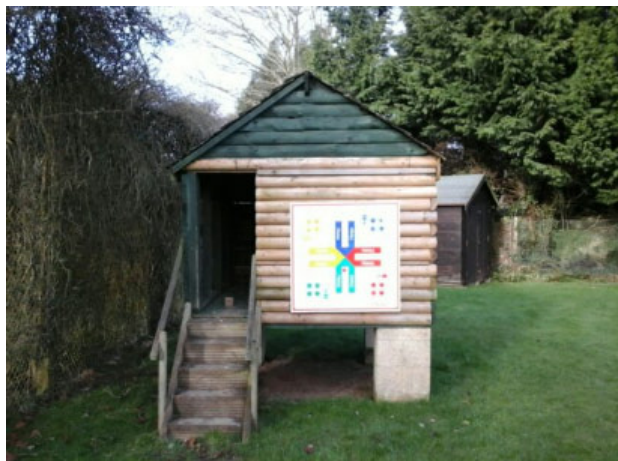
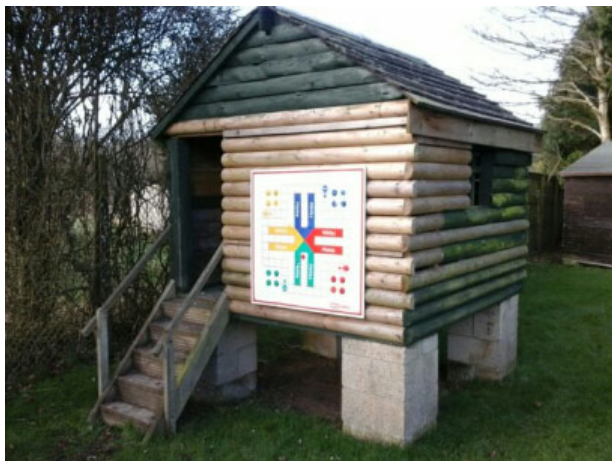
**Item:** Activity Equipment - Playhouse  
**Manufacturer:** Unknown

**Finding:** This equipment has not been designed or installed to meet with the requirements of BS EN 1176 for public playground equipment; we have however used our knowledge of these standards to assist in forming the basis of our risk assessment for the equipment and our report.

**Action:** Monitor use and review the use of the equipment and risk assessment regularly

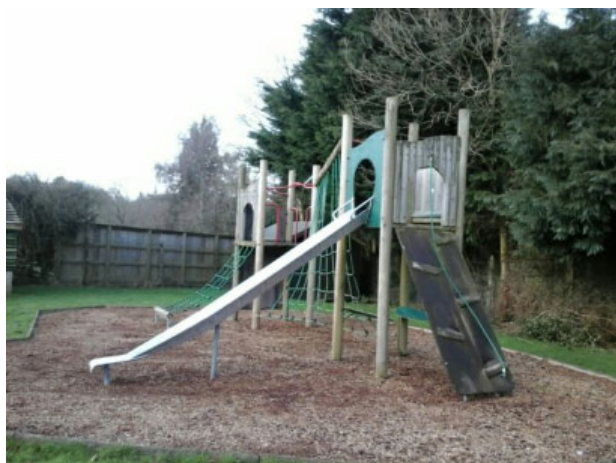
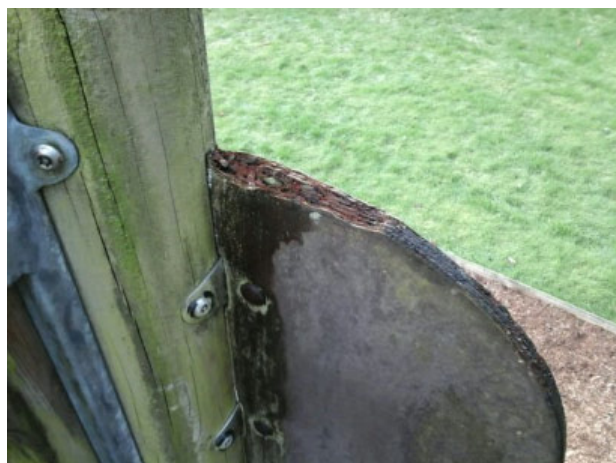
**Item:** Activity Equipment - Multi Play (Junior)  
**Manufacturer:** Playdale Playgrounds Ltd

**Finding:** The plywood has delaminated in some places

**Action:** Remove all rough or splintered edges.

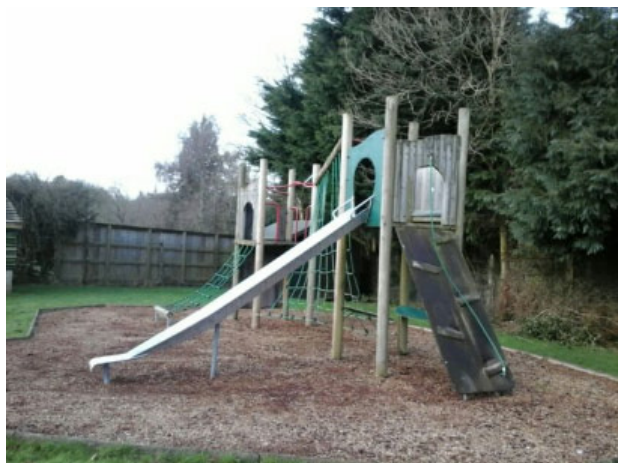
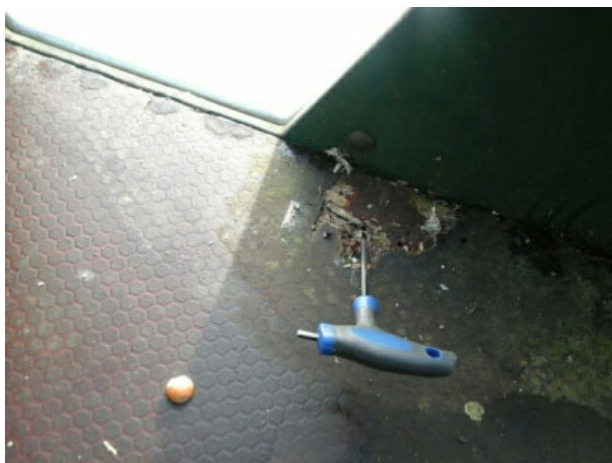
**Item:** Activity Equipment - Multi Play (Junior)  
**Manufacturer:** Playdale Playgrounds Ltd

**Finding:** The plywood has delaminated in the deck by the slide

**Action:** Remove all rough or splintered edges.
