Annual Inspection

Winchester City Council

The Jubilee RG (Bramdean and Hinton Ampner PC)

Off Woodlane Close, Bramdean, Winchester,
Hampshire, SO24 0JR

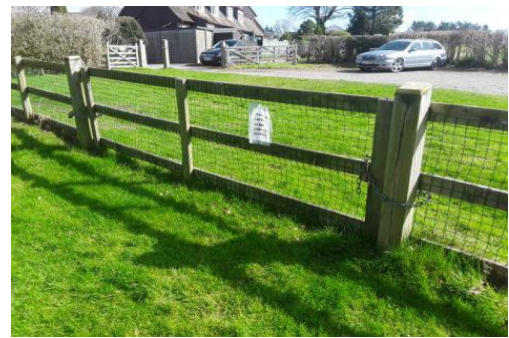
Finding 1
 There are areas or parts of the timber on the structure that have rotted - Replace all affected timbers

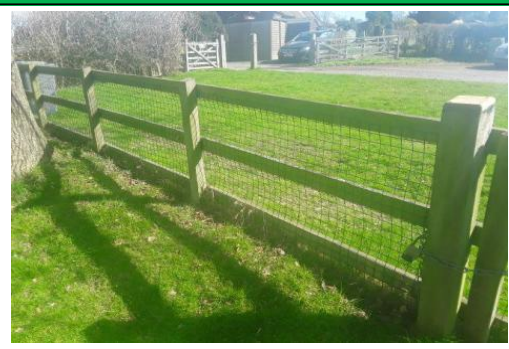
Finding 1
 There are areas or parts of the timber on the structure that have rotted - Replace all affected timbers

Finding 2
 There is some strimmer / machinery damage apparent on the posts, this can penetrate the preservative applied to the timber and accelerate the rotting process - Monitor for any deterioration (rot) and replace as required

Finding 3
 There are a number of loose posts around the fence - Monitor for any further deterioration and reset as required

Finding 4
 The timber has a number of splits/shakes or air cracks and this may affect the stability or allow water ingress which will accelerate the rotting process - Monitor to ensure the splits do not cross through fixing points of the structure and/or cause any instability

Finding 5
 There is some damage to the fence sections - Monitor for any further deterioration and repair as required

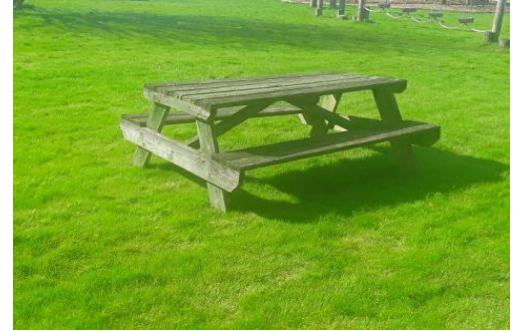
There are areas or parts of the timber on the structure that have rotted - Replace all affected timbers

There is some evidence of fire damage to the item - Monitor for any further deterioration and repair as required

There is or are fixings missing on the item - Replace all missing fixings

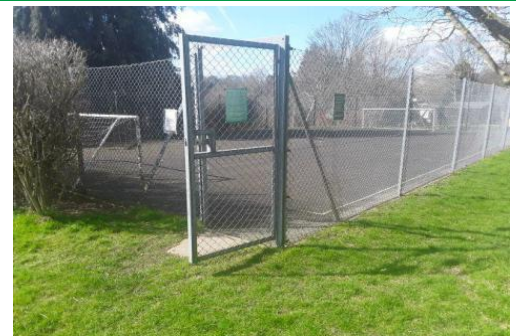
There are a number of loose posts around the fence - Monitor for any further deterioration and reset as required

The goal posts are slightly loose in the ground - Monitor for any further deterioration and reset as required

The goal nets are damaged - Repair / replace as required

There are missing goal frame fixings - Replace all missing fixings

There is some damage to the fence sections - Monitor for any further deterioration and repair as required

There are missing ground mount fixings - Replace all missing fixings

The paintwork on this item has been damaged or worn exposing the metal underneath which is rusting - Treat any rusting components and repaint

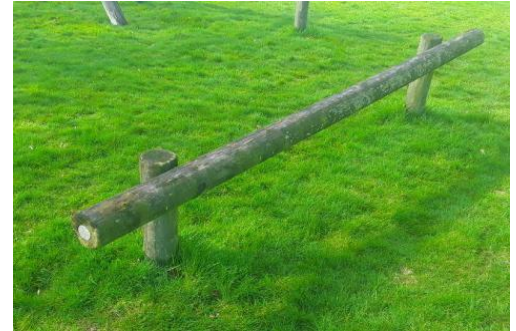
There is some strimmer / machinery damage apparent on the posts, this can penetrate the preservative applied to the timber and accelerate the rotting process - Monitor for any deterioration (rot) and replace as required

There is some evidence of rot in the timber - Monitor for any further deterioration and replace as required

The timber has a number of splits/shakes or air cracks and this may affect the stability or allow water ingress which will accelerate the rotting process - Monitor to ensure the splits do not cross through fixing points of the structure and/or cause any instability

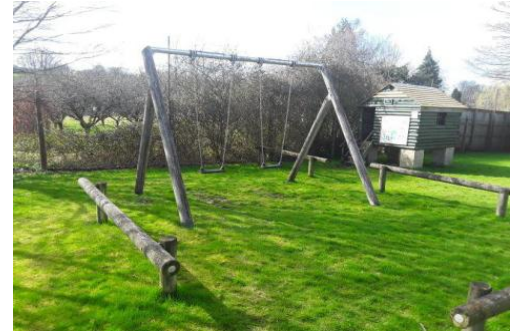
There is some strimmer / machinery damage apparent on the posts, this can penetrate the preservative applied to the timber and accelerate the rotting process - Monitor for any deterioration (rot) and replace as required

There is some evidence of rot in the posts - Monitor for any further deterioration and replace as required

There is some notable evidence of chain wear - Monitor for any further deterioration and replace when 40% worn

The seat has minor damage or wear - Monitor for any further deterioration and replace as required

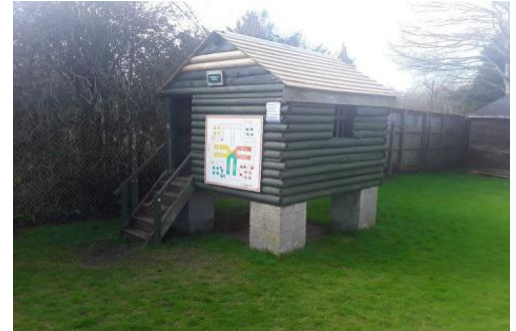
The item fails to meet the requirements of BS EN 1176 Part 1 4.2.7.2 for head and neck entrapment in the window - Monitor - No remedial work recommended

The fencing forms a hard object within the falling space of the equipment and there is also insufficient surfacing provided in contravention of BS EN 1176 Part 1 - Monitor - no remedial work recommended

There is some evidence of rot in the timber - Monitor for any further deterioration and replace as required

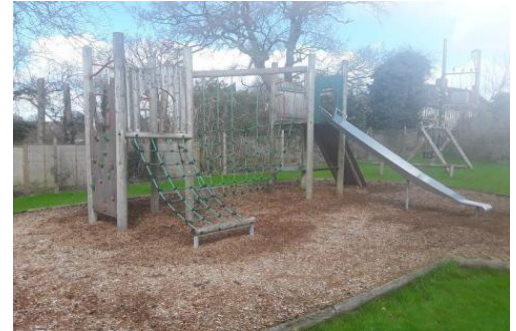
The depth of the loose fill surfacing is lower than the recommended depth specified in BS EN 1176; the free height of fall of the equipment is less than 2.0m and a minimum of 300mm depth should be provided (including an extra 100mm to allow for compaction and displacement as per BS EN 1176 Part 1 - Table 4) - Top up loose fill surfacing to recommended levels

The net anchor timber forms a hard object within the falling space of the equipment in contravention of the requirements of BS EN 1176 Part 1 - Monitor - No remedial work recommended

There is/are finger entrapment/s between platform and post and the item fails to meet the requirements of BS EN 1176 Part 1 4.2.7.6 Entrapment of fingers - Monitor - No remedial work recommended

There is some evidence of rot in the climbing panels - Monitor for any further deterioration and replace as required

There is some evidence of rot in the posts - Monitor for any further deterioration and replace as required

There is some evidence of rot in the timber above the net climber - Monitor for any further deterioration and replace as required

There is some evidence of rot in the timber - Monitor for any further deterioration and replace as required

A number of barrier fixing(s) have worked loose - Secure all loose fixings

There are areas or parts of the timber edging surrounding the play equipment that have rotted - Replace all affected timbers

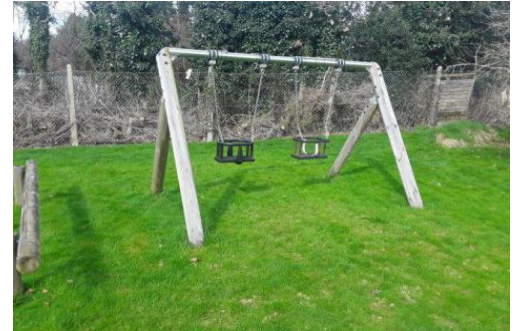
The seat has minor damage or wear - Monitor for any further deterioration and replace as required

The Anti Wrap bearings are dry and not moving freely - Lubricate bearings in accordance with the manufacturers recommendations

There is some notable evidence of chain wear - Monitor for any further deterioration and replace when 40% worn

There is some evidence of rot in the posts - Monitor for any further deterioration and replace as required

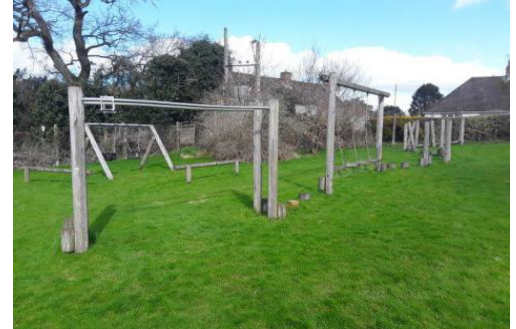
The timber has a number of splits/shakes or air cracks and this may affect the stability or allow water ingress which will accelerate the rotting process - Monitor to ensure the splits do not cross through fixing points of the structure and/or cause any instability

There is some evidence of rot in the timber throughout the trail - Monitor for any further deterioration and replace as required

There is algae or moss on the surface of the equipment that can lead to the onset of rot - Monitor condition of the timbers (rot), clean and treat appropriately

There is some notable evidence of chain wear - Monitor for any further deterioration and replace when 40% worn

The bushes are showing signs of wear - Monitor for any further deterioration and replace as required

There is some strimmer / machinery damage apparent on the posts, this can penetrate the preservative applied to the timber and accelerate the rotting process - Monitor for any deterioration (rot) and replace as required

There are areas or parts of the stepping pods that have rotted - Replace all affected timbers

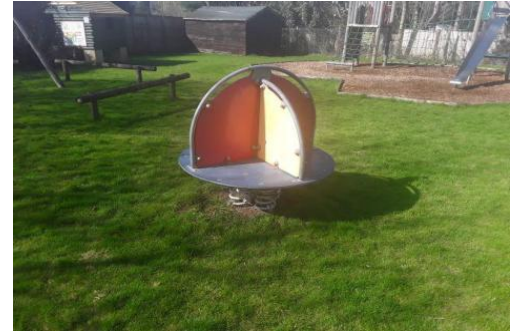
There is surface corrosion present on the item - Consider treating the item

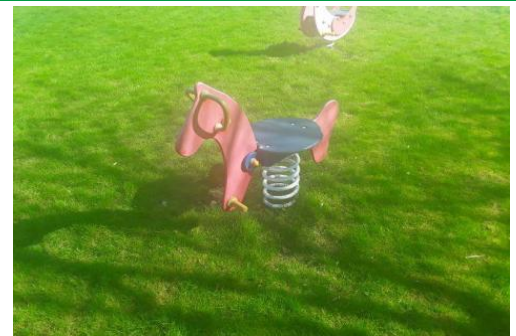
The end of handgrips and/or footrests have a cross section of less than 15cm² and fail to meet the requirements of BS EN 1176 Part 6 - Monitor - No remedial work recommended

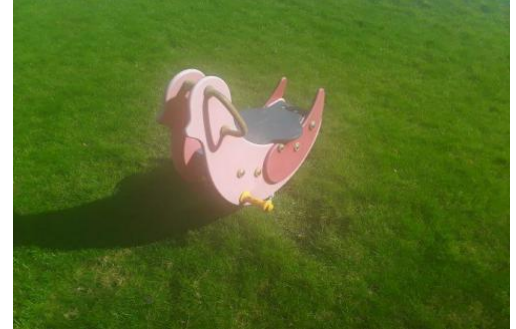
The end of handgrips and/or footrests have a cross section of less than 15cm² and fail to meet the requirements of BS EN 1176 Part 6 - Monitor - No remedial work recommended

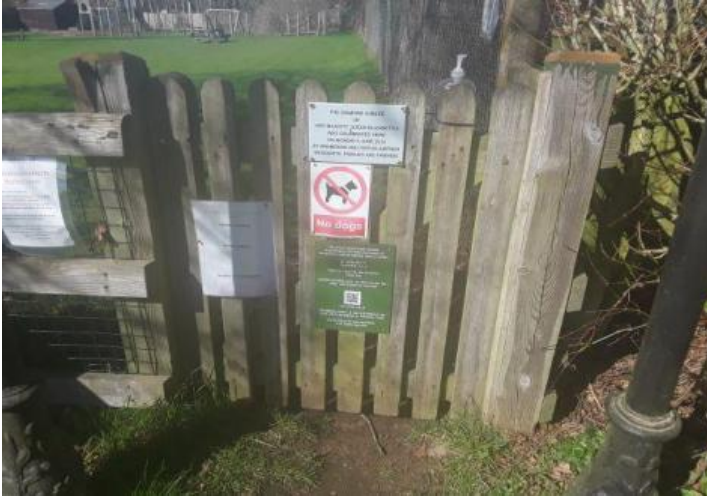
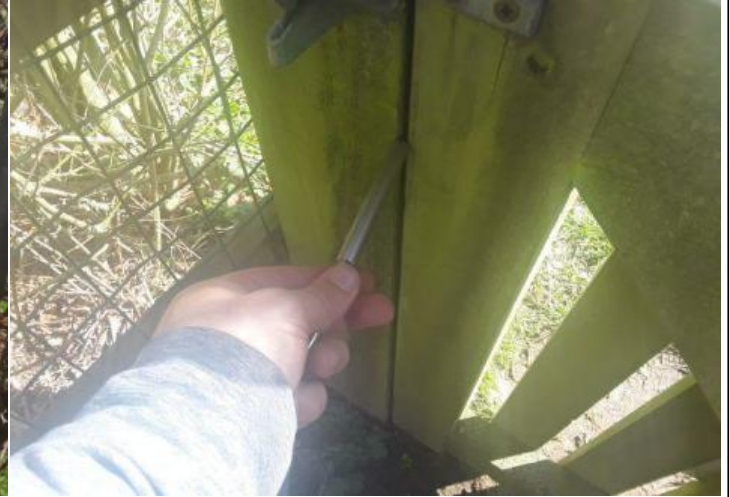
Finding: There are openings that are less than 12mm that could trap or crush fingers

Action: Where possible a 12mm gap should be maintained on both sides or between the gate leaves

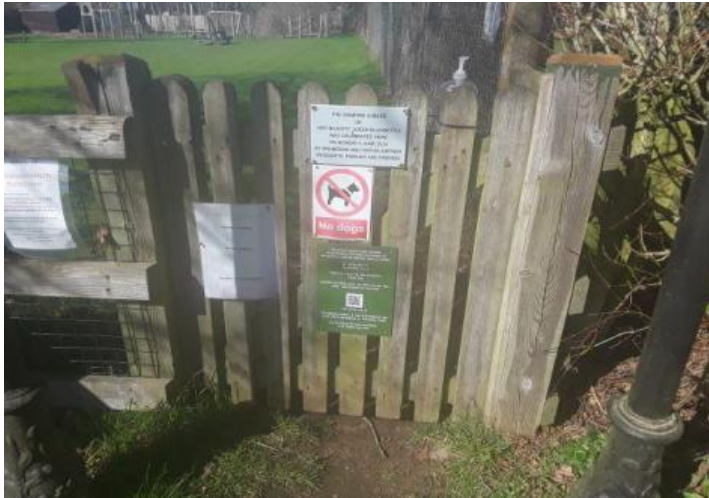
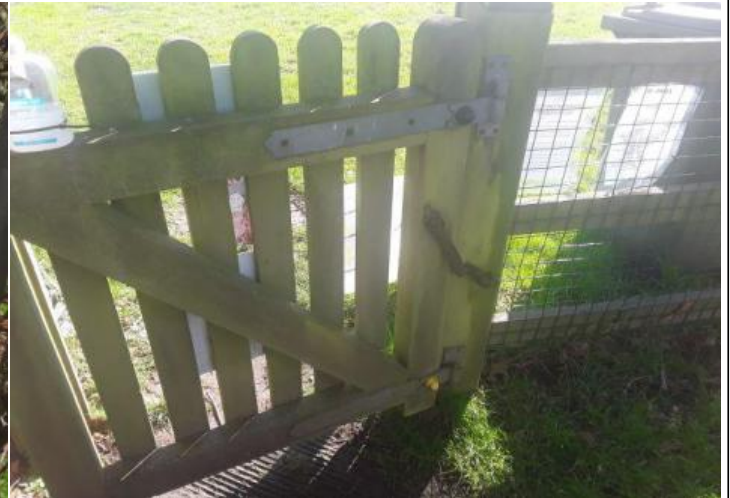
Finding: The gate is not operating correctly

Action: Take effective action to ensure the gate closes between 4 and 8 seconds

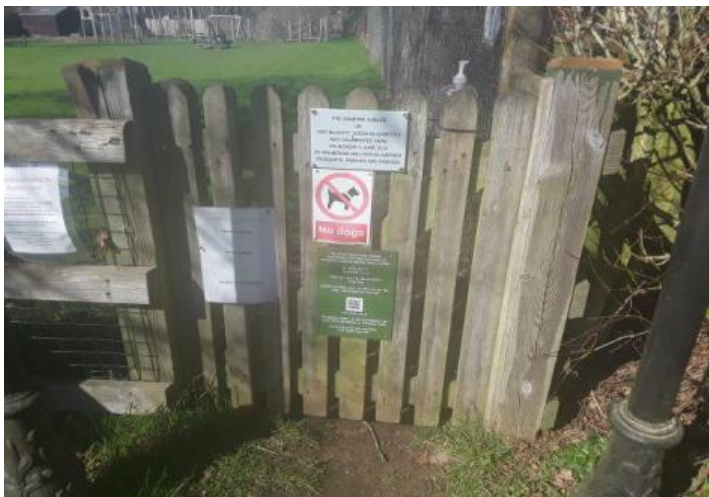
Finding: There is some evidence of rot in the timber

Action: Monitor for any further deterioration and replace as required

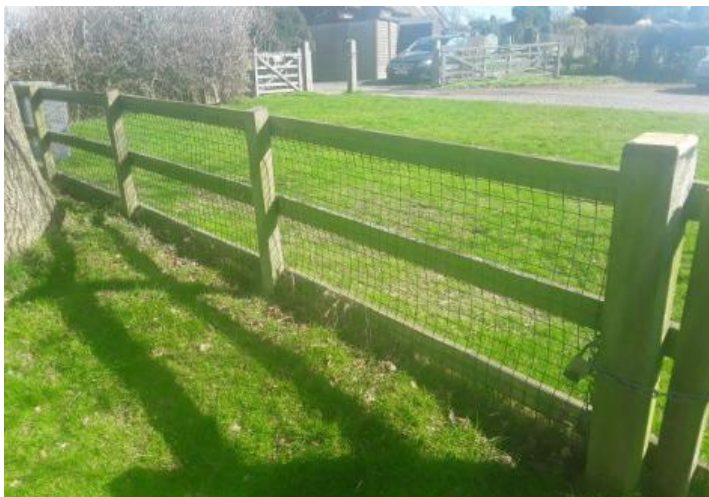
Finding: There are areas or parts of the timber on the structure that have rotted

Action: Replace all affected timbers

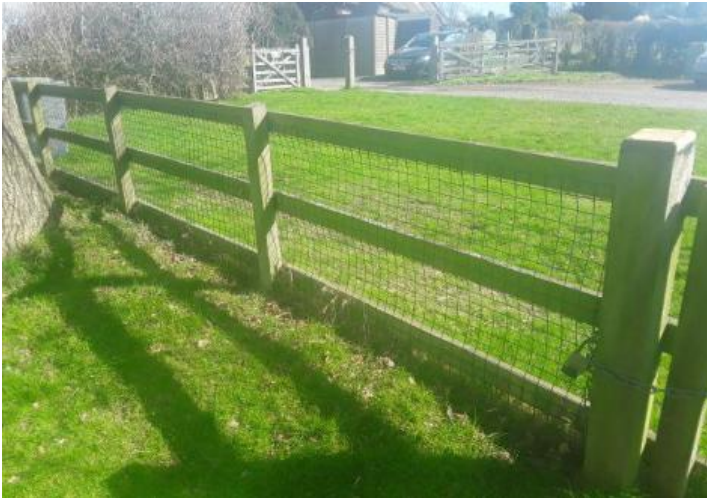
Finding: There is some strimmer / machinery damage apparent on the posts, this can penetrate the preservative applied to the timber and accelerate the rotting process

Action: Monitor for any deterioration (rot) and replace as required

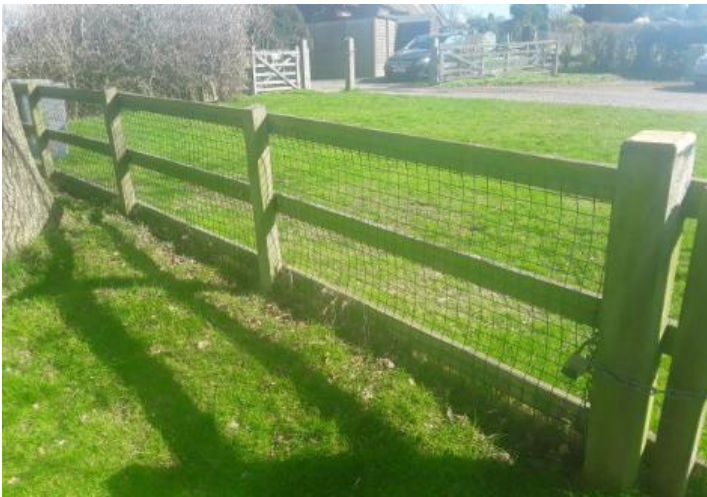
Finding: There are a number of loose posts around the fence

Action: Monitor for any further deterioration and reset as required

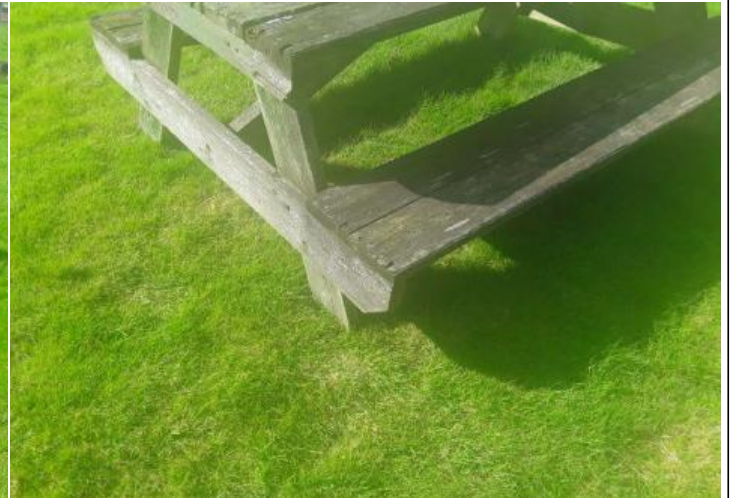
Finding: The table is not secured to the ground and there is some potential for the item to be moved within falling spaces of equipment
Action: Secure the item to the ground

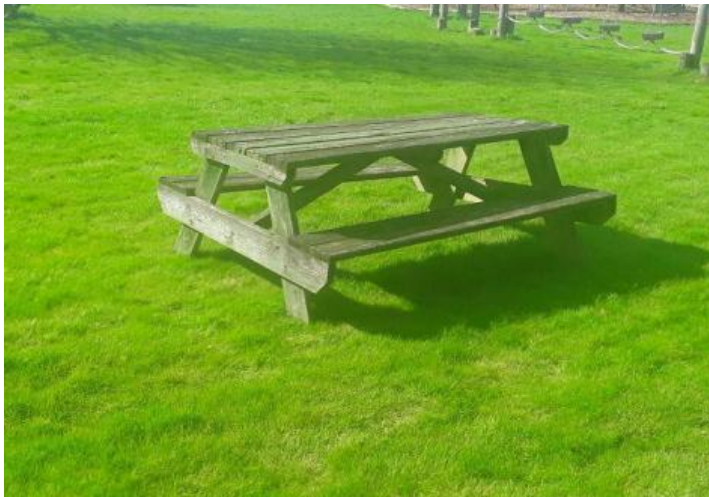
Finding: There are areas or parts of the timber on the structure that have rotted
Action: Replace all affected timbers

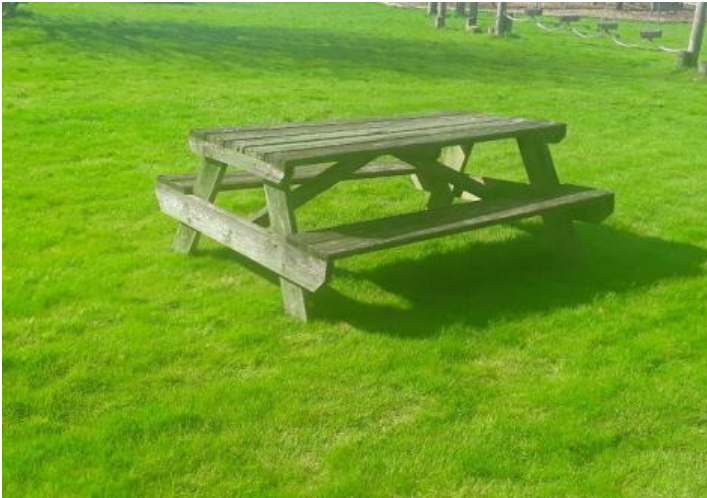
Finding: There is some evidence of fire damage to the item
Action: Monitor for any further deterioration and repair as required

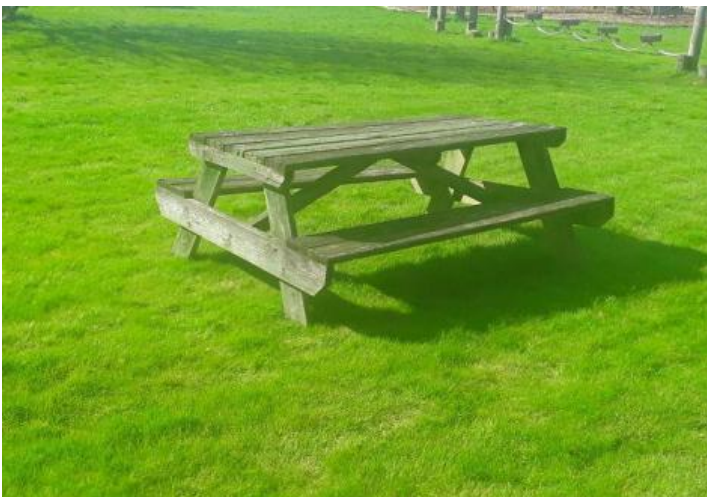
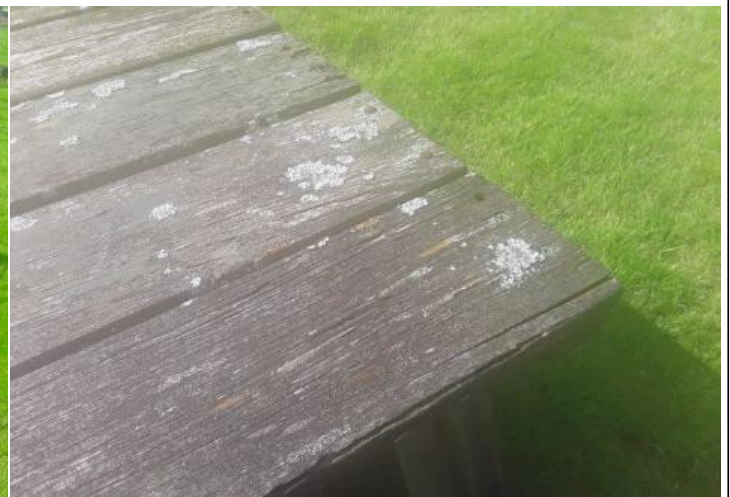
Finding: There is algae or moss on the surface of the equipment
Action: Clean and treat appropriately

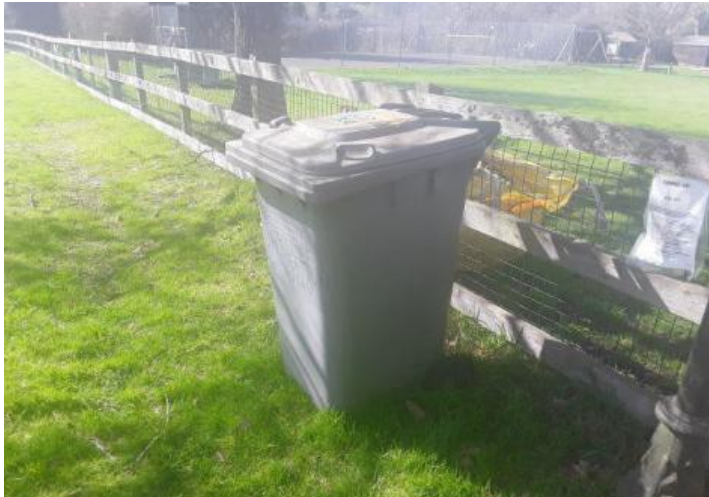
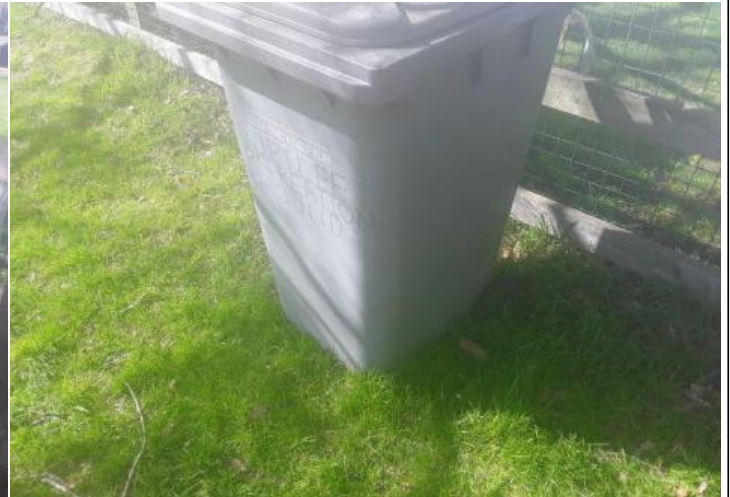
Finding: The bin is not securely fixed to the surface and there is some possibility of the item tipping or rolling over

Action: Secure the bin to the ground

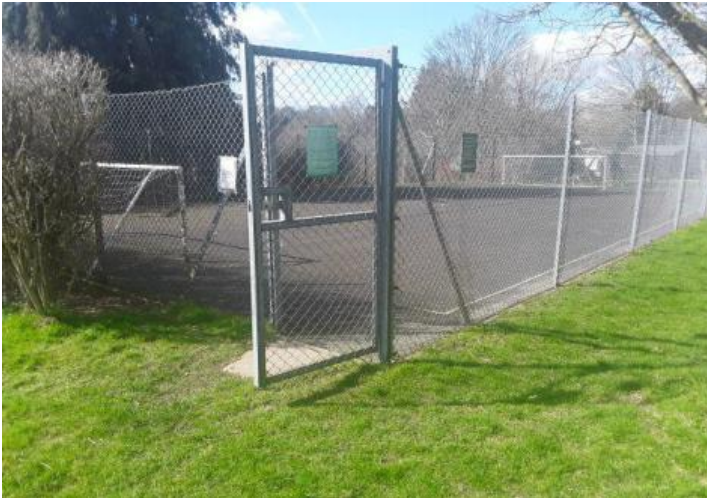
Finding: The goal posts are slightly loose in the ground

Action: Monitor for any further deterioration and reset as required

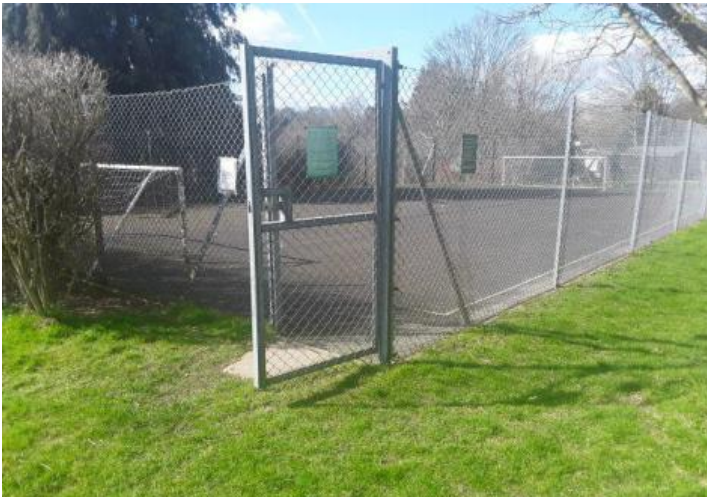
Finding: There are missing ground mount fixings

Action: Replace all missing fixings

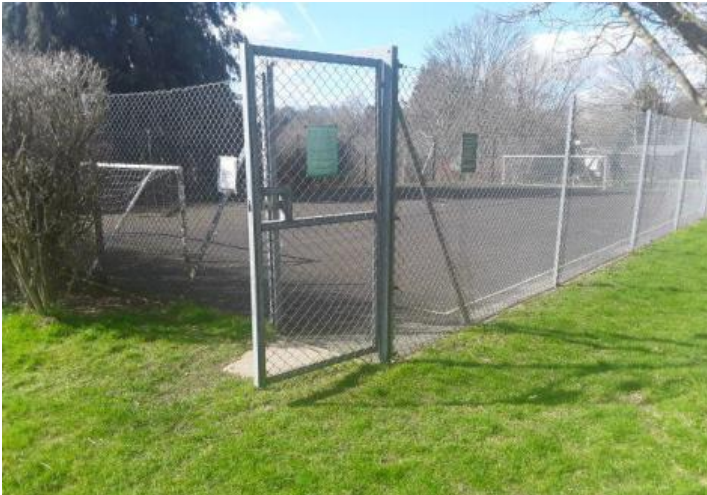
Finding: The goal nets are damaged

Action: Repair / replace as required

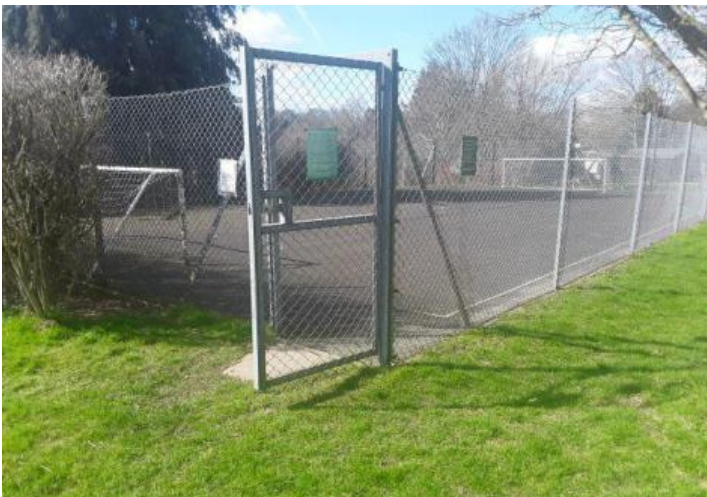
Finding: The paintwork on this item has been damaged or worn exposing the metal underneath which is rusting

Action: Treat any rusting components and repaint

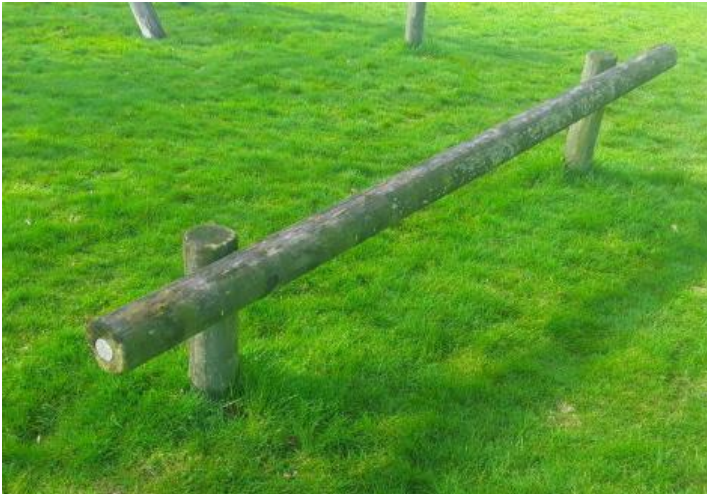
Item: Swings - Swing Barrier **Risk Level:** L - Low Risk
Manufacturer: Playdale Playgrounds Ltd **Surface:** Grass

Finding: There is some strimmer / machinery damage apparent on the posts, this can penetrate the preservative applied to the timber and accelerate the rotting process

Action: Monitor for any deterioration (rot) and replace as required

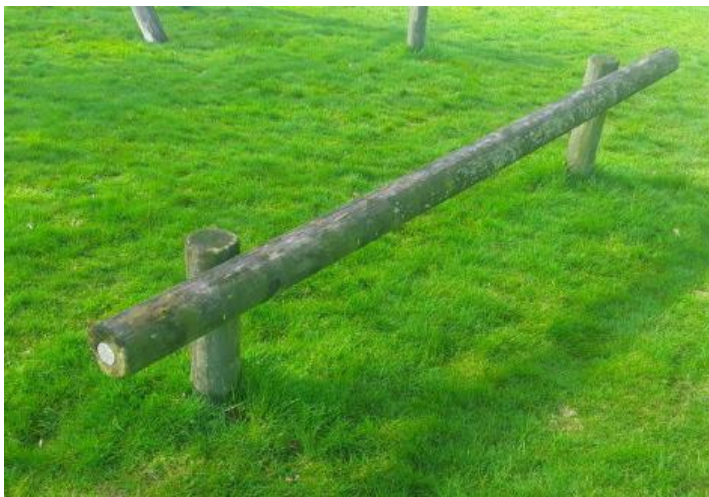
Item: Swings - Swing Barrier
Manufacturer: Playdale Playgrounds Ltd

Risk Level: L - Low Risk
Surface: Grass

Finding: The timber has a number of splits/shakes or air cracks and this may affect the stability or allow water ingress which will accelerate the rotting process

Action: Monitor to ensure the splits do not cross through fixing points of the structure and/or cause any instability

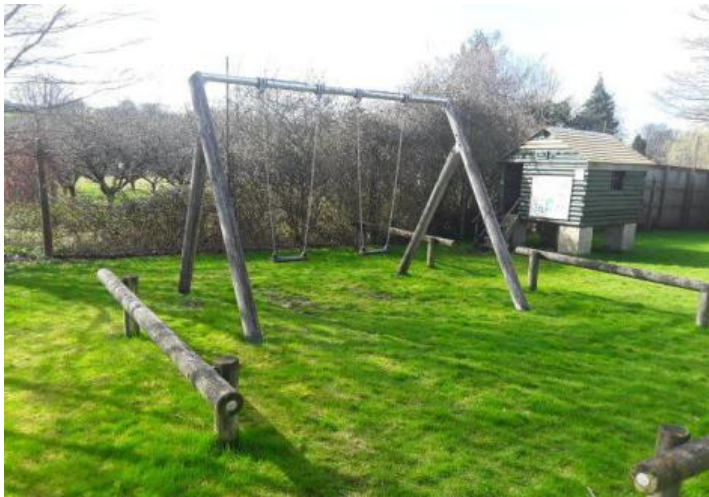
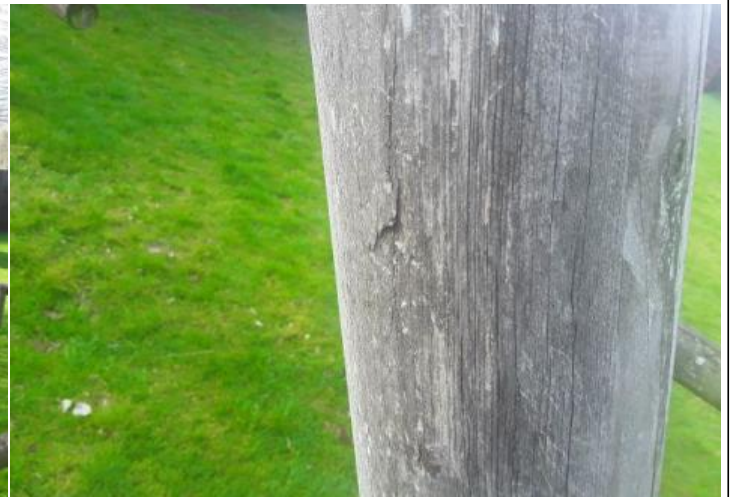
Item: Swings - 1 Bay 2 Seat (Flat)
Manufacturer: Playdale Playgrounds Ltd

Risk Level: L - Low Risk
Surface: Grass

Finding: Parts of the timber are rough or splintered

Action: Remove all rough or sharp edges

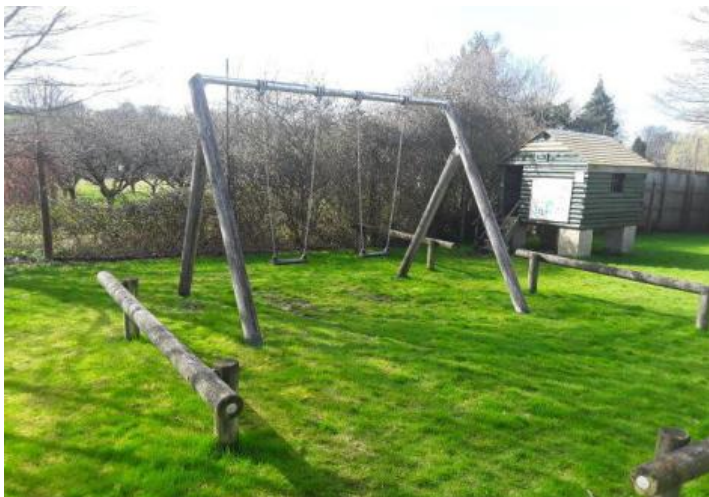
Item: Swings - 1 Bay 2 Seat (Flat)
Manufacturer: Playdale Playgrounds Ltd

Risk Level: L - Low Risk
Surface: Grass

Finding: The seat has minor damage or wear

Action: Monitor for any further deterioration and replace as required

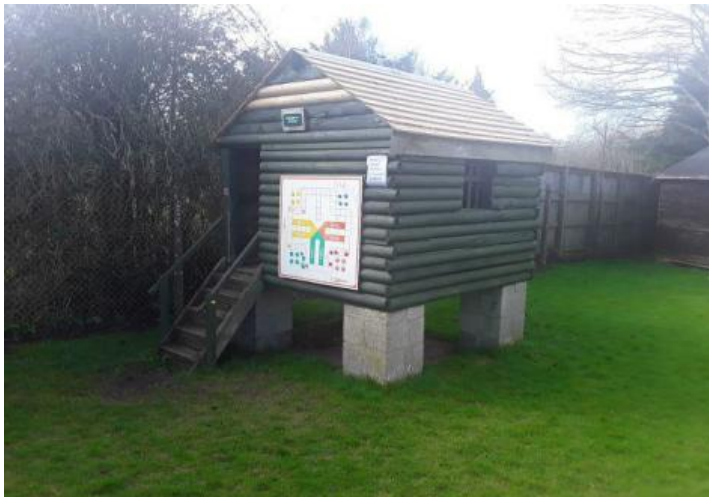
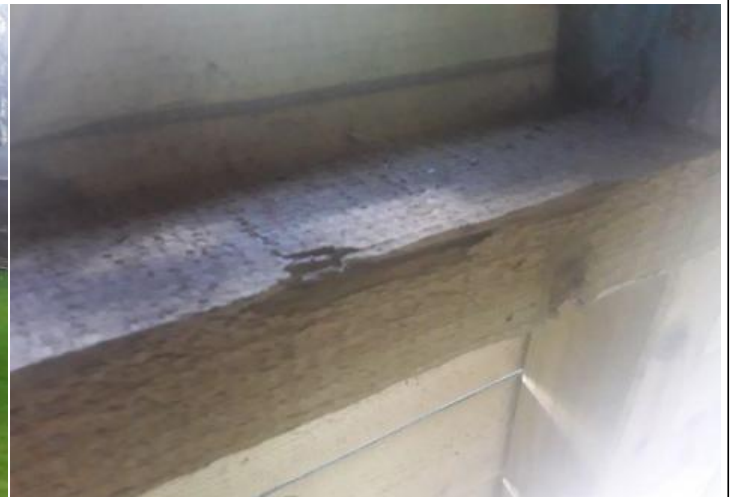
Item: Activity Equipment - Playhouse
Manufacturer: Not Identified

Risk Level: L - Low Risk
Surface: Grass

Finding: Parts of the timber are rough or splintered

Action: Remove all rough or sharp edges

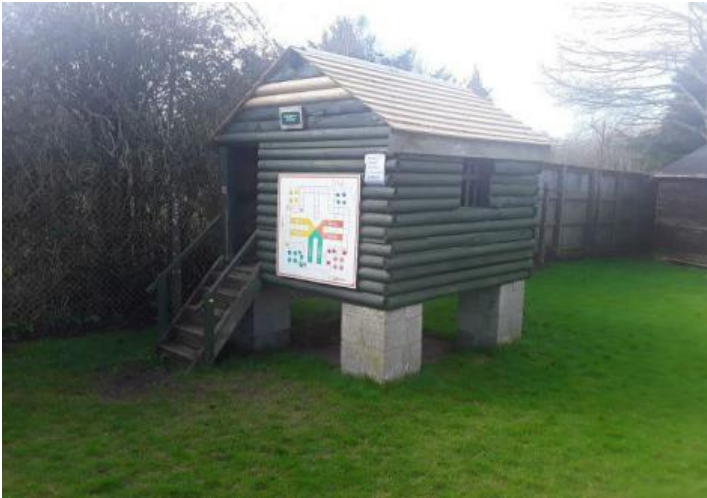
Item: Activity Equipment - Playhouse
Manufacturer: Not Identified

Risk Level: L - Low Risk
Surface: Grass

Finding: There is some evidence of rot in the timber

Action: Monitor for any further deterioration and replace as required

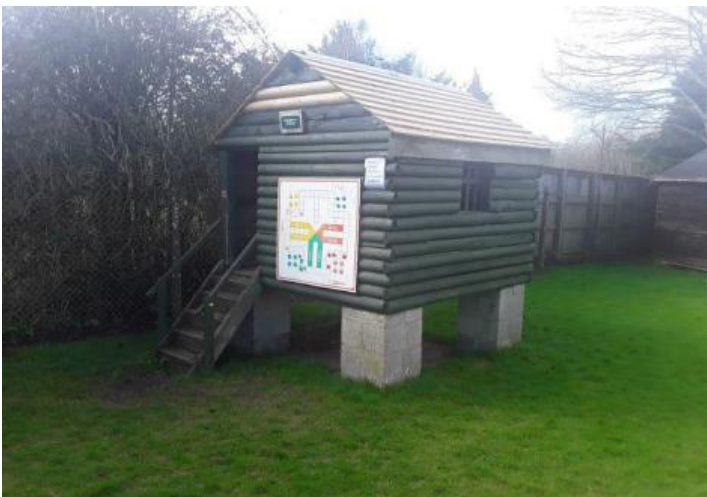
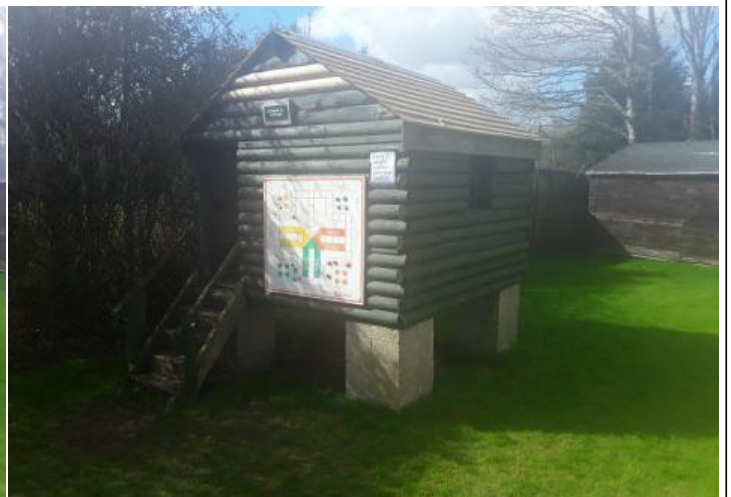
Item: Activity Equipment - Playhouse
Manufacturer: Not Identified

Risk Level: V - Very Low Risk
Surface: Grass

Finding: This equipment has not been designed or installed to meet with the requirements of BS EN 1176 for public playground equipment; we have however used our knowledge of these standards to assist in forming the basis of our report.

Action: The equipment should either be removed from use or written confirmation be sought from the supplier concerning the suitability of this equipment for the intended use

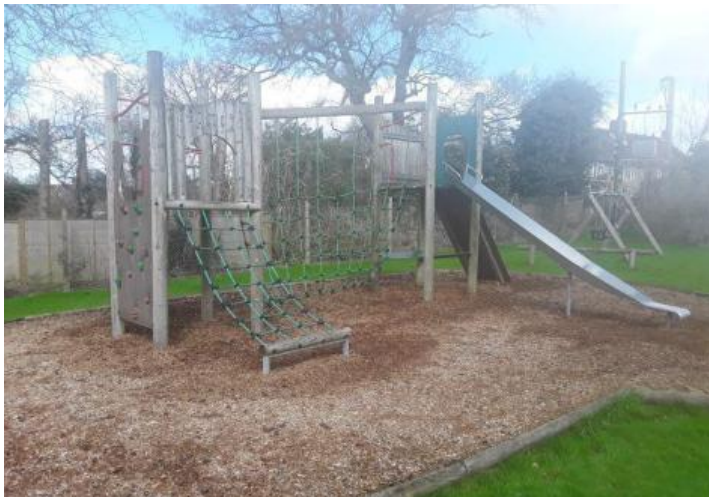
Item: Activity Equipment - Multi Play (Junior)
Manufacturer: Playdale Playgrounds Ltd

Risk Level: V - Very Low Risk
Surface: Bark Mulch

Finding: There is/are finger entrapment/s between platform and post and the item fails to meet the requirements of BS EN 1176 Part 1 4.2.7.6 Entrapment of fingers

Action: Monitor - No remedial work recommended

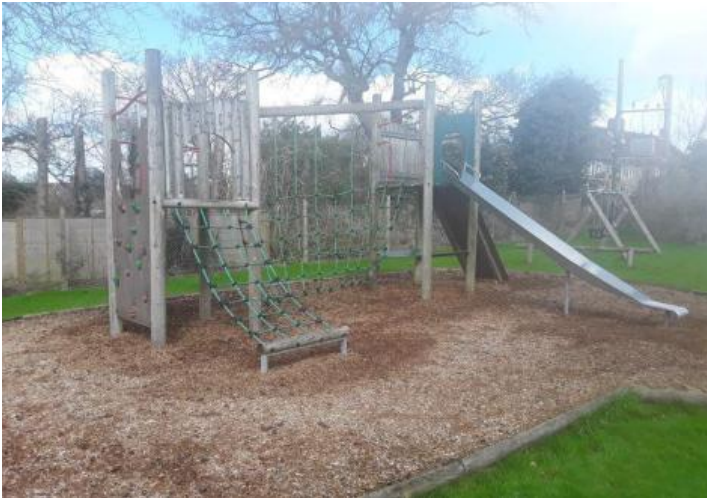
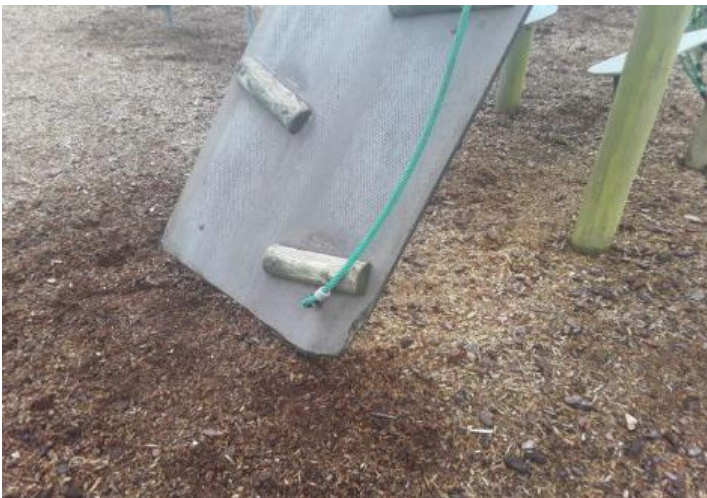
Item: Activity Equipment - Multi Play (Junior)
Manufacturer: Playdale Playgrounds Ltd

Risk Level: L - Low Risk
Surface: Bark Mulch

Finding: There is some evidence of rot in the climbing panels

Action: Monitor for any further deterioration and replace as required

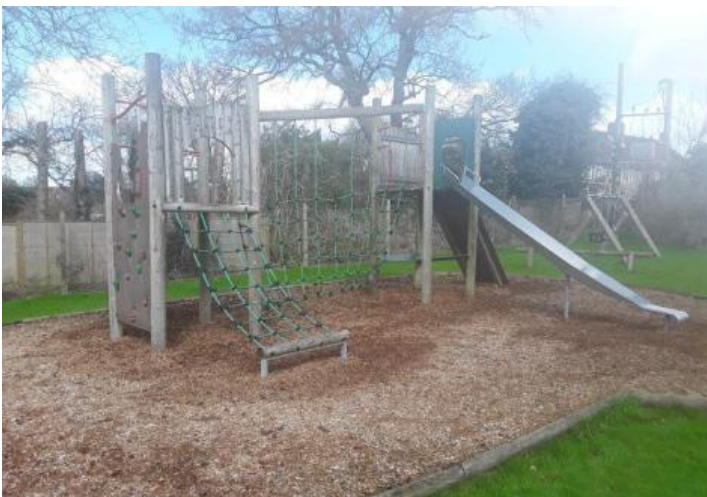
Item: Activity Equipment - Multi Play (Junior)
Manufacturer: Playdale Playgrounds Ltd

Risk Level: L - Low Risk
Surface: Bark Mulch

Finding: There is some evidence of rot in the timber above the net climber

Action: Monitor for any further deterioration and replace as required

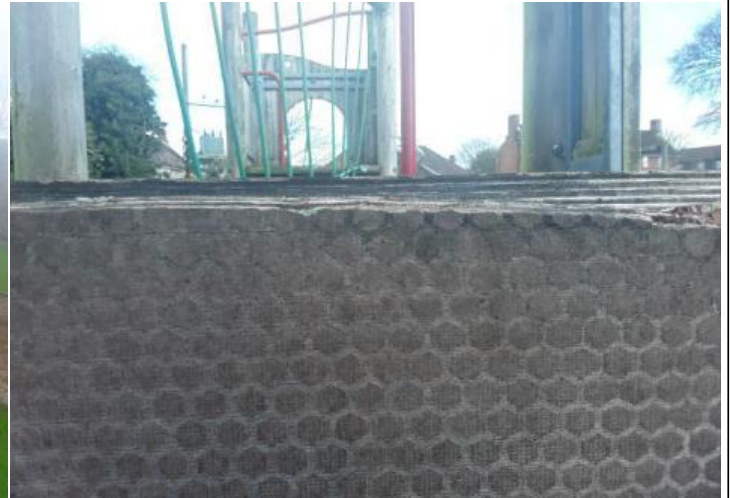
Item: Activity Equipment - Multi Play (Junior)
Manufacturer: Playdale Playgrounds Ltd

Risk Level: L - Low Risk
Surface: Bark Mulch

Finding: Parts of the timber are rough or splintered

Action: Remove all rough or sharp edges

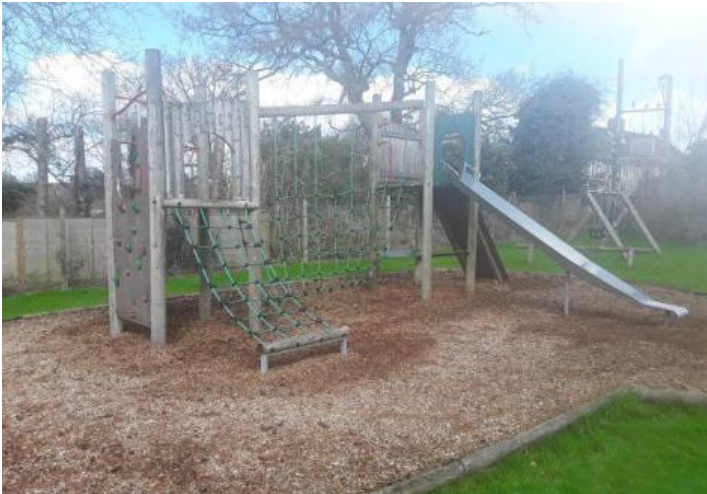
Item: Activity Equipment - Multi Play (Junior)
Manufacturer: Playdale Playgrounds Ltd

Risk Level: L - Low Risk
Surface: Bark Mulch

Finding: There is some evidence of rot in the timber

Action: Monitor for any further deterioration and replace as required

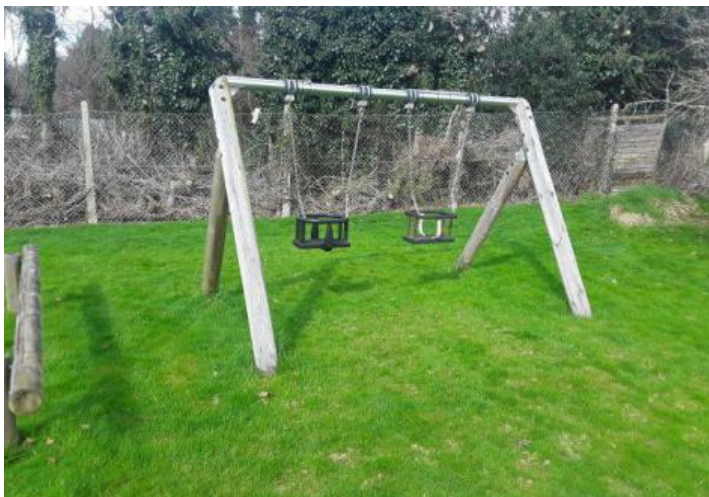
Item: Swings - 1 Bay 2 Seat (Cradle)
Manufacturer: Playdale Playgrounds Ltd

Risk Level: L - Low Risk
Surface: Grass

Finding: The Anti Wrap bearings are dry and not moving freely

Action: Lubricate bearings in accordance with the manufacturers recommendations

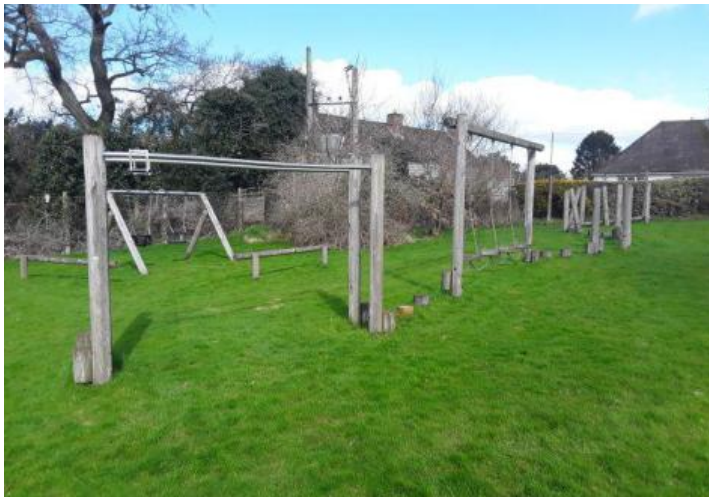
Item: Activity Equipment - Activity Trail
Manufacturer: Playdale Playgrounds Ltd

Risk Level: L - Low Risk
Surface: Grass Matrix Tiles

Finding: There is some evidence of rot in the timber throughout the trail
Action: Monitor for any further deterioration and replace as required

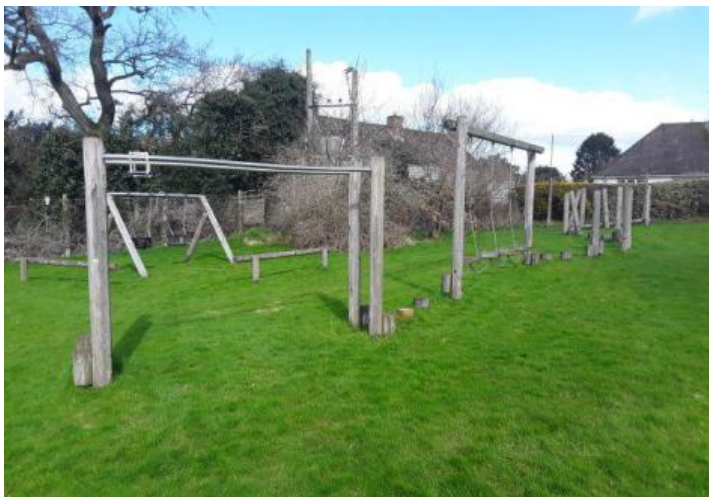
Item: Activity Equipment - Activity Trail
Manufacturer: Playdale Playgrounds Ltd

Risk Level: L - Low Risk
Surface: Grass Matrix Tiles

Finding: There is some notable evidence of chain wear

Action: Monitor for any further deterioration and replace when 40% worn

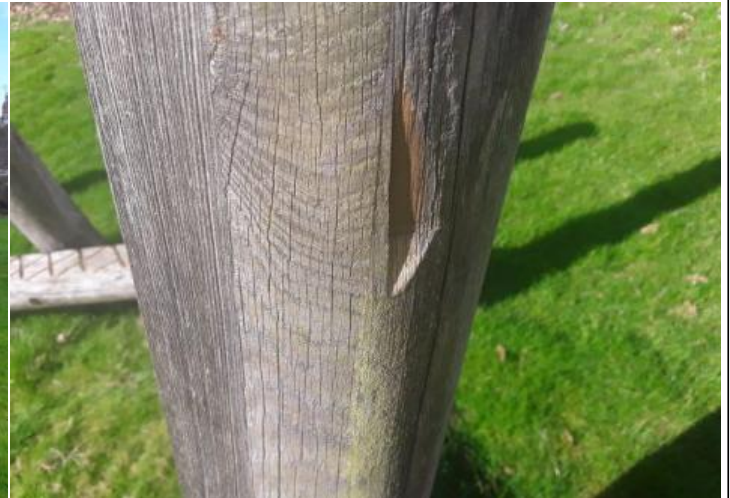
Item: Activity Equipment - Activity Trail
Manufacturer: Playdale Playgrounds Ltd

Risk Level: L - Low Risk
Surface: Grass Matrix Tiles

Finding: Parts of the timber are rough or splintered

Action: Remove all rough or sharp edges

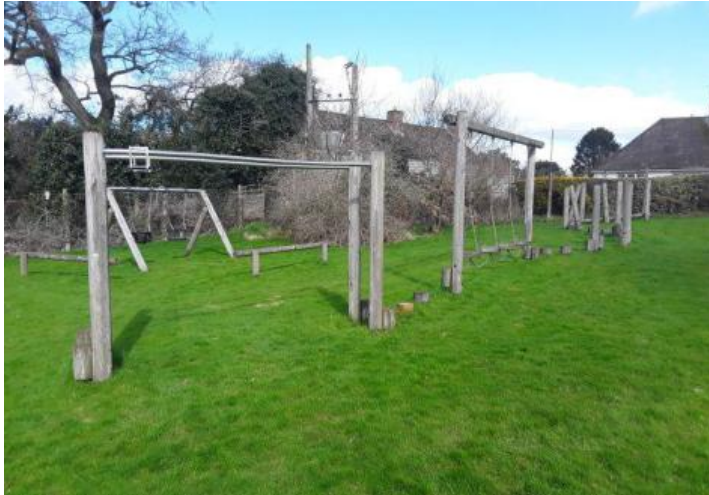
Item: Activity Equipment - Activity Trail
Manufacturer: Playdale Playgrounds Ltd

Risk Level: M - Moderate Risk
Surface: Grass Matrix Tiles

Finding: There are areas or parts of the stepping pods that have rotted

Action: Replace all affected timbers

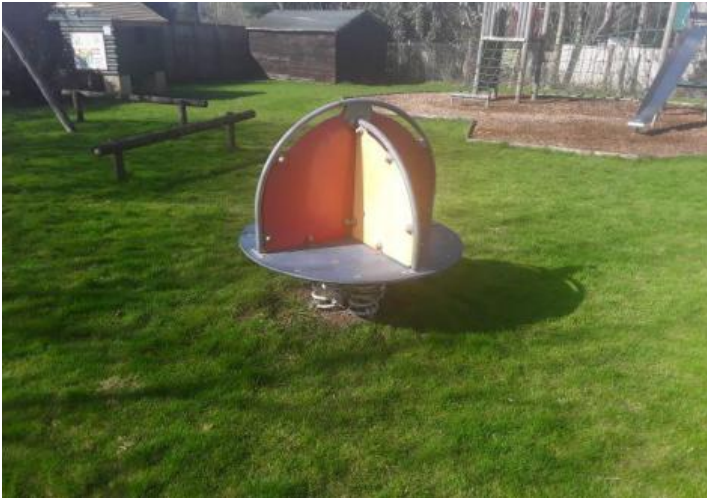
Item: Rocking Equipment - Spring Ark
Manufacturer: Playdale Playgrounds Ltd

Risk Level: L - Low Risk
Surface: Grass Matrix Tiles

Finding: There is surface corrosion present on the item

Action: Consider treating the item

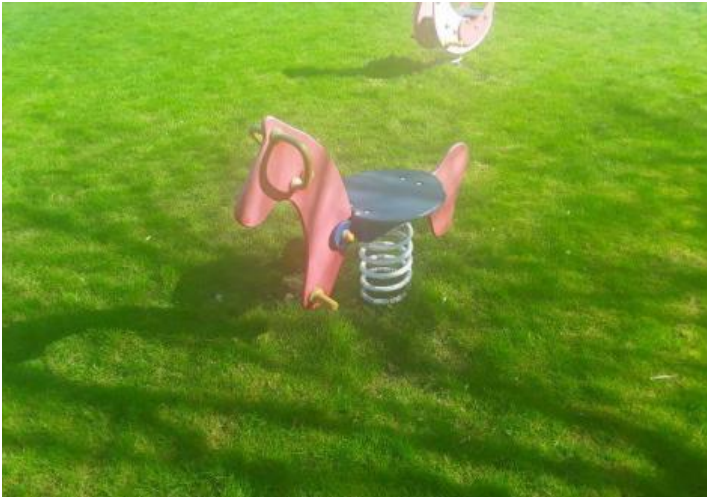
Item: Rocking Equipment - Spring Horse
Manufacturer: Ledon

Risk Level: L - Low Risk
Surface: Grass Matrix Tiles

Finding: The end of handgrips and/or footrests have a cross section of less than 15cm² and fail to meet the requirements of BS EN 1176 Part 6

Action: Monitor - No remedial work recommended
